MARINE TRANSPORTATION SAFETY INVESTIGATION REPORT M19P0020

STRIKING OF BERTH AND SHORE GANTRY CRANE

CONTAINER VESSEL *EVER SUMMIT*

Vanterm, Port of Vancouver

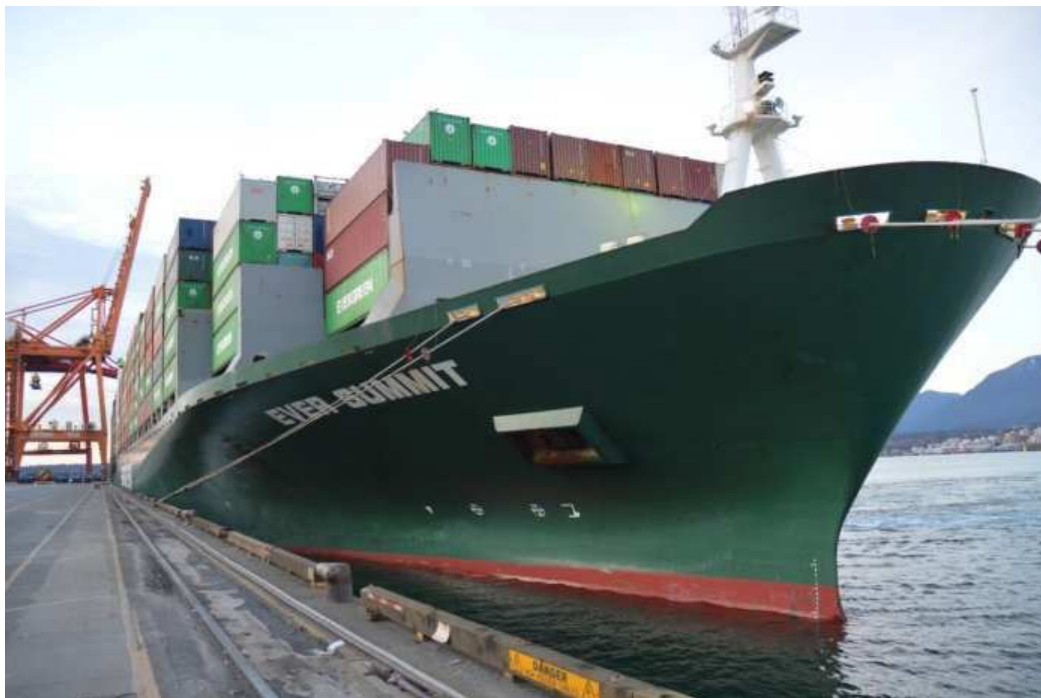
Figure 1. *Ever Summit* (Source: TSB)

The *Ever Summit* is a 7024 TEU¹ fully cellular² container vessel (Figure 1). It has a steel hull that is flared at the bow and stern. The bridge front is located approximately 88 m forward of the stern.

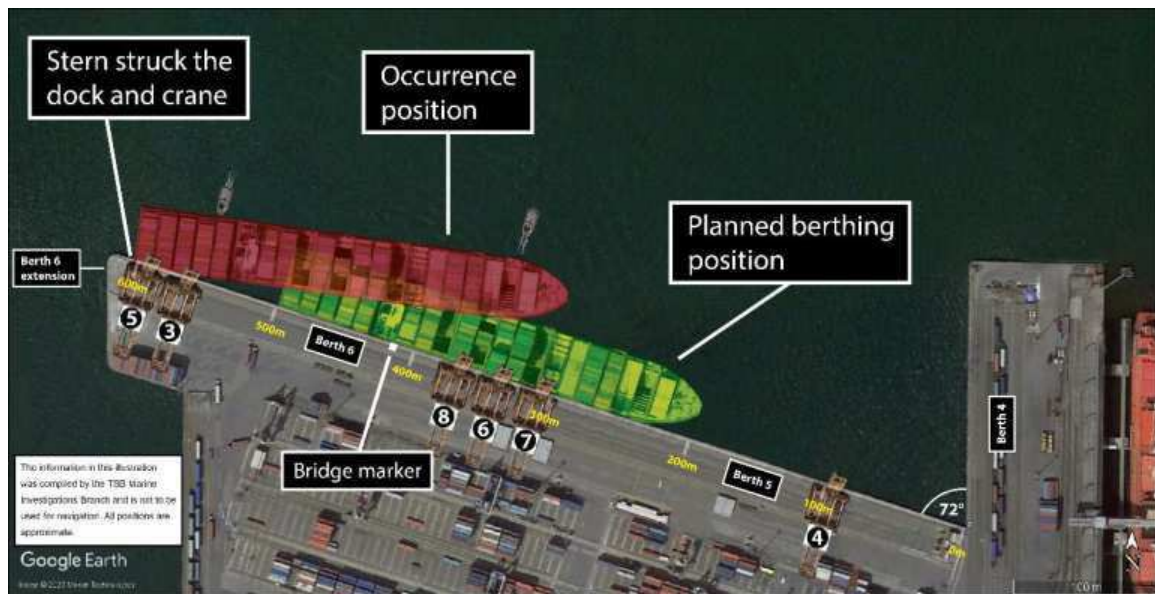
Figure 3. Vanterm berth layout (Source: Google Earth, with TSB annotations)

For large container vessels, Vanterm has a 619 m berth face made up of berths 5 and 6 combined (Figure 3). The original berth plans for the terminal indicate that the terminal was designed to have 2 separate berths.²⁹ However, the increase in length of container vessels currently berthing at Vanterm has effectively reduced the terminal to a one berth operation, with the vessels being docked somewhere between berths 5 and 6. The water depth alongside is approximately 15.5 m. The apron extends 7.08 m above chart datum. At the mean high tide point, the distance between the top of the apron and the water level is approximately 2.2 m.

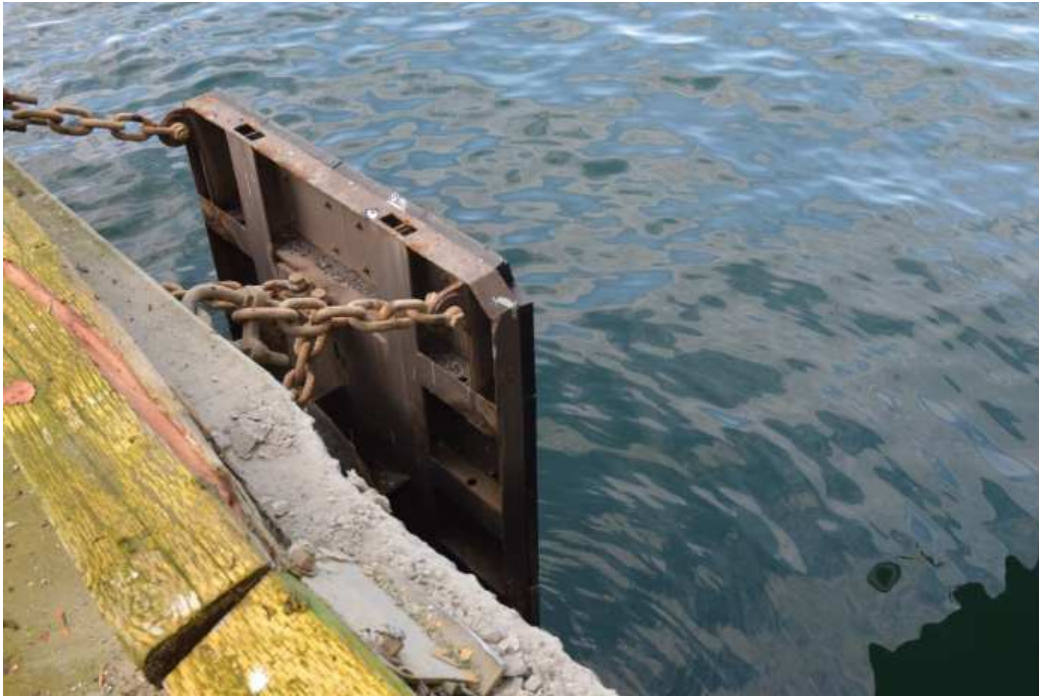
Figure 9. Cone fenders on Vanterm berth 6 extension (Source: TSB)

The fender system installed on the berth 6 extension differed from the fenders on berth 5 and the original part of berth 6. The fenders on the berth extension are cone fenders fitted with fender panels and support chains (Figure 9). The energy absorption capacity of these fenders is rated at 799 kN-m.

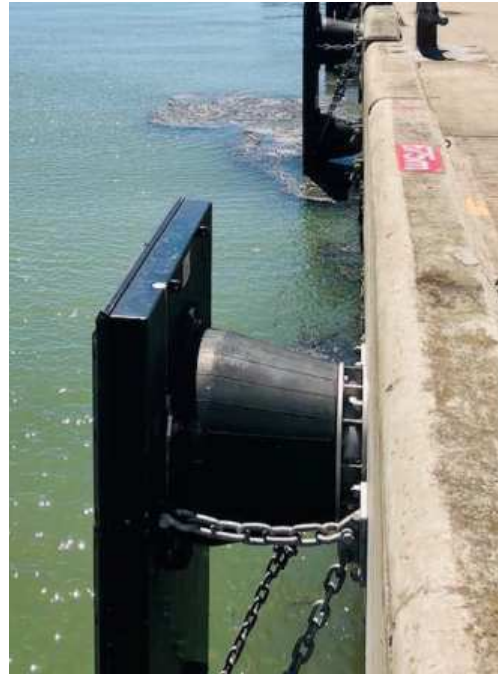
Figure 11. Fender at Deltaport 3 (Source: GCT Canada)

Deltaport 3 was designed for a maximum approach angle of 5° at a velocity of 12.5 cm/s. The bollards are rated for 125 tonnes safe working load, with 200 tonnes safe working load bollards at the ends of the berth. The distance from the waterside crane rail to the berth line is approximately 6.96 m at Deltaport 3, whereas the distance from the crane rail to the berth line at Vanterm is 2.13 m (Figure 12 and Figure 13).

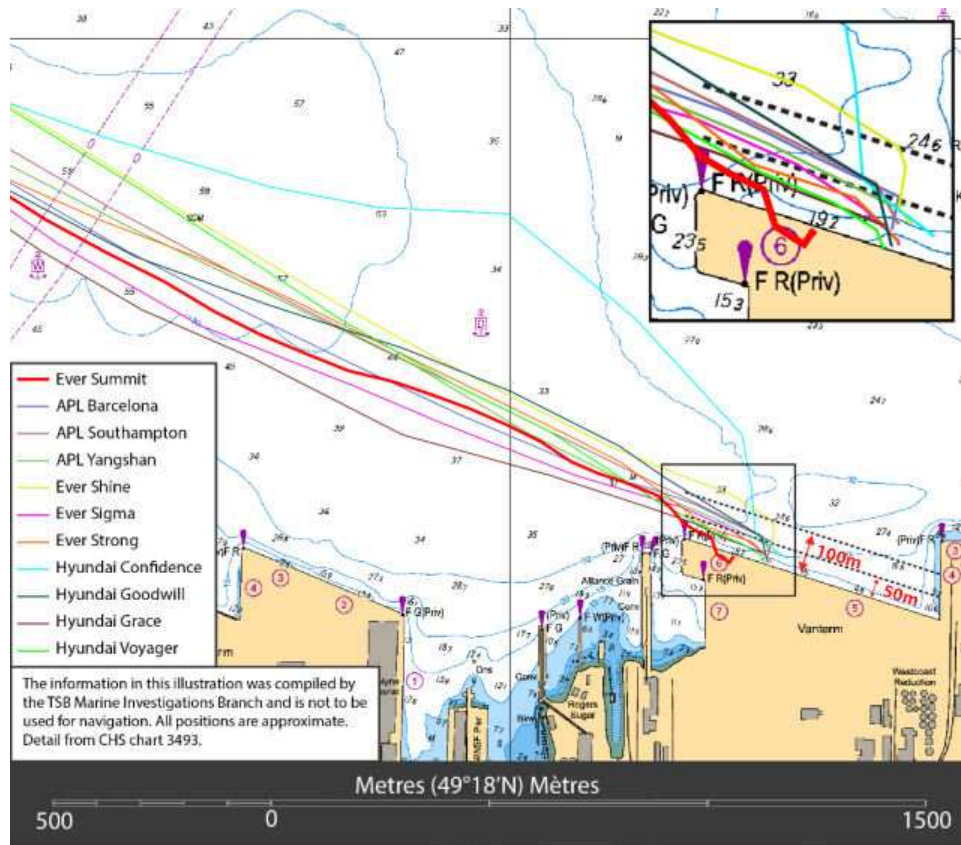
Figure 16. Tracks of vessels berthing at Vanterm berth 6 in January 2019 (Source: Canadian Hydrographic Service, with TSB annotations)

Information about the approaches taken by vessels⁴⁰ berthing at Vanterm in January 2019 has been compiled in the figure below (Figure 16). All of the vessels were successfully berthed. A total of 4 vessels transited the berth face at a distance

of 50 m or less while approaching the berth. On approach, the *Ever Summit* was the closest of the 4 to the berth.
