DUTCH  
SAFETY BOARD

# Fatal outcome following parting of mooring line

Lessons learned from the accident  
on board the RN Privodino

*The Hague, November 2020*

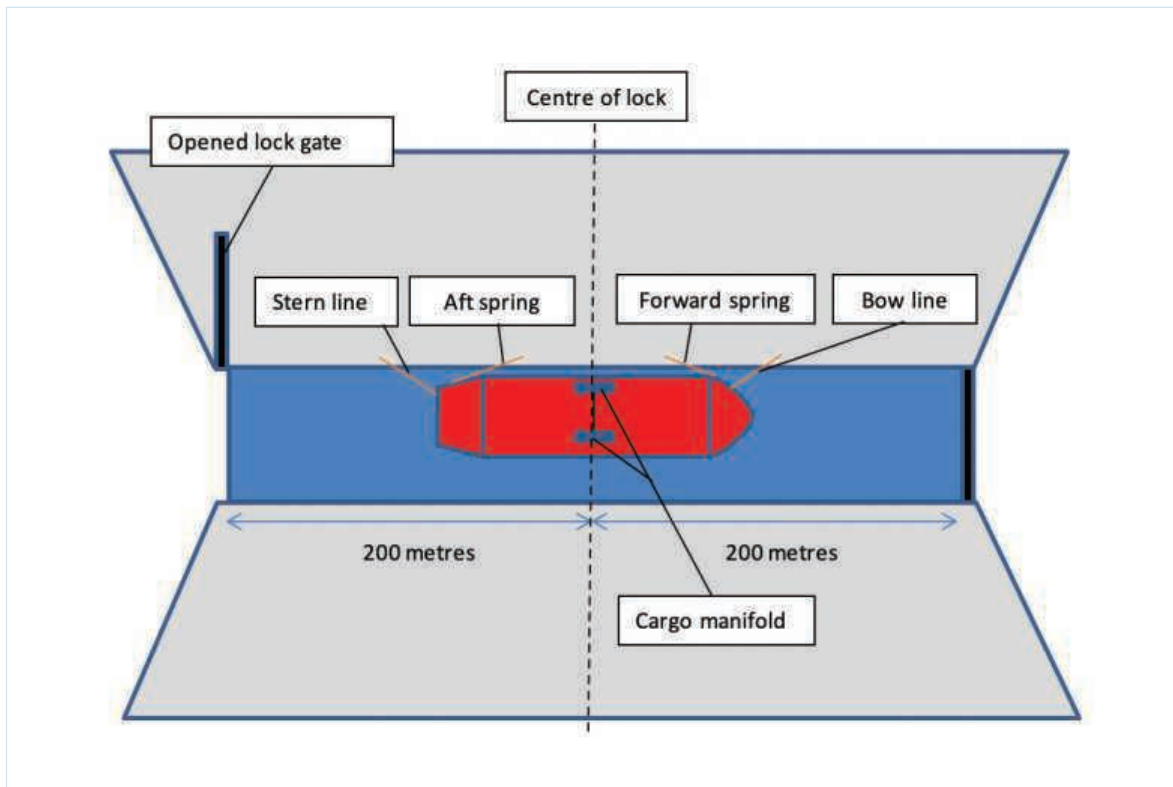
Figure 2: Planned mooring configuration of RN Privodino on 28 June 2018 at the lock in IJmuiden.

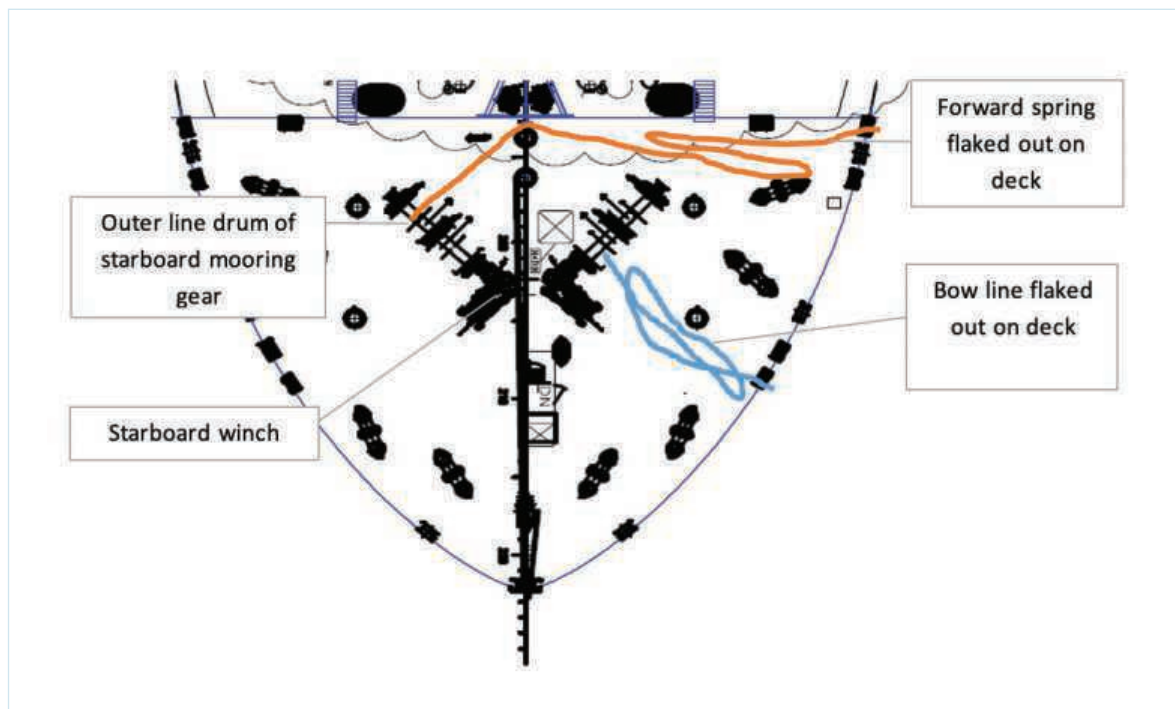
The two mooring teams then took all the necessary preparatory measures. On the foredeck, the bow line and forward spring were flaked out on the deck in several bights, so that as they were paid out to shore, length was available. The winches and mooring line drums were engaged and prepared for use.

Figure 3: Situation on foredeck upon entering the lock.

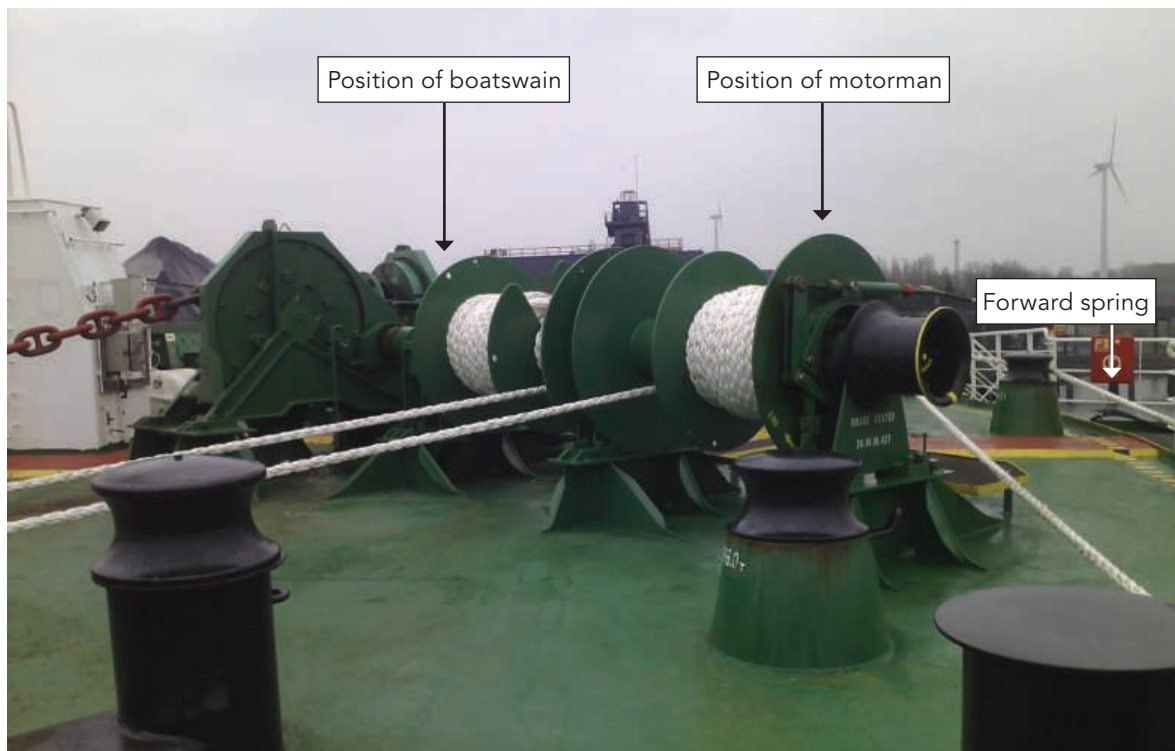
When the forward spring was sent ashore, and up to the moment the accident happened, the third officer stood on a raised position near the port railing, close to the point where the spring left the vessel, via a fairlead. From that position, he had a clear view of the quayside, the lock gate, the transfer of the forward spring to shore, and the two deckhands who stood close to him, waiting until the bow line could be passed over. From this position, his view of the boatswain, who was operating the winches and who stood at a raised point, was hindered by the port mooring gear. He was able to partially see the boatswain, but could not see what the boatswain was doing. The third officer had no view whatsoever of the motorman, who was located on the starboard side of the foredeck (see photograph 6).

Photograph 6: View from the position taken up by the third officer (Source: Dutch Safety Board)

Maintaining an overview of the operation and keeping an eye on the members of the mooring team, including supervising safety, was the task and responsibility of the third officer and mooring team leader on the foredeck. However, his view of the boatswain and motorman was partially obstructed; in addition, neither explained what they were doing, as a consequence of which he was unable to intervene when the forward spring line was transferred to the tension drum too early, nor to prevent the dangerous position of the motorman. It should be noted that at that moment he was also responsible for a number of other tasks, such as monitoring the transfer to shore of the forward spring line and the bow line, and passing on the distance to the closed lock gate. As long as the vessel was still moving, and was not in position, this latter task still had to be carried out.

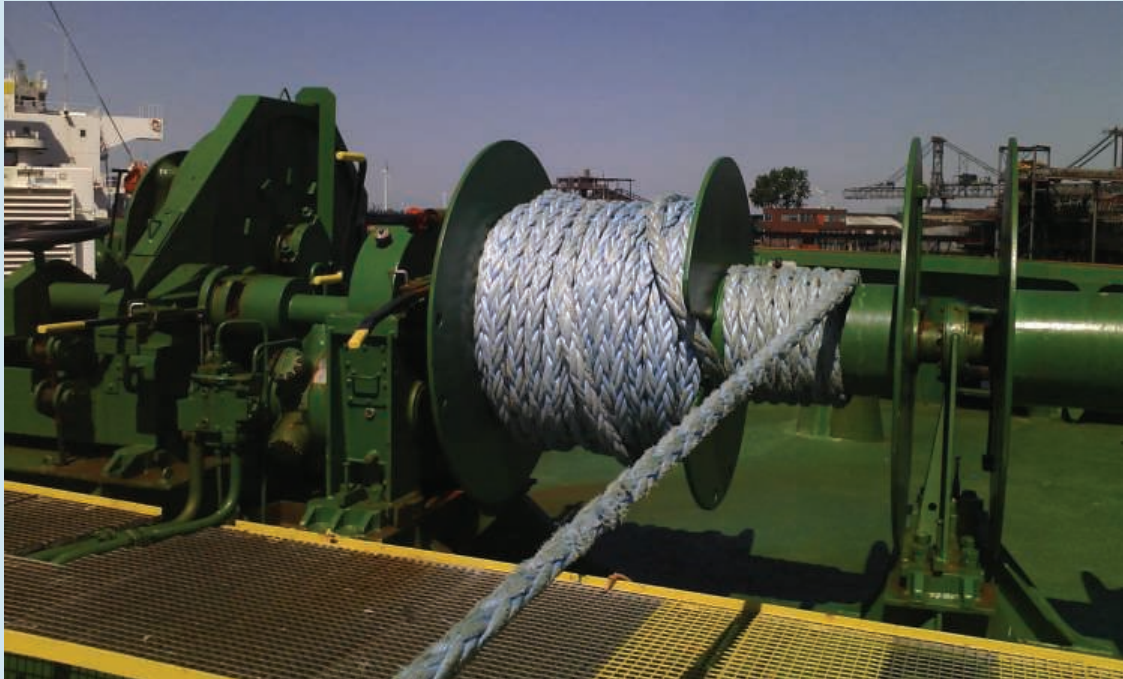
The mooring line drums on the foredeck of the RN Privodino are therefore each split into two separate drums. The example in photograph 7 shows that the storage drum is located on the left, with many layers of stored mooring line. The mooring line runs from the storage drum to the tension drum on the right. It is the role of this tension drum to maintain the force of the mooring line at a pre-set tension. The precondition, as shown on the photograph, is that only a single layer of mooring line may be wound around the tension drum. The tension drum is large enough for a maximum of ten turns in each layer.

*Photograph 7: Mooring line drum with split drums on the foredeck of the RN Privodino (Source: Dutch Safety Board)*

The second precondition is that all force is transferred only to the tension drum. A situation must be avoided in which, due to the slipping of the mooring line on the tension drum, the section of mooring line still on the storage drum is pulled tight. If this happens, the mooring line will be drawn between the other layers of mooring line wrapped around the storage drum, and can become stuck, so that no further mooring line can run off the drum for use as required. This effect is avoided if at least four turns of mooring line remain wrapped around the tension drum. On the photograph 7, there are 8 turns of mooring line around the tension drum.
