Report on the investigations of
heavy weather damage
on board the container ship

Maersk Newport

on 10 November 2008

on 15 November 2008

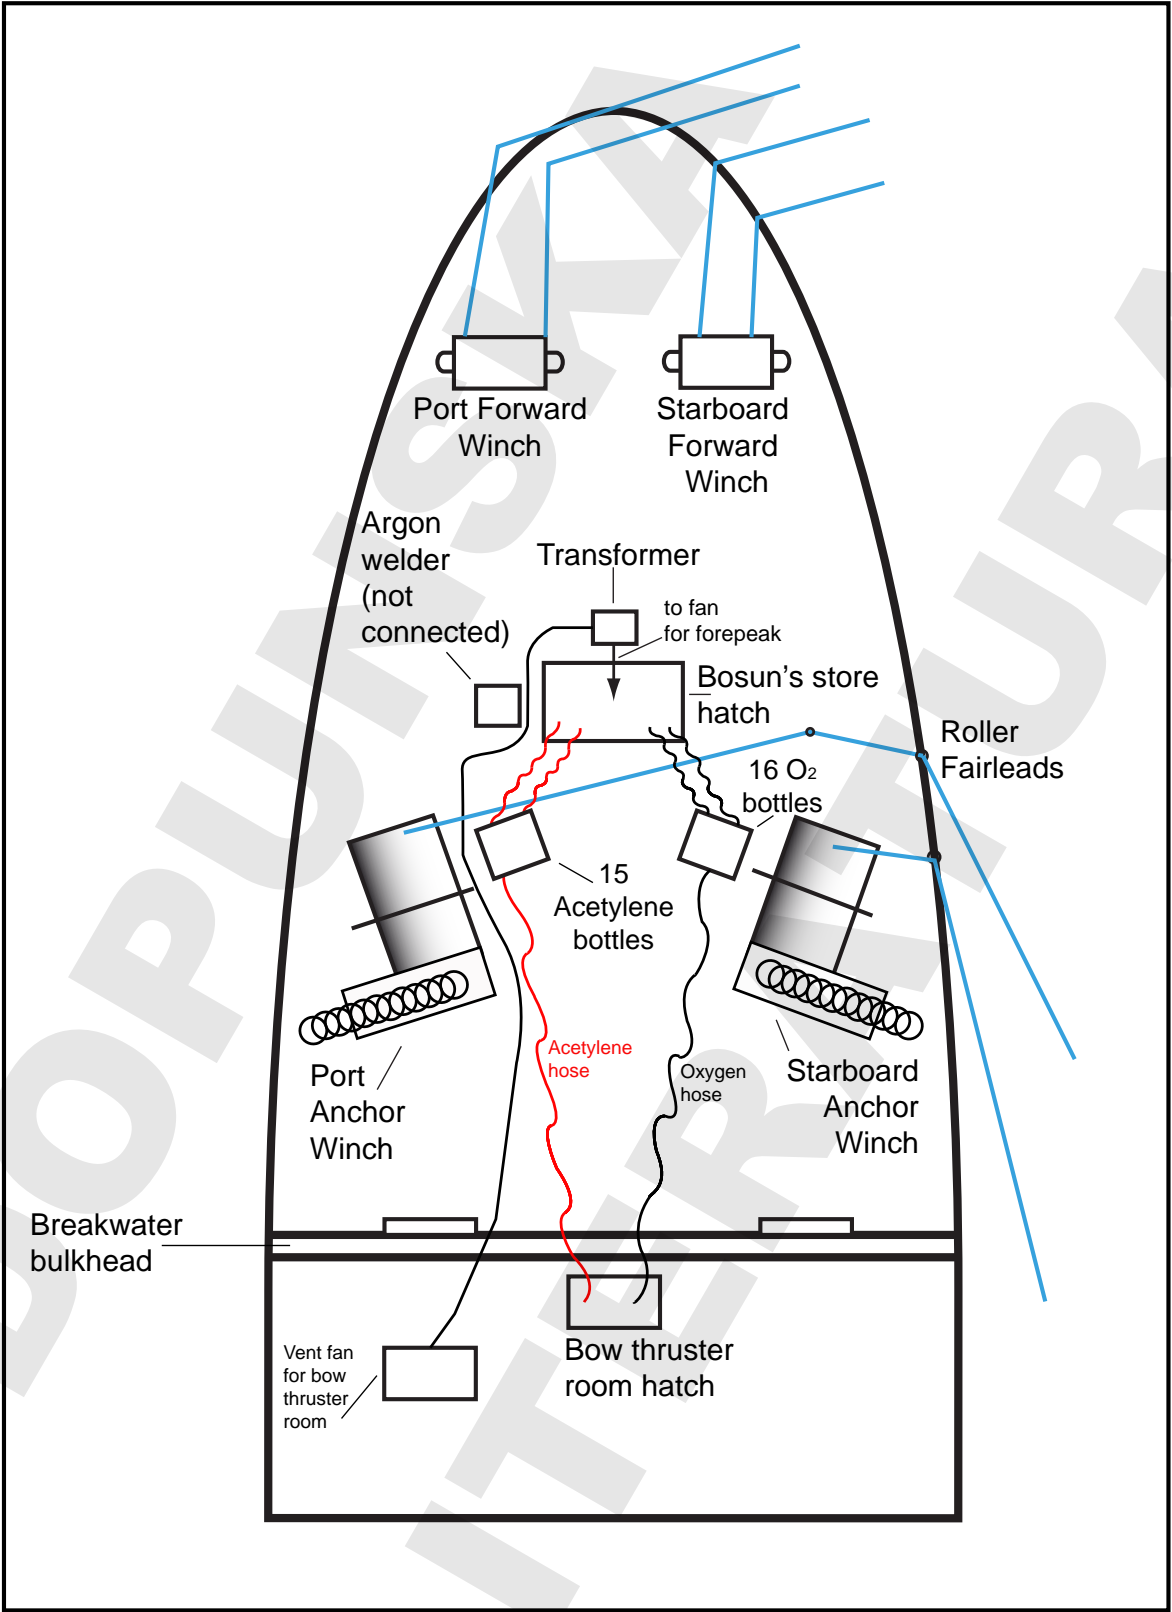
Figure 13

Diagrammatic layout of the contractor's equipment and forward mooring arrangements

Very soon afterwards the electrician/safety watchman left the forecastle area and went into the ship's accommodation to use the toilet facilities. He did not inform the foreman of his intentions, and contractors and their equipment were left without a safety oversight. On passing through the port access in the breakwater bulkhead the electrician/safety watchman noticed four, unidentified, stevedores about 25m aft of the gas bottle storage area. He was unsure if they were smoking at the time.

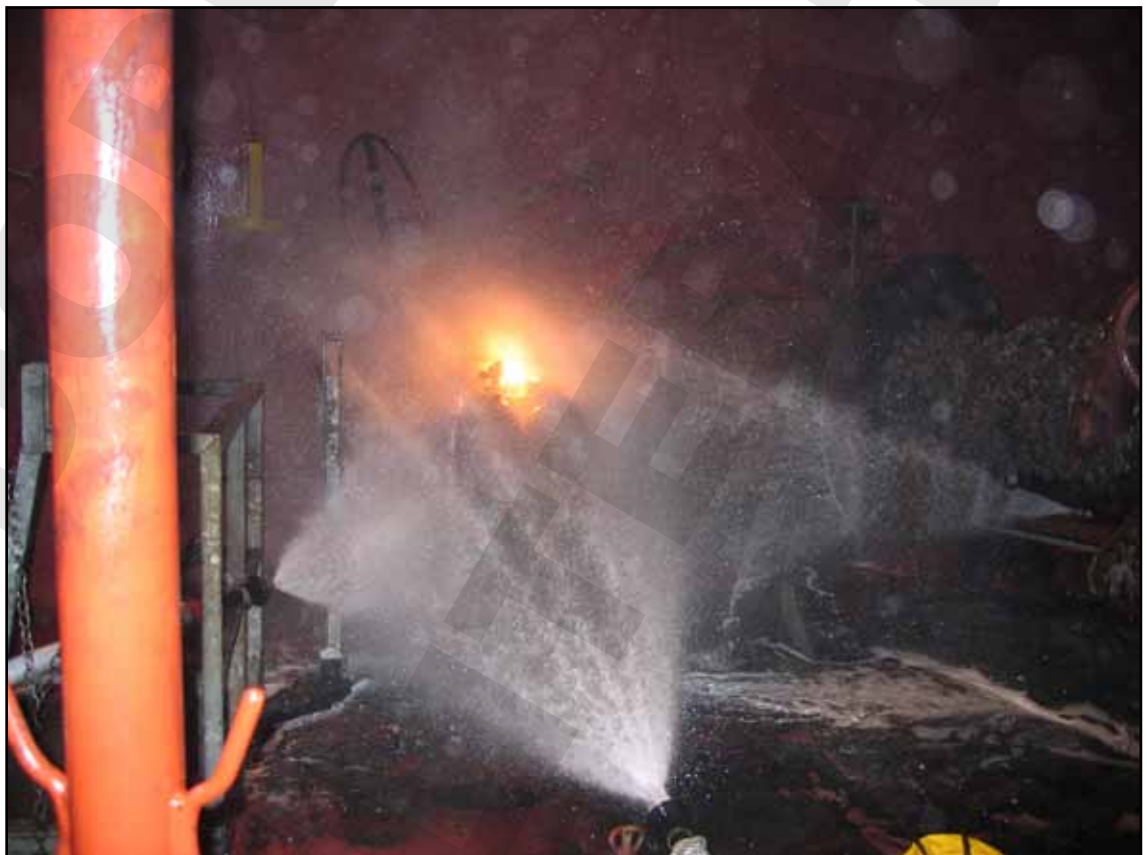
Figure 15

At 0252 the Head of Inspection and Survey recommended that the accessible acetylene bottles be dropped into the harbour to rapidly cool them down in view of the particular dangers associated with heated acetylene bottles. This was rejected by the OIC on pollution grounds. It was then decided to secure the fire-fighting hoses and direct the nozzles on to the acetylene and oxygen bottles and vacate the vicinity of the forecastle (**Figure 15**).

Hoses rigged to cool down the acetylene and oxygen bottles

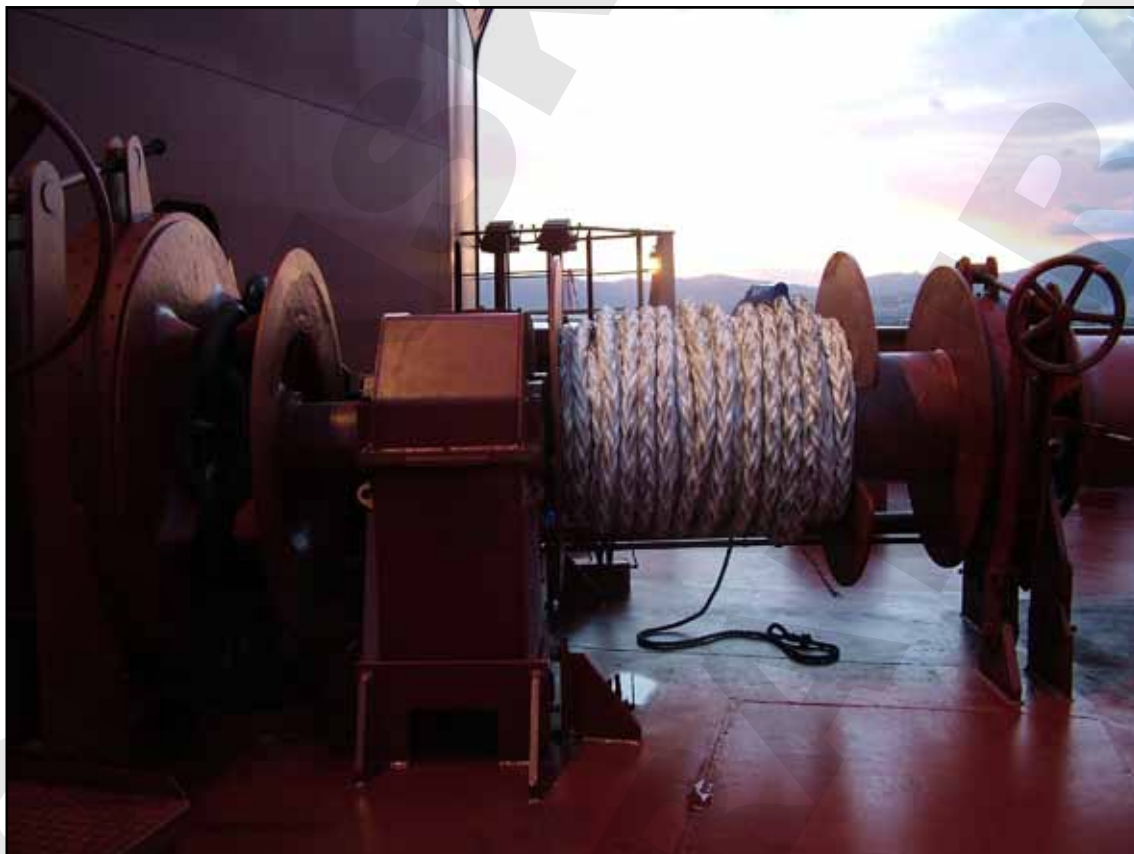
Figure 22

Maersk Newport was fitted with two, type 2 AMW 120/76 K3 R, twin drum windlass winches on the forecastle (**Figure 22**). The winches were designed and manufactured in 2008 by KGW Marine GmbH based in Schwerin in Germany.

General view of the port windlass winch

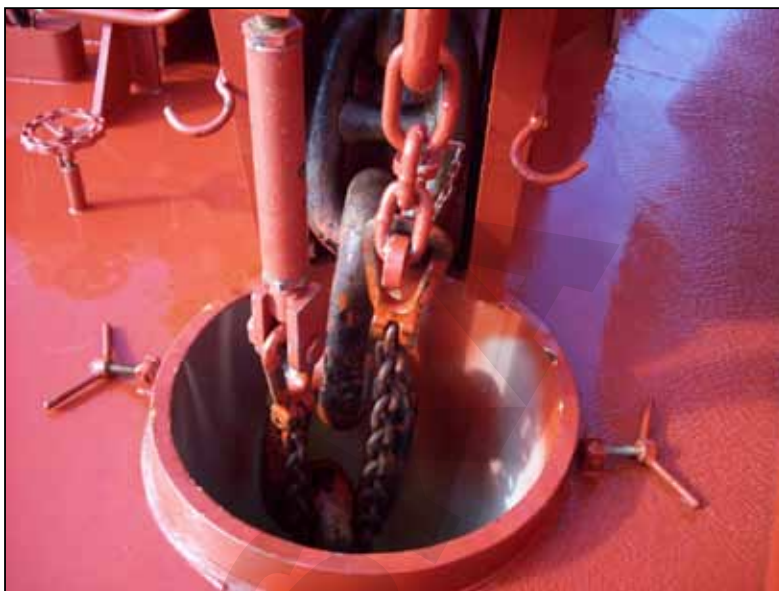
Chain lashing arrangement

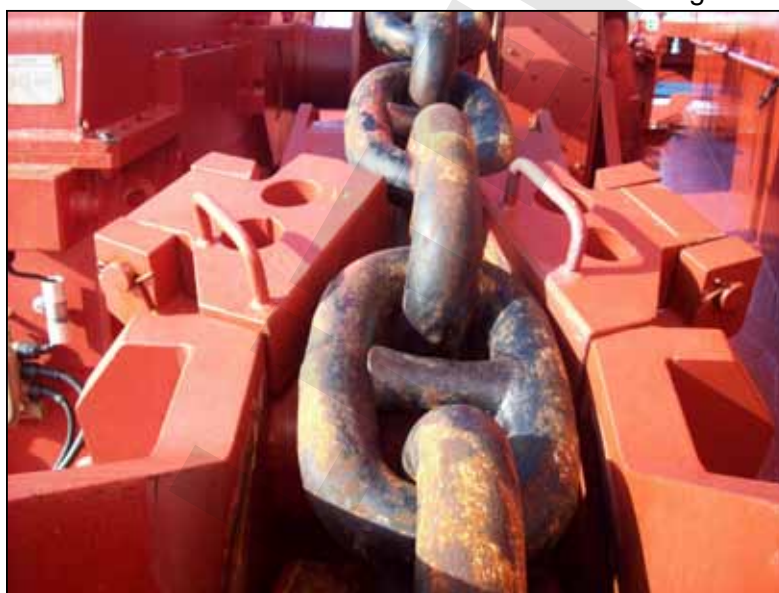
Guillotine block arrangement

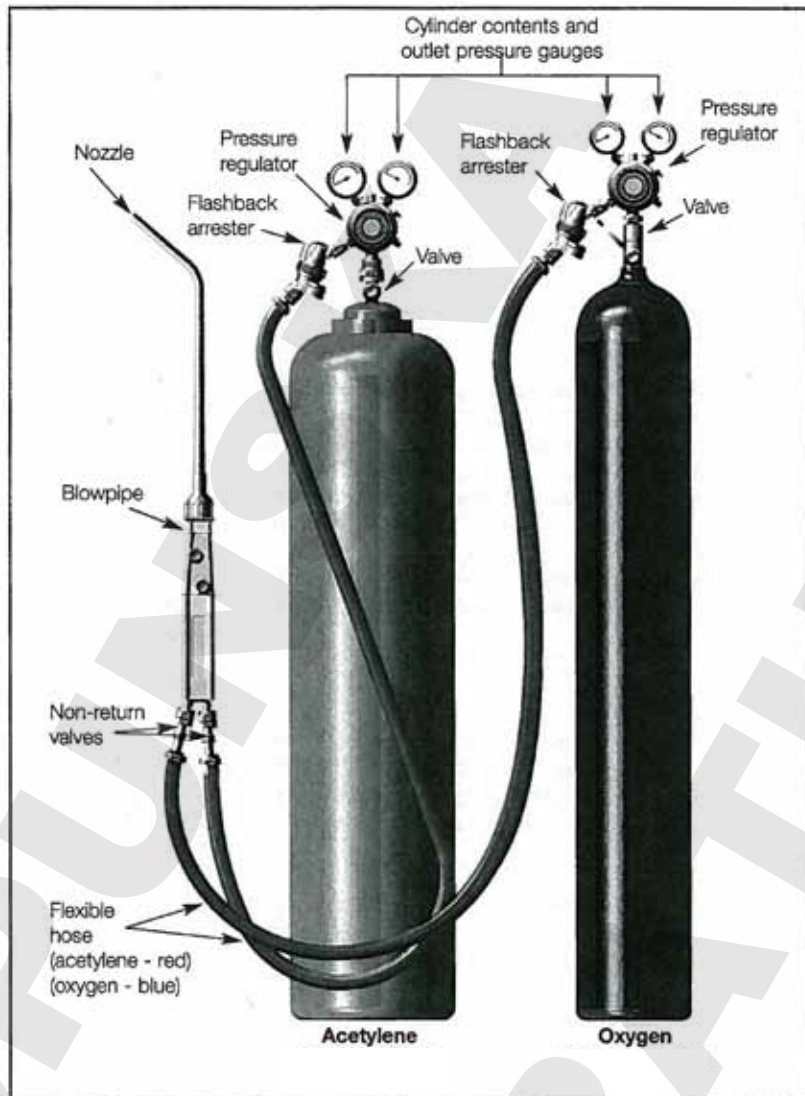
A typical oxy/acetylene burning/welding arrangement is shown at **Figure 26**.

Typical equipment used in oxy/acetylene gas welding and similar processes
