Report on the investigation into
the structural failure and foundering
of the general cargo ship
Swanland

Irish Sea

27 November 2011

with the loss of six crew

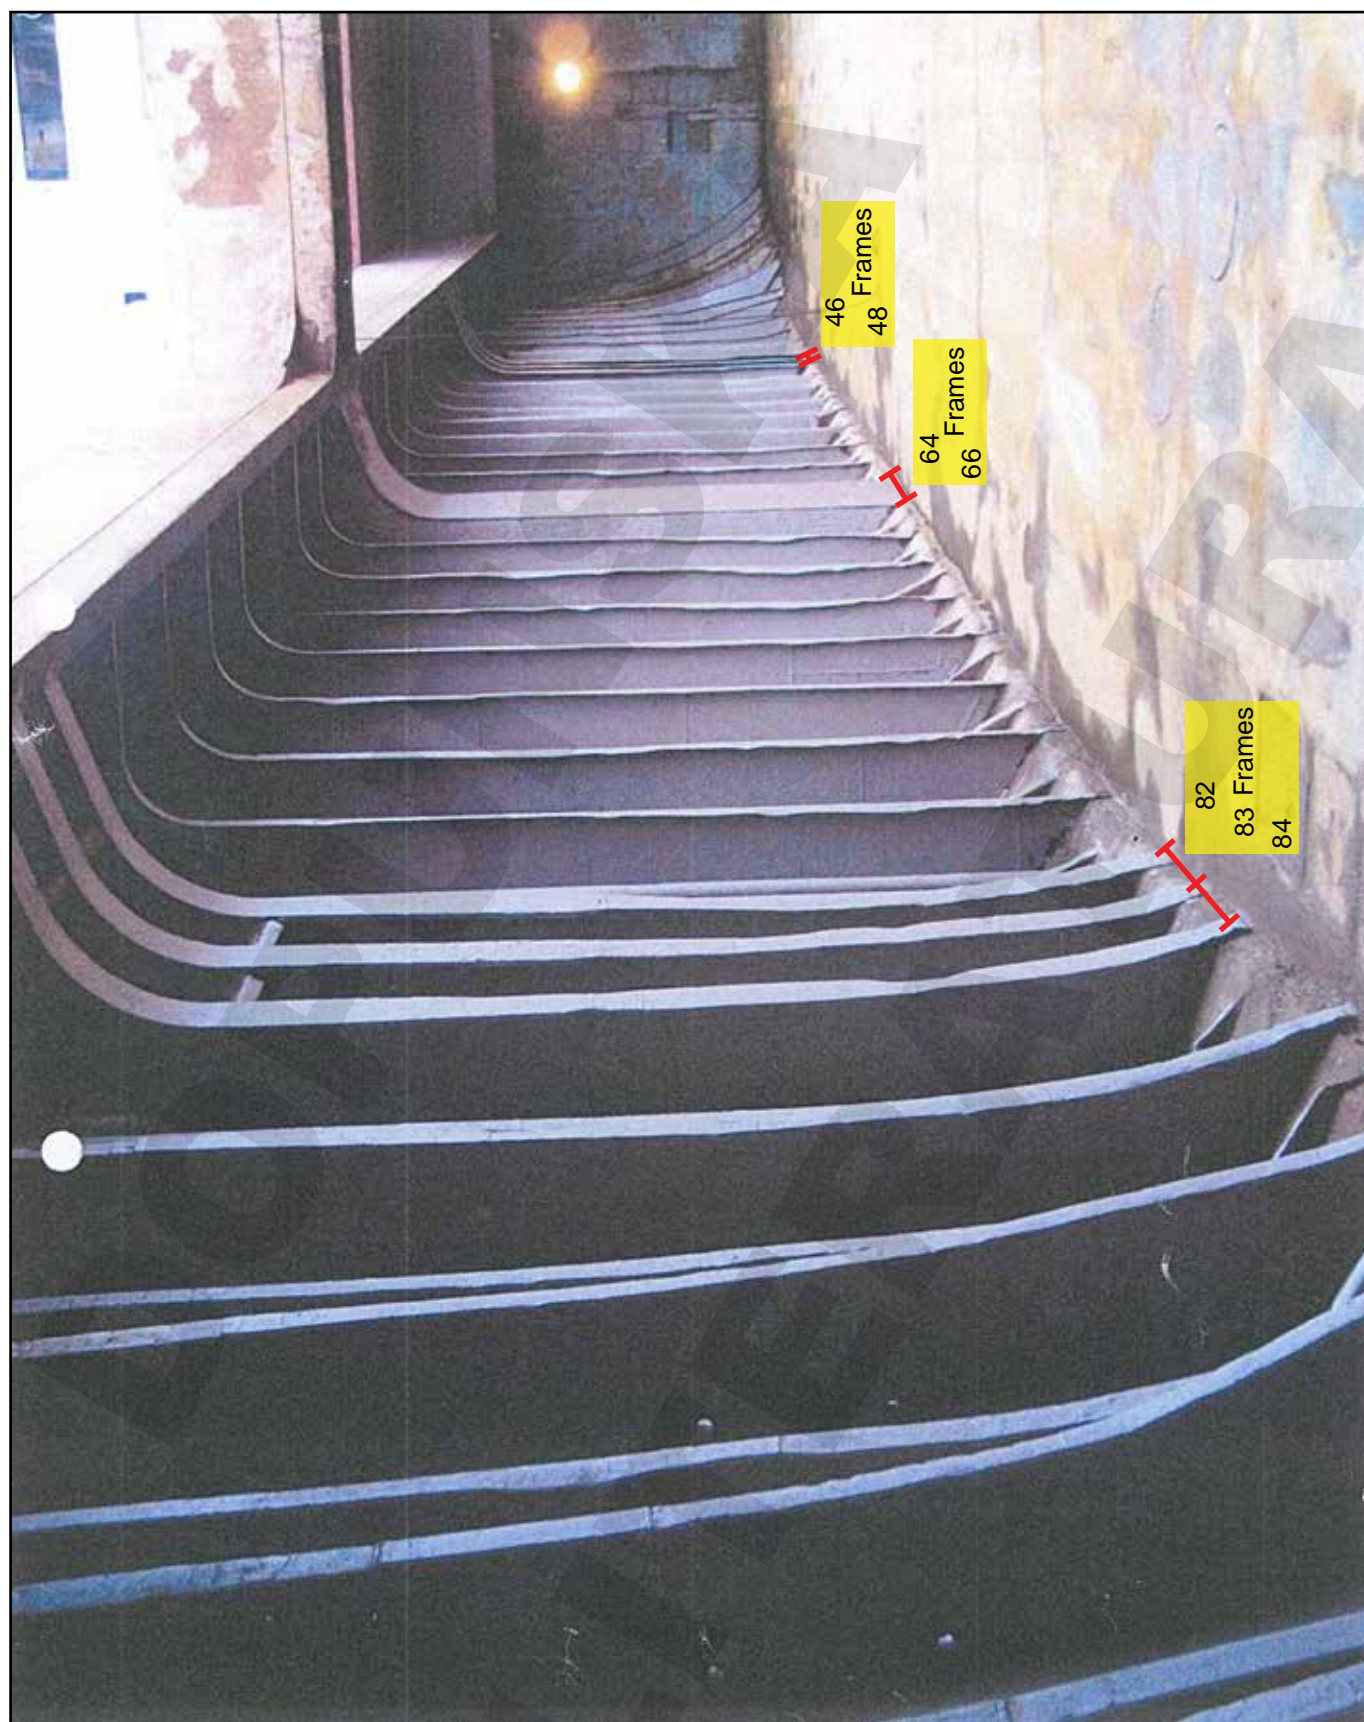
Figure 36: View of cargo hold looking aft, showing additional deep frames at Frames 47, 65 and 83

As **Figure 36** shows, deep frames replaced the expected intermediate frames at Frames 47, 65 and 83 respectively. Frames 64 to 66, in way of the central transverse beam above were also plated-in to form a vertical box section. Two removable small access covers were incorporated into the plating at Frames 64 to 66, which also featured a fuller connection to the DB structure beneath. Braemar's report (**Annex D**) concluded that the box section at Frames 64 to 66 would have been provided to create a "strong portal frame", which, assisted by the additional deep frames at Frames 47 and 83, would have acted to counter racking loads¹⁰.

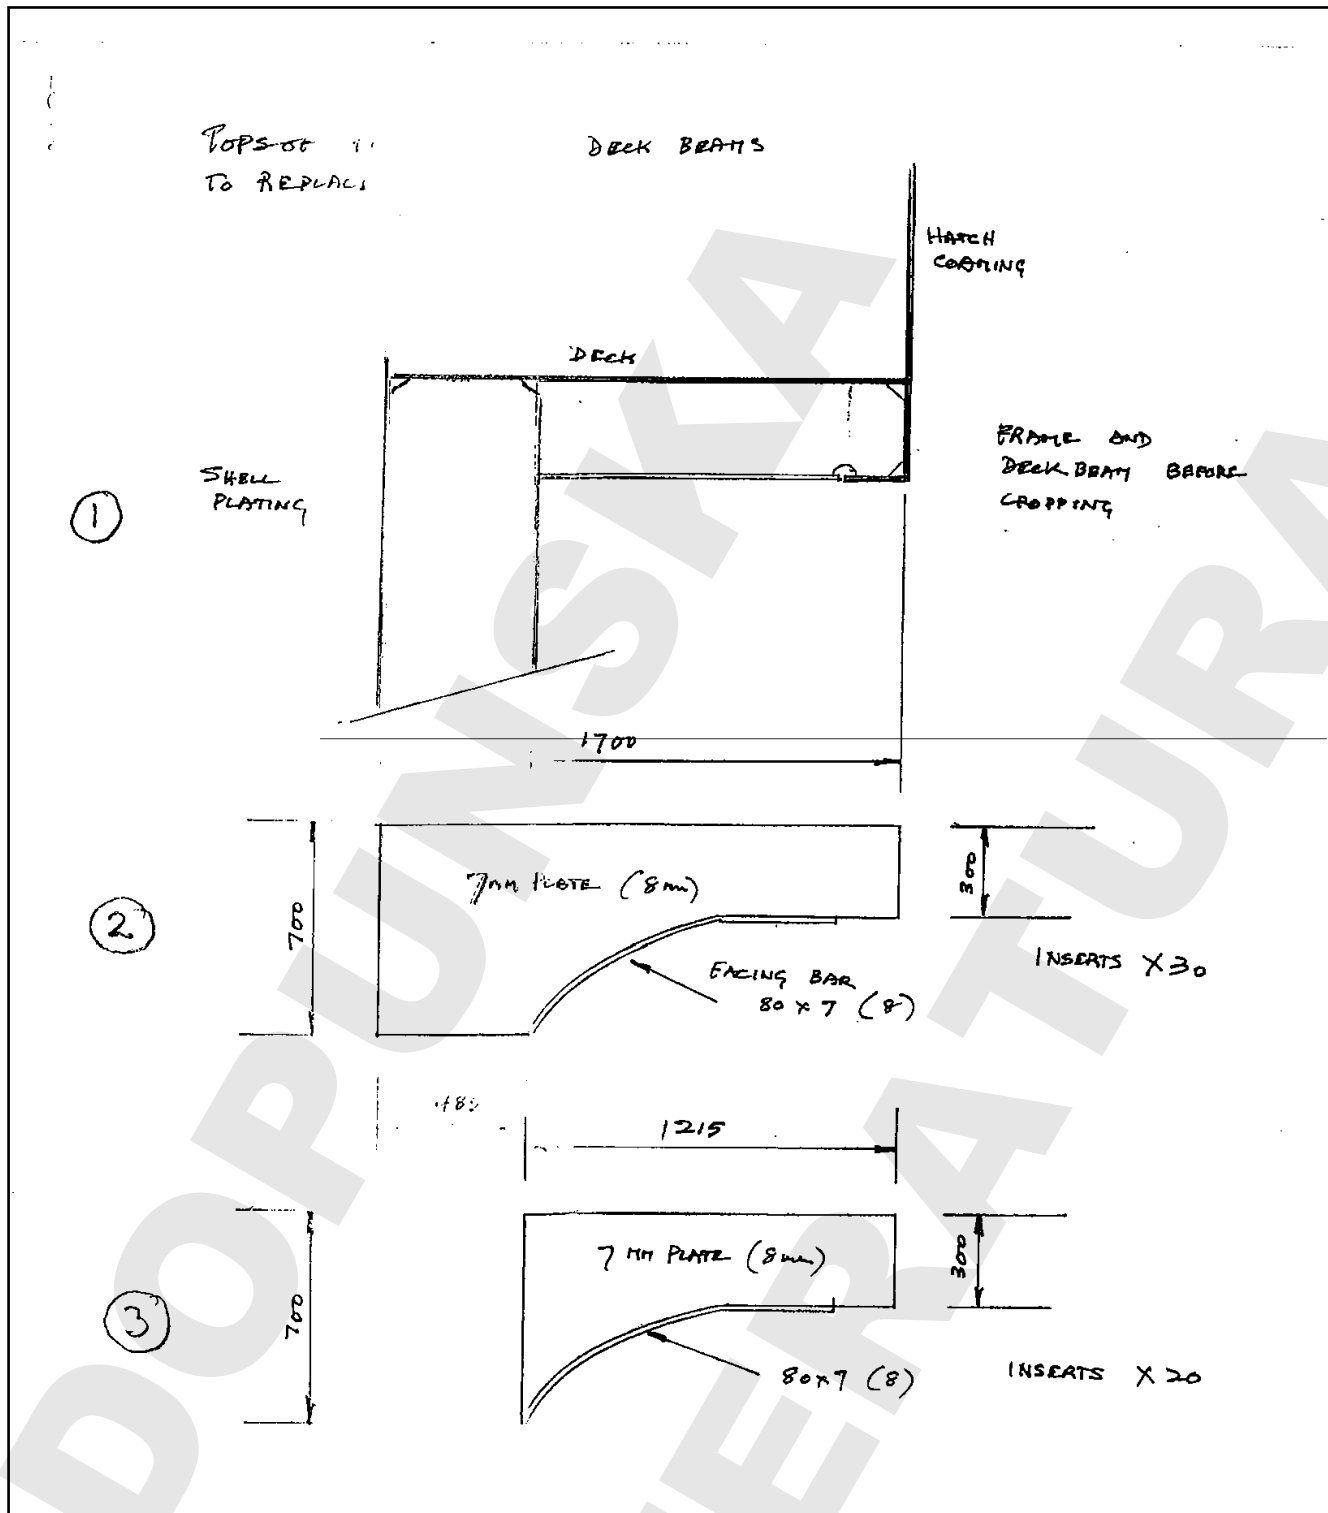
Figure 38: Contemporaneous sketch of modifications to cargo hold deck beams carried out in 2003

The design and the installation of the equipment were approved by a local LR surveyor. At the time of this accident, all documentary records of the approval of the modifications had been destroyed in accordance with LR’s records retention policy. However, a general description of the modification was recorded on LR’s survey database. This noted that several deck beams and frames in the cargo hold had been identified as severely wasted at their connections. Accordingly, 26 and 22 deep frames on the port and starboard sides of the cargo hold respectively were cropped, along with the accompanying deck beams. For each of the 48 frames, a new internal radius section was installed, as shown at item 2 on the contemporaneous sketch at **Figure 38**. Two further deck beams on the port side were also modified as shown at item 3 on **Figure 38**, as were six deck beams on the starboard side.

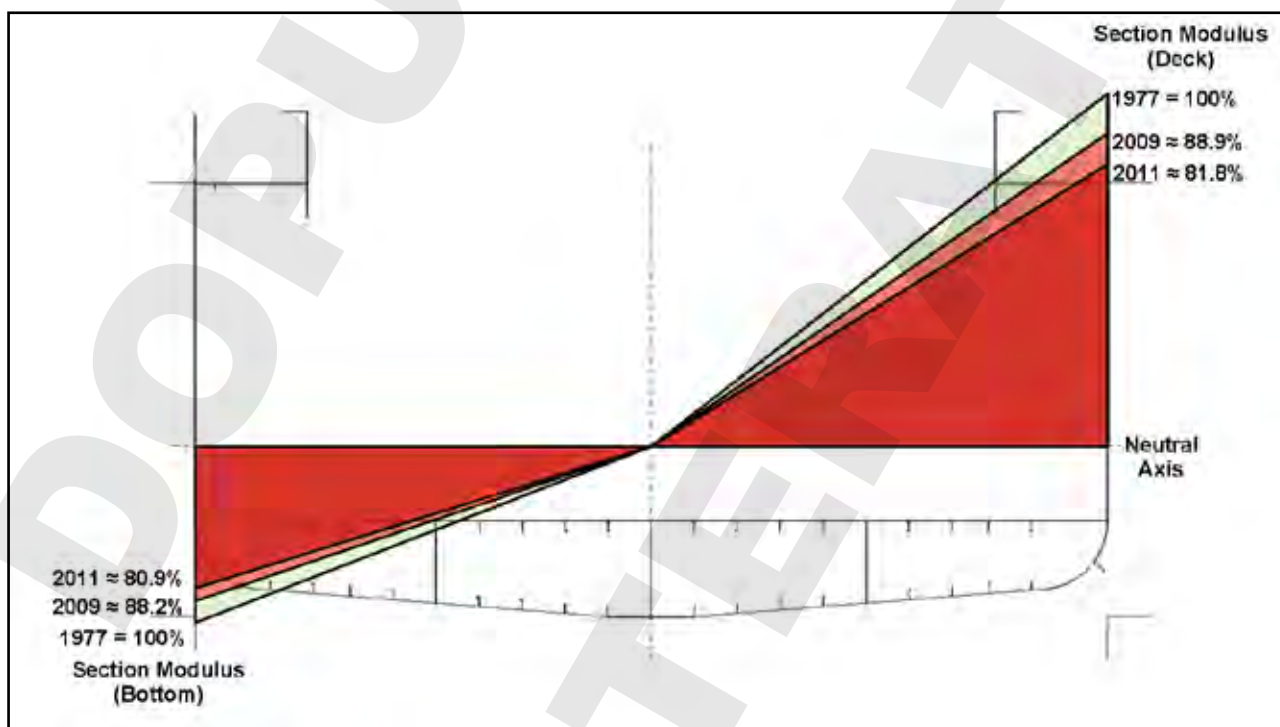
Figure 46: Comparison of calculated *Swanland's* midships section modulus using scantlings: as-built; in May 2009; and in November 2011 (as estimated by Braemar based on assumed corrosion rates)

Figure 46 shows that even following the repairs conducted as part of the 2009 intermediate survey, the deck section modulus had reduced by approximately 11% from its original 'as-built' value. Applying the assumed corrosion rates, Braemar estimated that the section modulus would have been further reduced by about 18% of its original 'as-built' value by November 2011.

Braemar concluded that by the time of the accident, significant areas of *Swanland's* structure contributing to her longitudinal strength would have been significantly weakened due to corrosion and damage. At the time of the accident, the reduction in the thickness of some of these elements would also likely have been close to the INSB diminution limits.

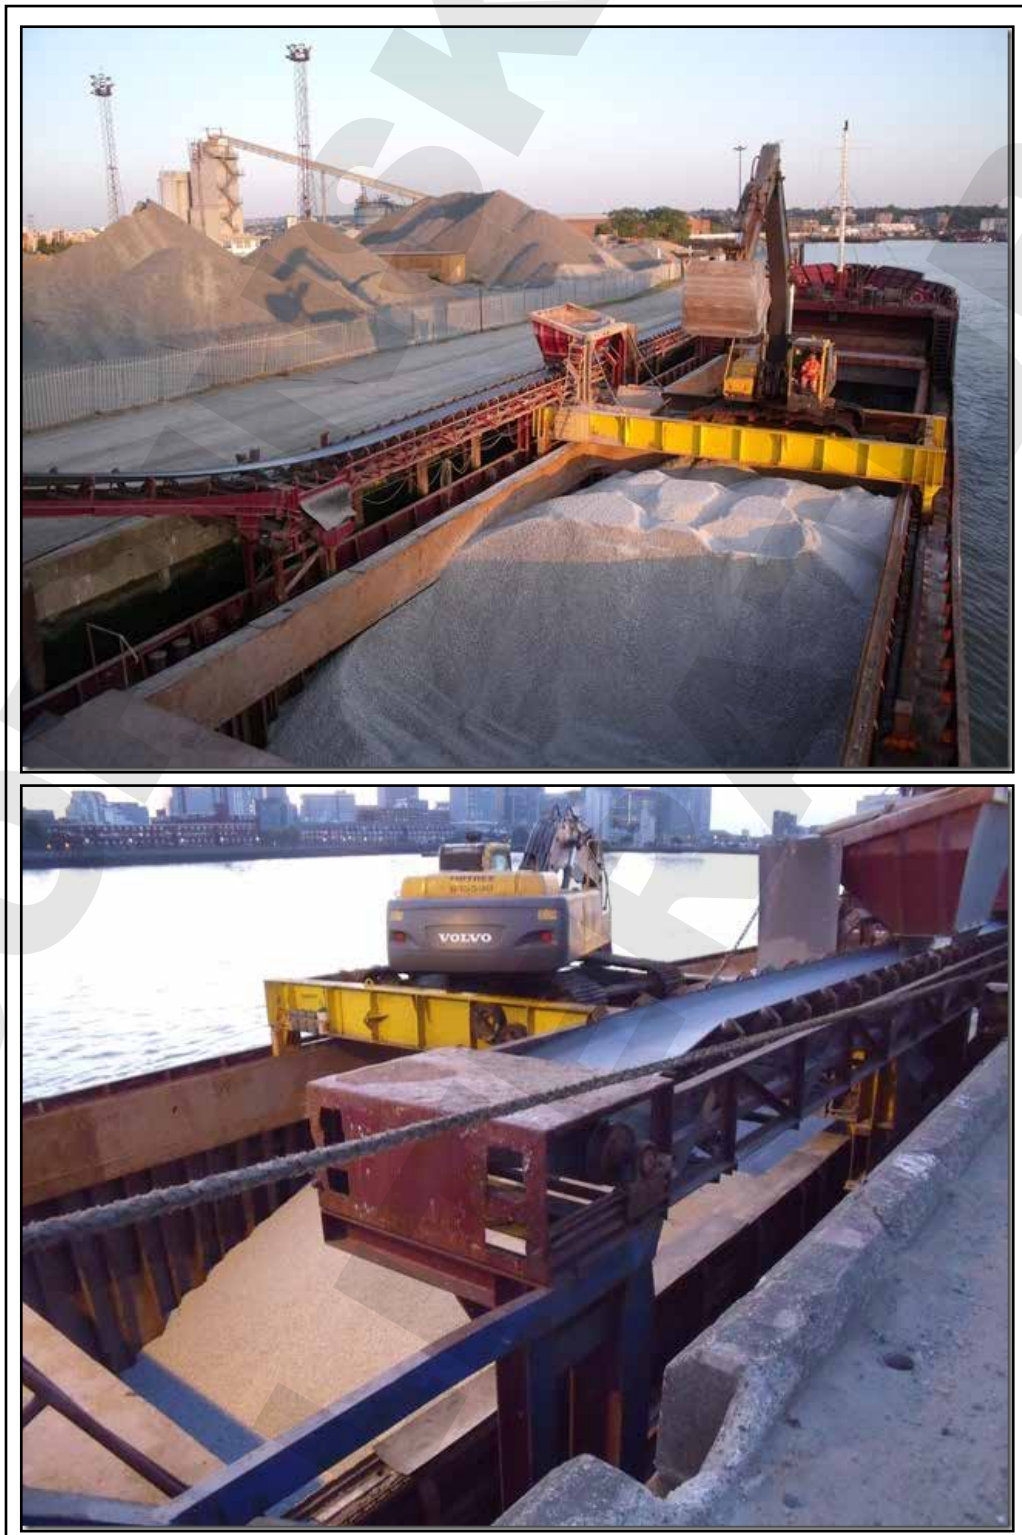
Figures 52a and 52b show *Swanland* discharging 4mm-20mm aggregate at Victoria Deep, Greenwich on 22 October 2011. The vessel had arrived loaded with 2796 tonnes of aggregate. When the photographs were taken approximately 200 tonnes of cargo had been discharged.

Figures 52a and 52b: *Swanland* discharging aggregate in October 2011

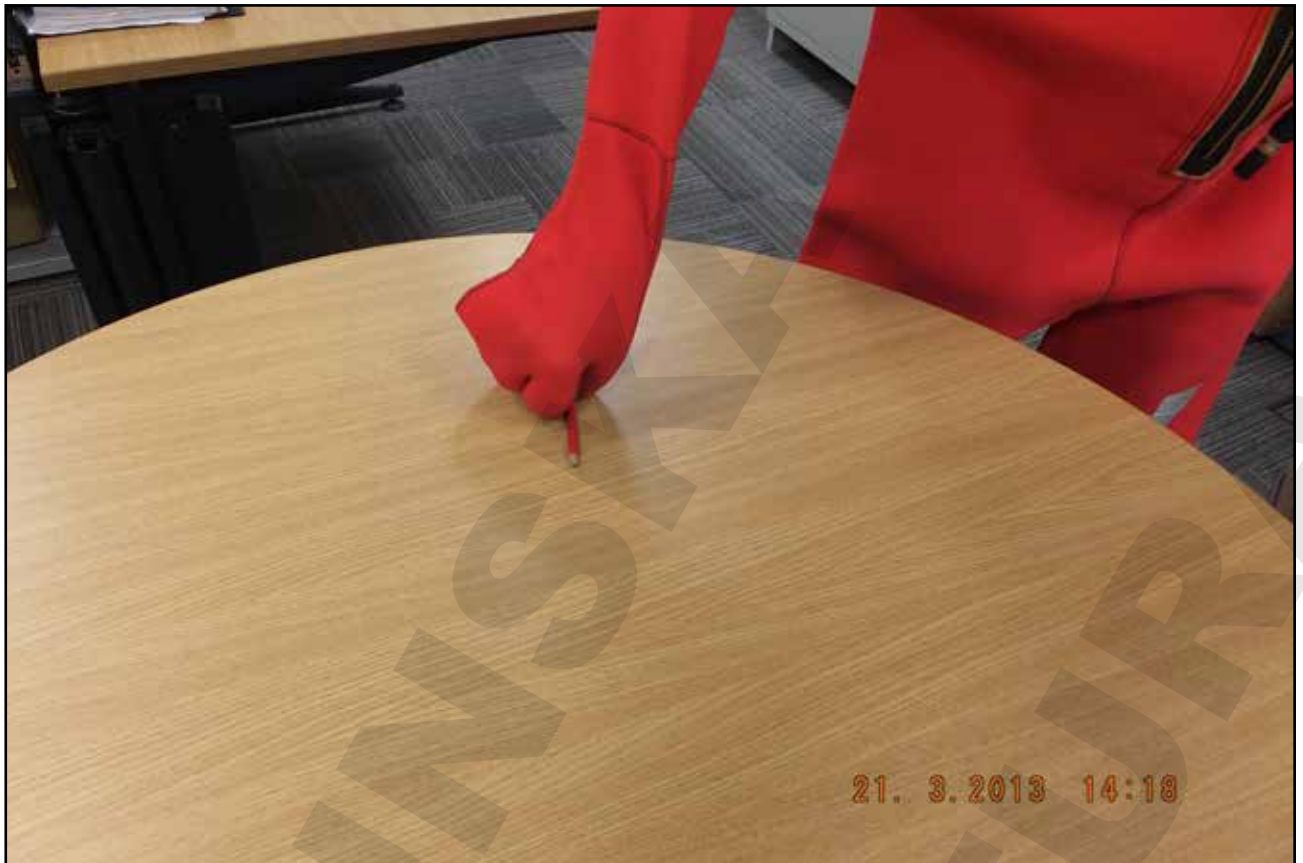
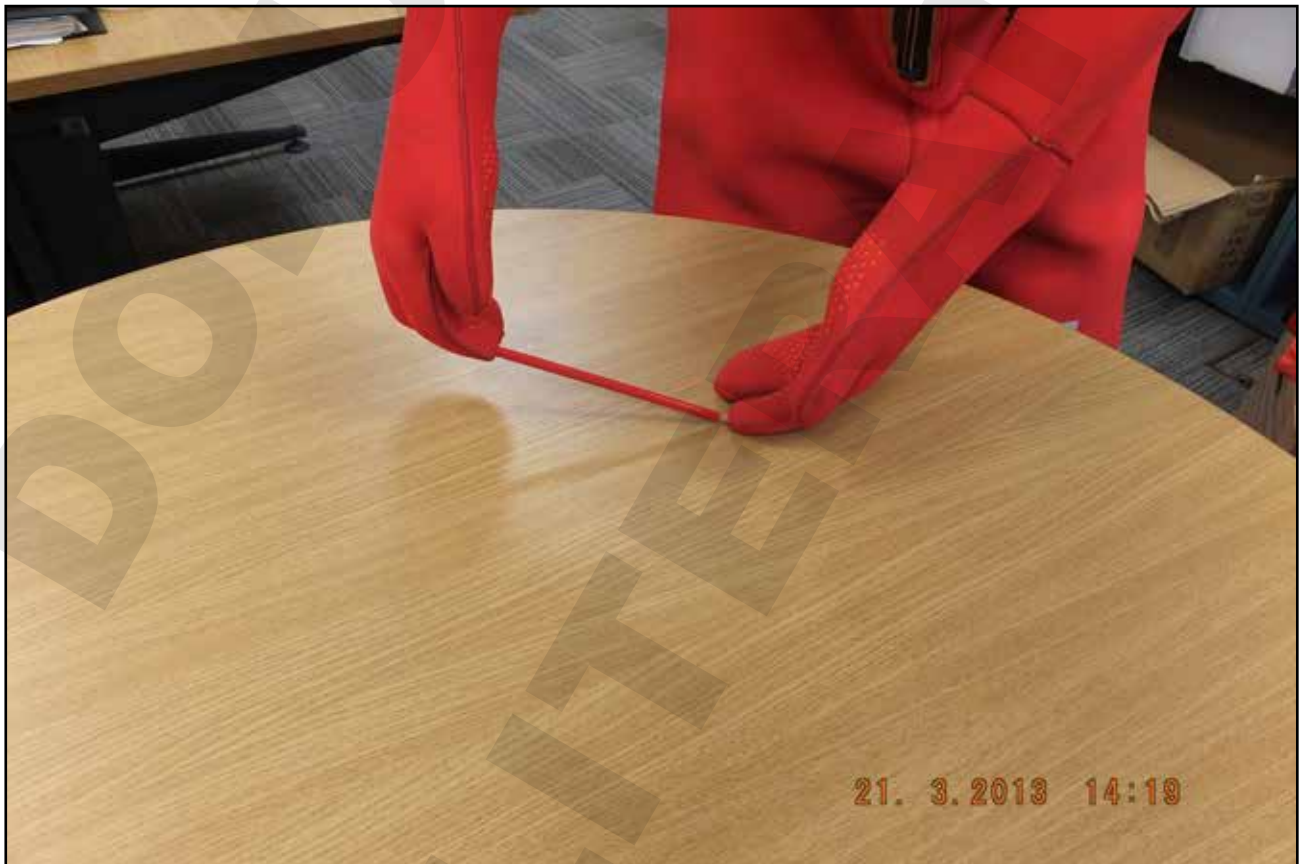
In order to assess the dexterity afforded by the Parkway Imperial MQ254 and the Autoflug KS1 immersion suits, the MAIB conducted practical trials (**Figure 59a** and **59b**) in accordance with the requirements of both MSC 81(70) and ISO 15027-2:2012. During the trials, the wearer experienced no difficulty with either of the suits when picking up and securing an 8mm rope around his waist with a double overhand knot. However, he could only pick up an 8mm pencil from a flat surface by using two hands. Although this task became less difficult when a larger diameter pencil was used, two hands were still generally required. Once the pencil had been lifted from the flat surface, the wearer had no difficulty in writing his name.

Figures 59a and 59b: Dexterity trial conducted by MAIB using Parkway Imperial immersion suit

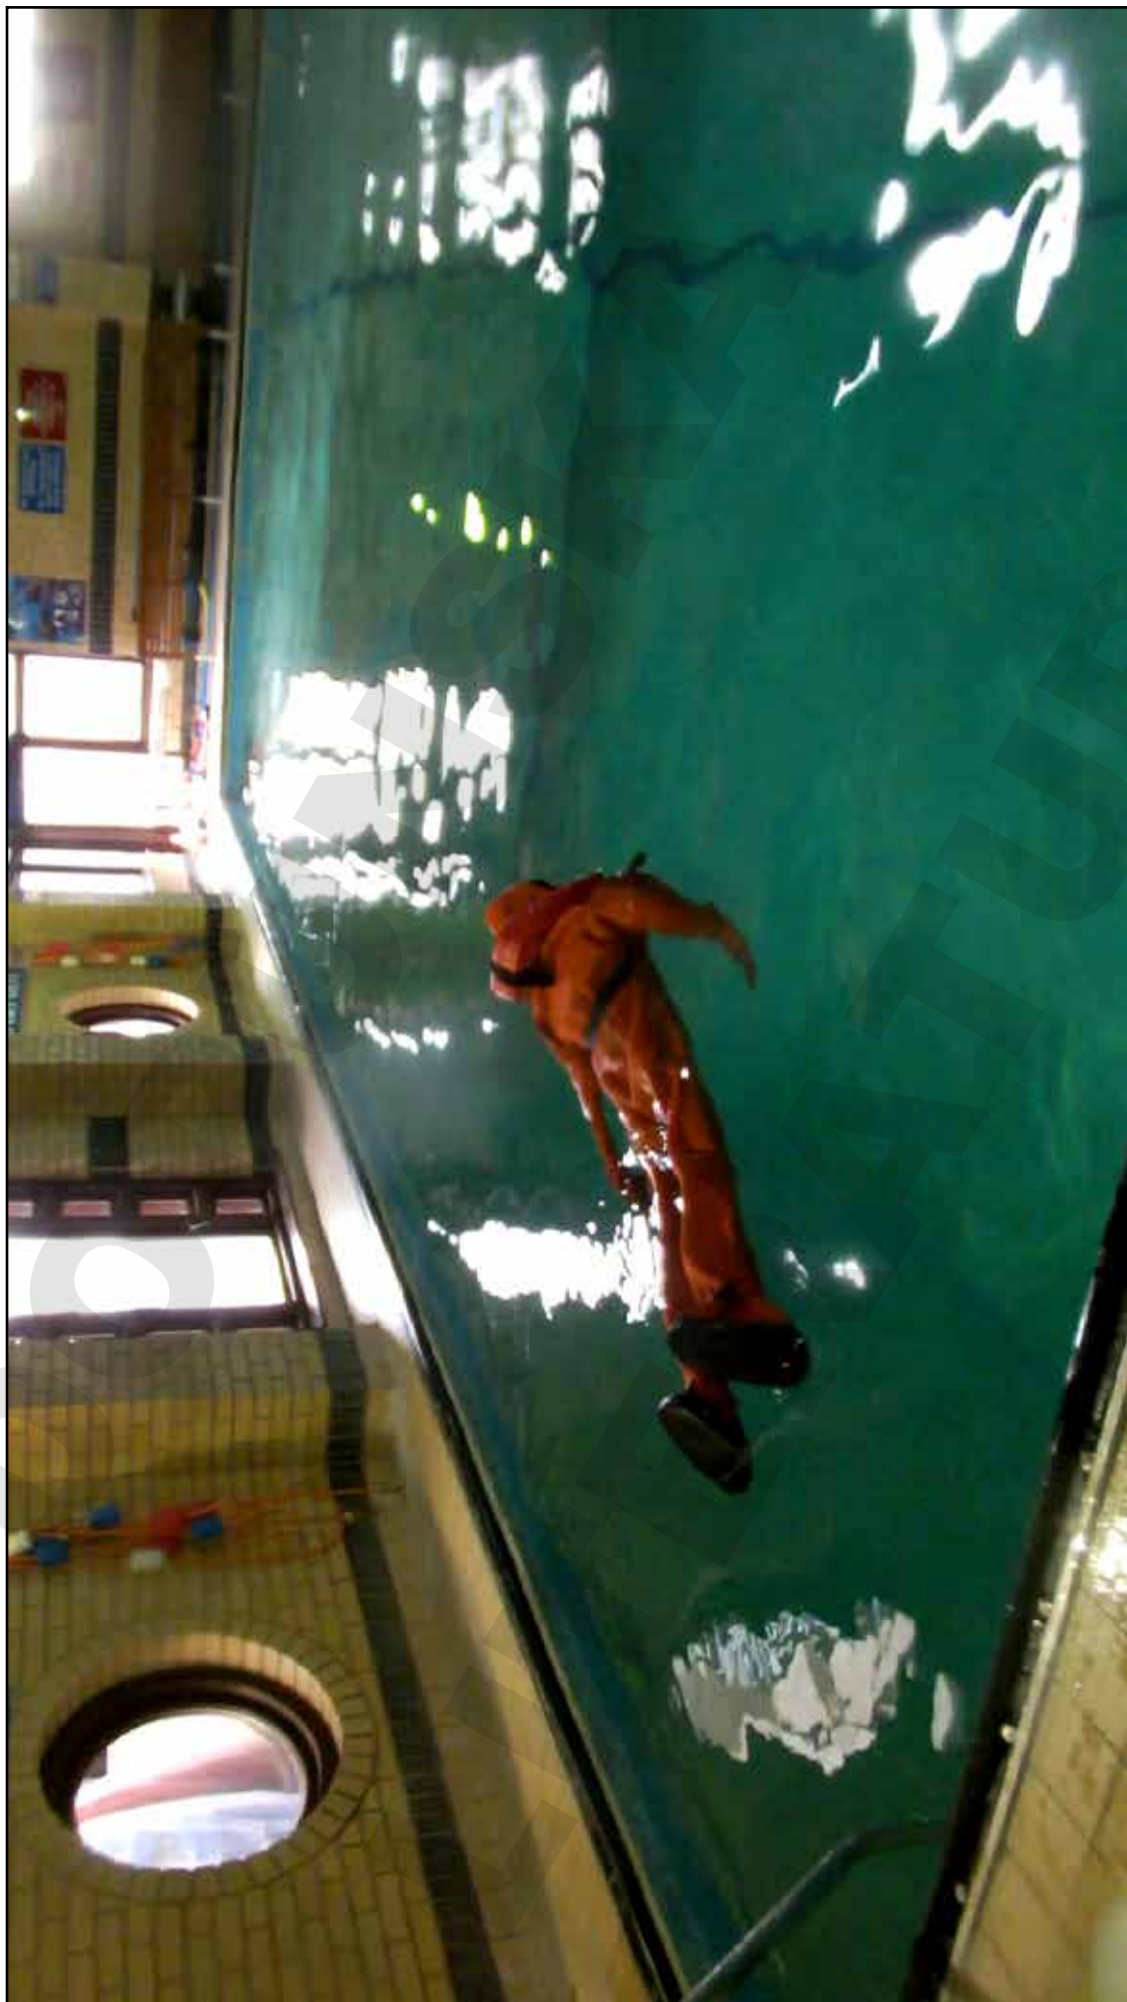
During the trials, the subject wearing the Autoflug KS1 immersion suit was able to don and secure the Aquavel Mk2/UK without difficulty. After swimming 3 strokes forward (breast stroke), the subject remained 'face-down' in the water (**Figure 60**). The immersion suit and the lifejacket did not produce any self-righting moment in this respect. However, with effort, the subject was able to turn from a 'face-down' position in the water to a 'face-up position' within 5 seconds. Once in a 'face-up' position, the subject's mouth was kept clear of the water by 135mm. The lifejacket remained in position and did not harm the subject.

Figure 60: Immersion suit/lifejacket compatibility trial using Autoflug KS1 immersion suit and Aquavel Mk2//UK lifejacket

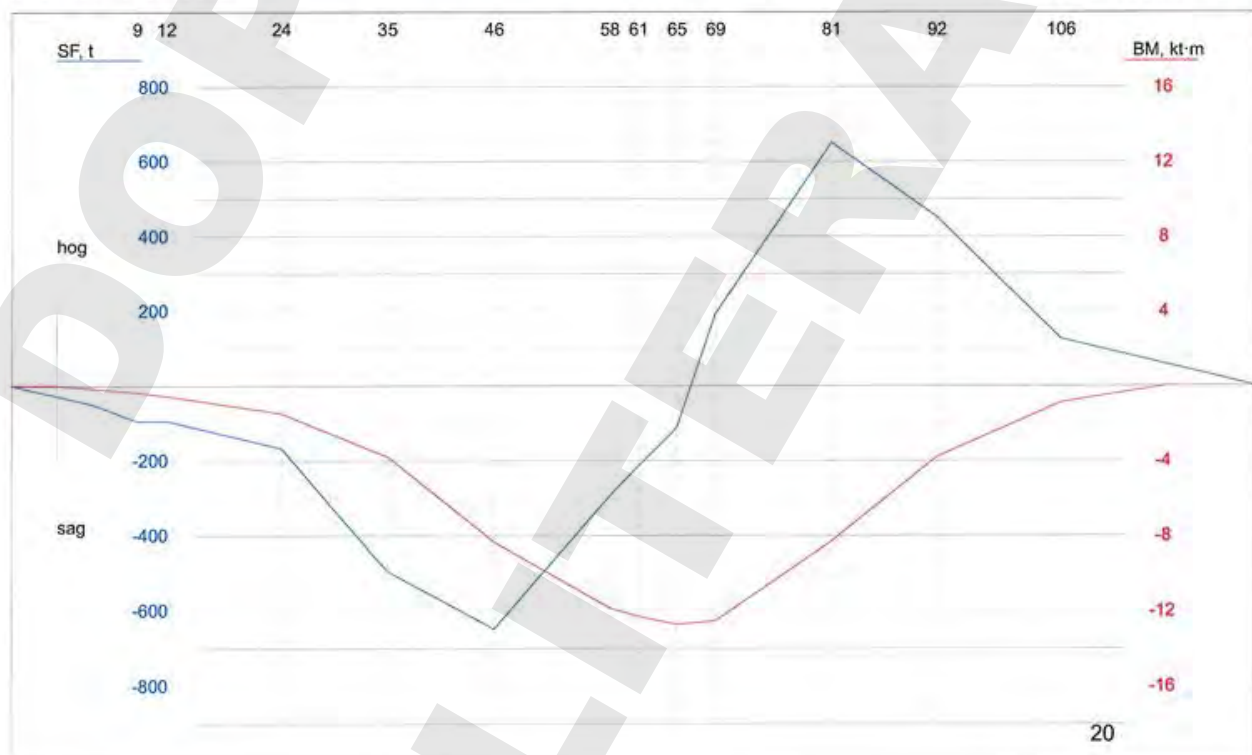
Output from TMC's analysis (**Figure 66**) represents *Swanland* in the sea conditions encountered at the time of the failure, and confirms that the maximum bending moment (red line) would have occurred at Frame 65, the middle of the transverse central beam. The positioning of the maximum bending moment in this area was to be expected given that Frame 65 coincided with the approximate longitudinal centre of the limestone cargo in the hold (**Figures 3, 67a and 67b**).

As the structure beneath the transverse beam had been strengthened to form a portal frame (**Figure 36**) during the vessel's construction, a structural failure at this particular frame would have been unlikely. However, **Figure 66** also indicates that a large bending moment would have still been present in the general midships area, particularly between Frame 58 and Frame 69.

Figure 66: Output from TMC analysis showing *Swanland* in the estimated sea conditions encountered at the time of the failure and the calculated bending moments (condition 5b)

midships section would have been in the wave trough when her bow was lifted by the large wave at the time of the initial structural failure, as illustrated at **Figures 66 and 67b**. It is also significant that Table 5.1 of the Met Office report (**Annex B**) confirmed that the estimated wave heights were at their maximum around the same time as the structural failure; the tidal stream and the seas were also in direct opposition, which would have caused the steepness of the waves to increase.

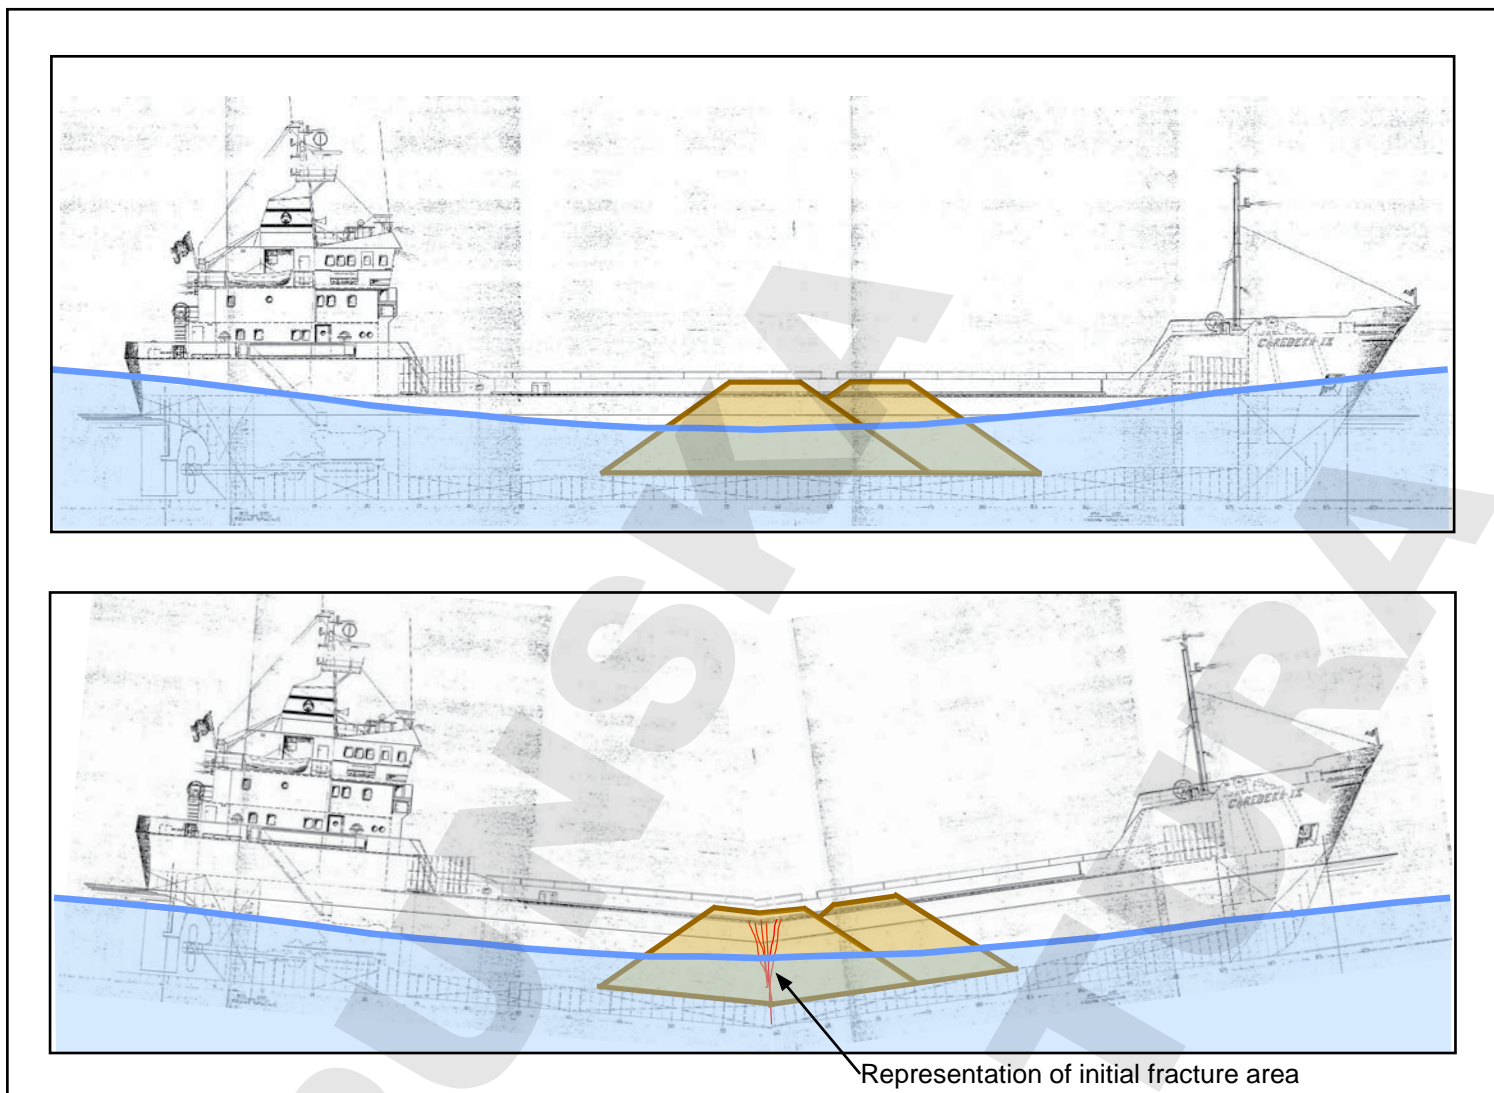
Figures 67a and 67b represent *Swanland* in the sea conditions and the possible post-failure sagging condition respectively. Both of these figures include the distribution of cargo (TMC's condition 5b); **Figure 67b** also shows the most likely location of the initial structural failure on the starboard side, based on the underwater evidence described below.

Figures 67a and 67b: Representation of *Swanland* in the estimated sea conditions at the time of the initial failure and the possible post-failure sagging condition

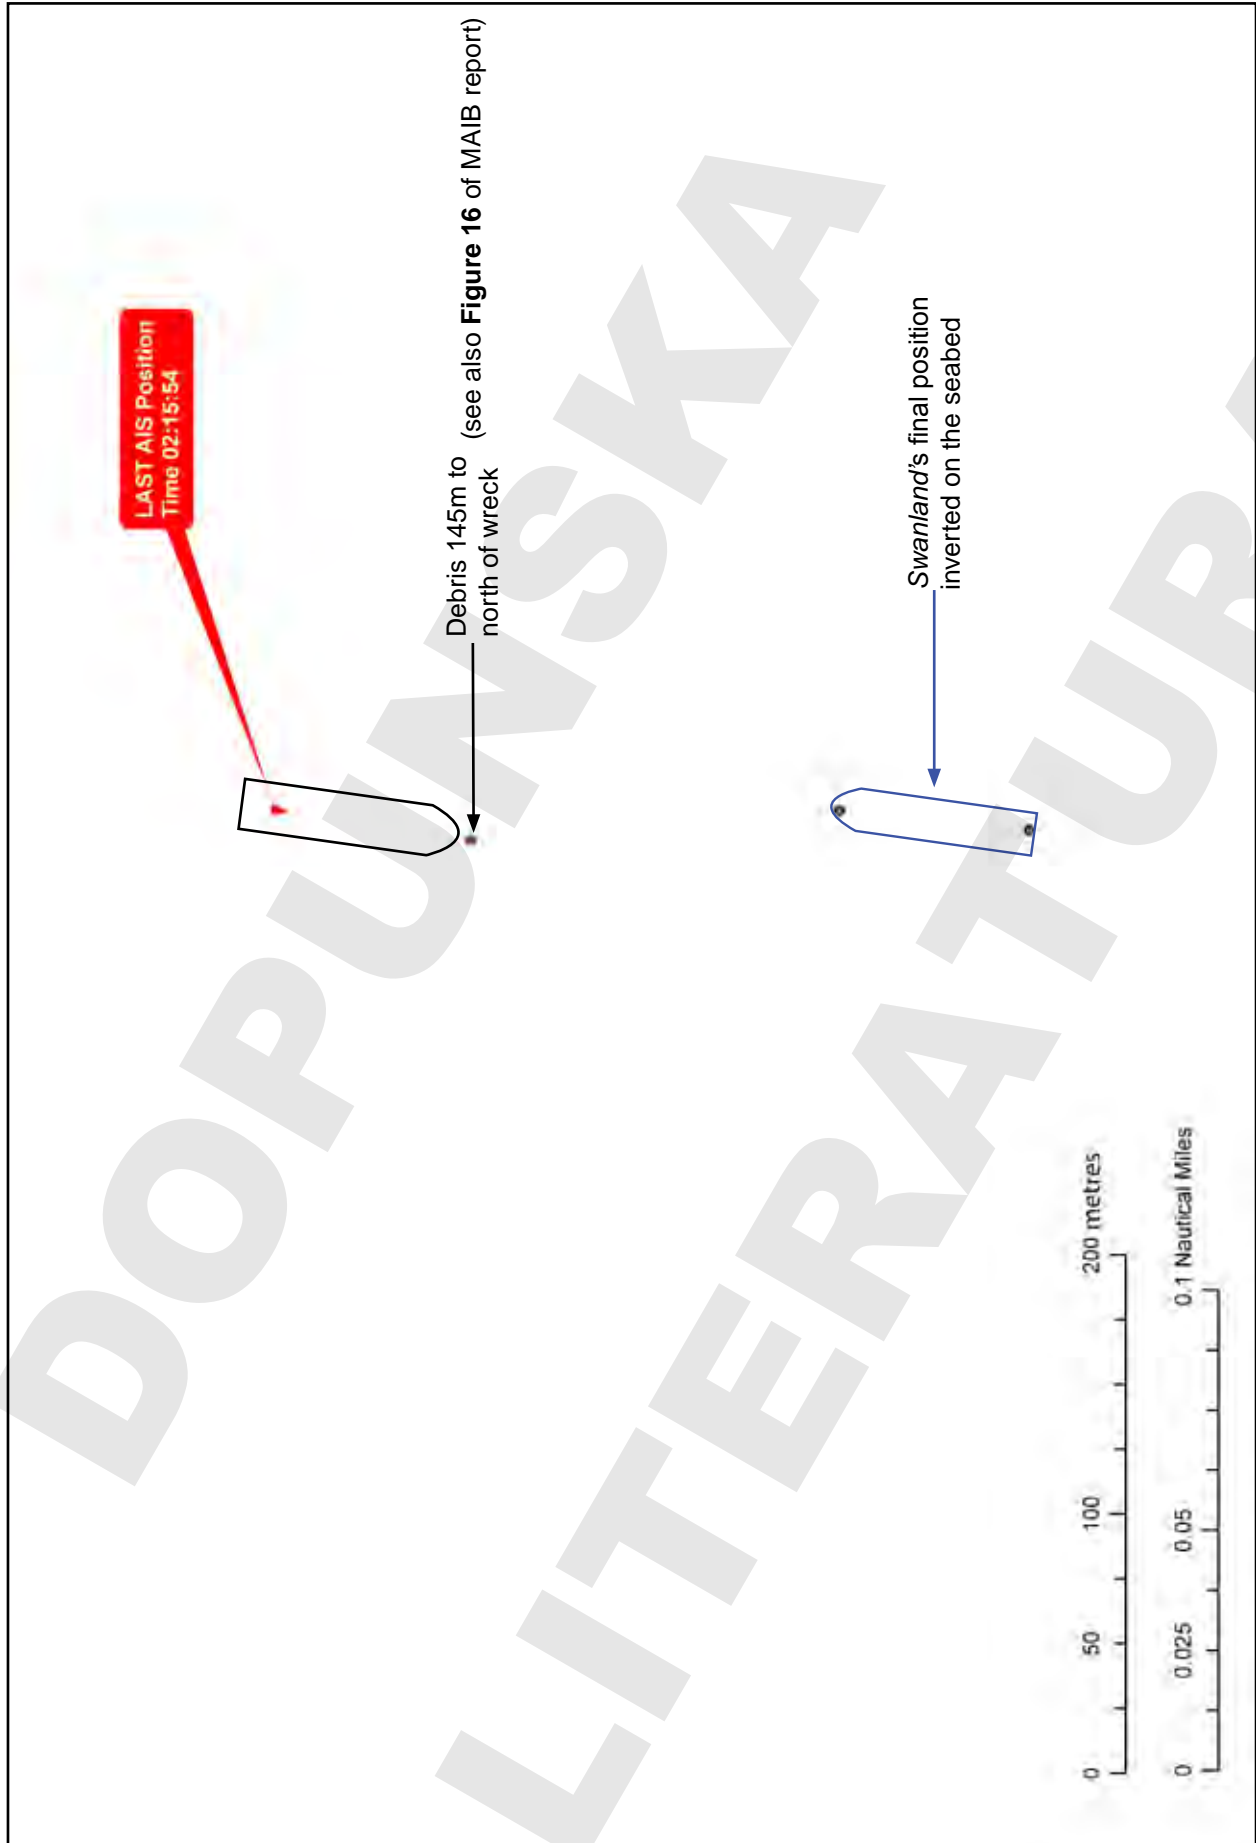
As shown at **Figure 72**, by the time of the final AIS transmission *Swanland* was on a heading of 193° but was being set in the same direction by the tidal stream. The final sequence of events leading to *Swanland* ending up inverted on the seabed on a heading of approximately of 008° (**Figure 16**) will never be known. However, it is evident that the vessel must have capsized at some stage after the two survivors were swept overboard. In view of the close proximity of the excavator carriage on the seabed to the vessel's last AIS position, it is evident that capsize must have occurred at about 0216.

Figure 72: Chart showing *Swanland*'s last AIS position and heading relative to her location and orientation on the seabed
