## SUMMARY REPORT ON OCCUPATIONAL ACCIDENT ON HAV STREYM 2 NOVEMBER 2019

*This summary concerns an occupational accident involving an able seaman who suffered severe injuries while opening hatch covers on board HAV STREYM during port stay in Karmøy, Norway, and focuses on the placement of control panels, which provided a restricted overview of the work area.*

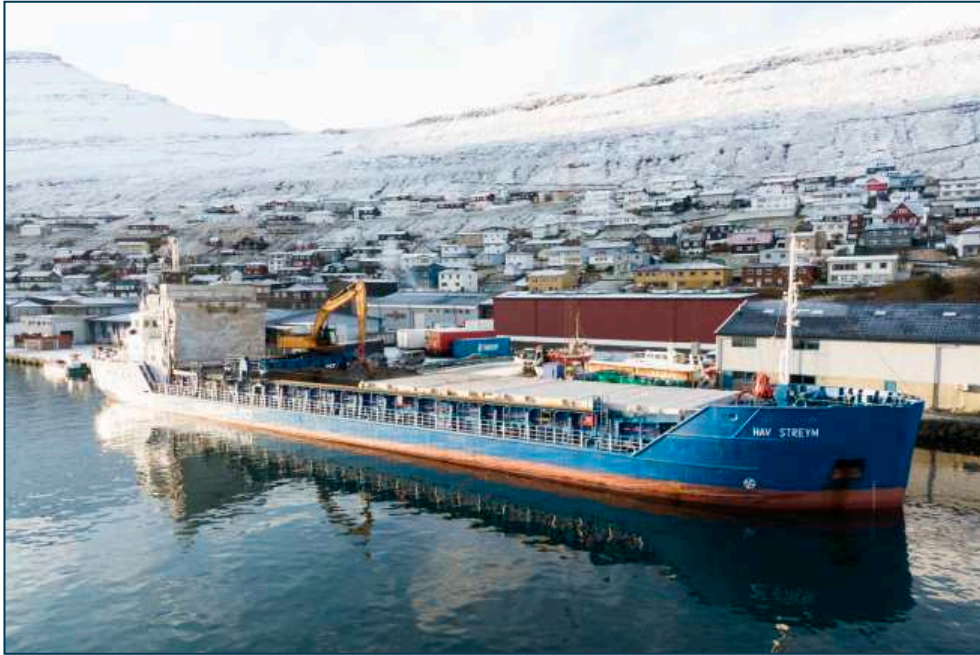
Figure 1: HAV STREYM  
Source: DMAIB

HAV STREYM (figure 1) was a Faroese self-discharging general cargo ship primarily carrying various bulk cargo between ports in Norway and the Faroe Islands. The ship was manned with a master, chief officer, chief engineer, ship's cook and two able seamen.
