Report on the investigation of the collision between

ACX Hibiscus

Hyundai Discovery

at 0756 local time on 11 December 2011

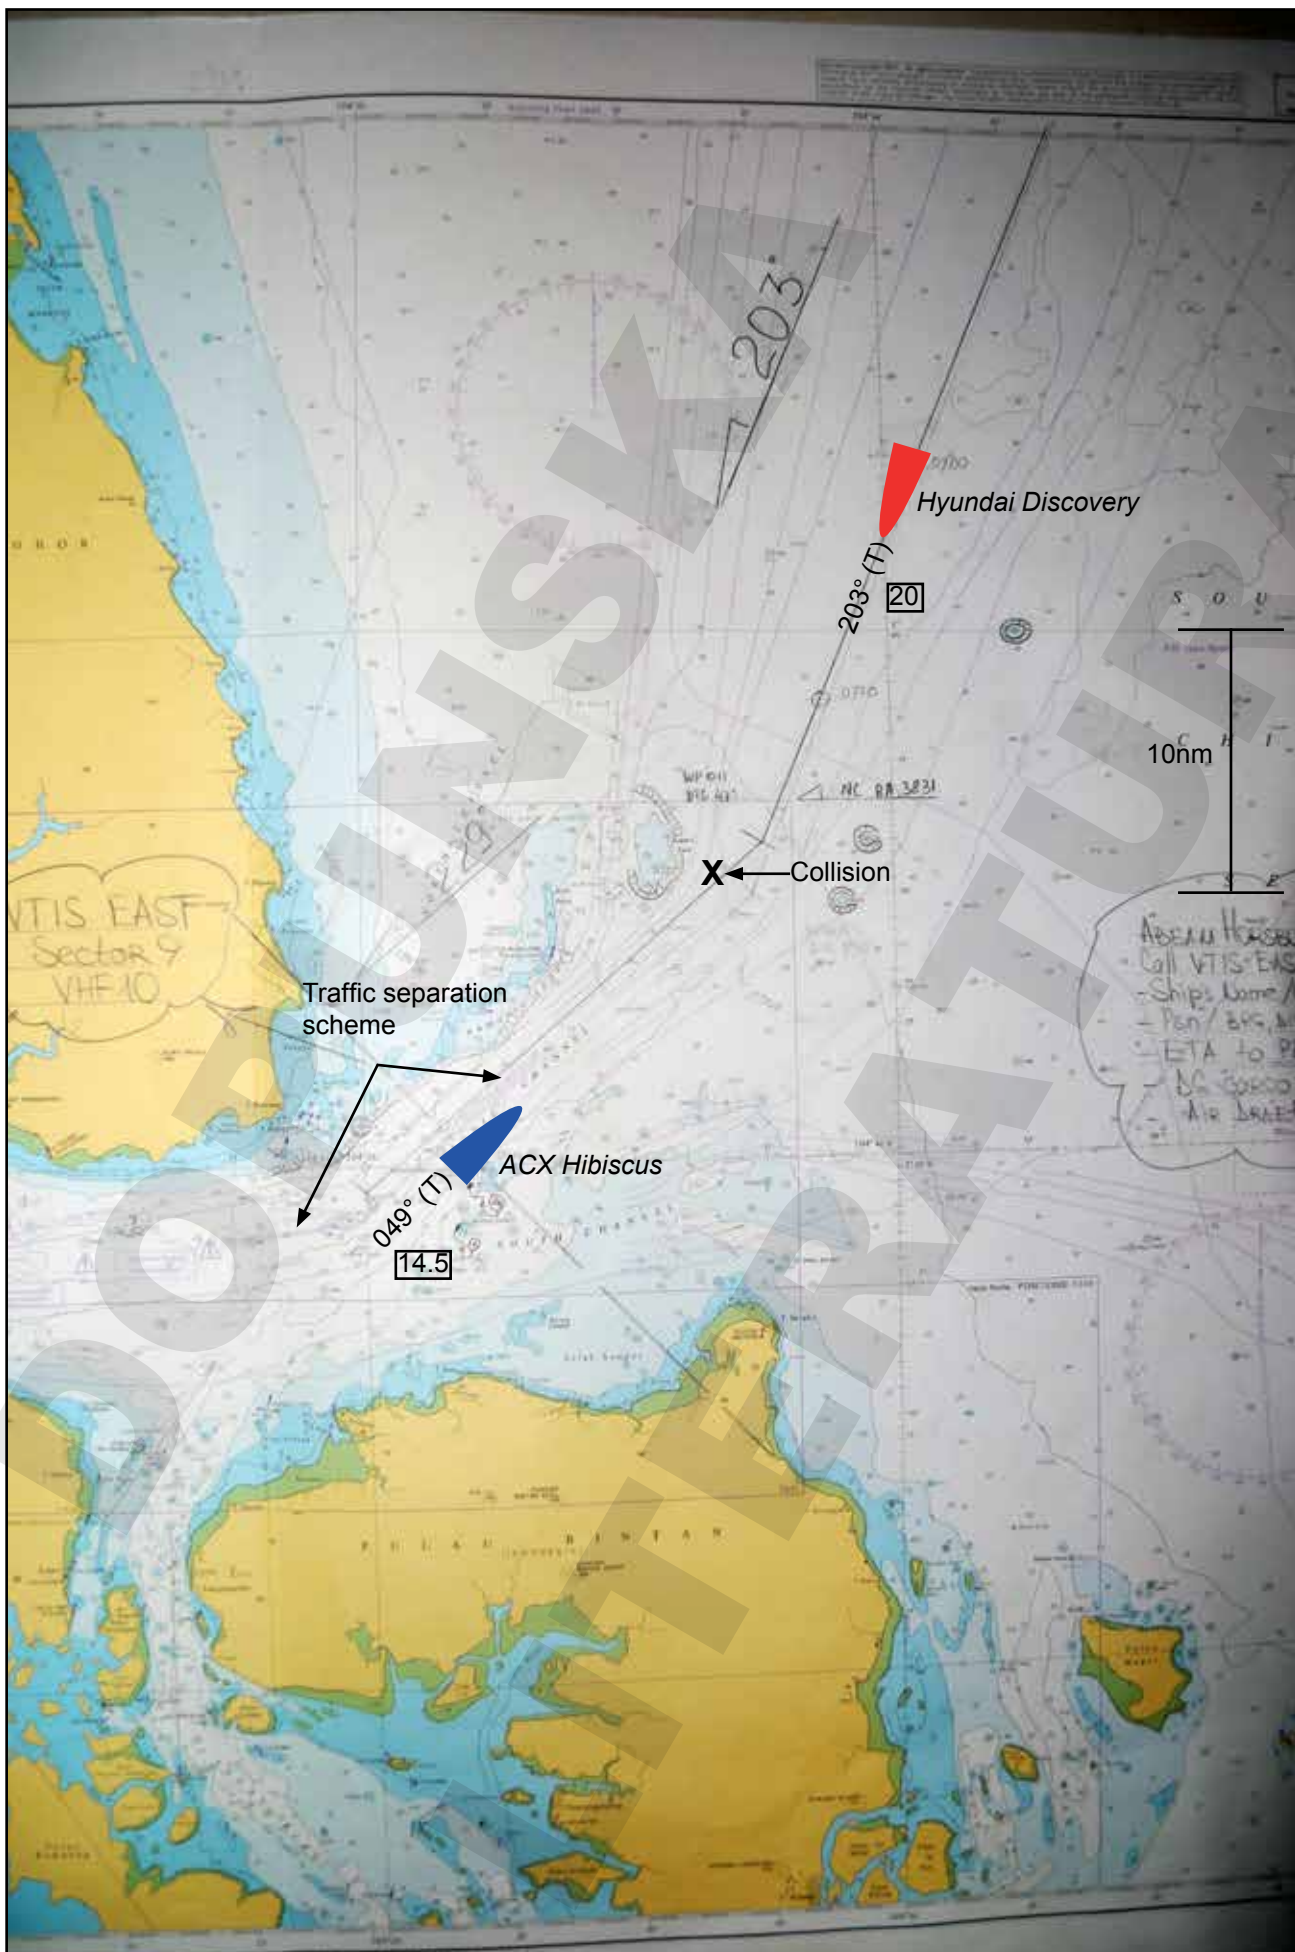
Figure 1: *Hyundai Discovery's* chart with the positions of *ACX Hibiscus* and *Hyundai Discovery* at 0700 superimposed

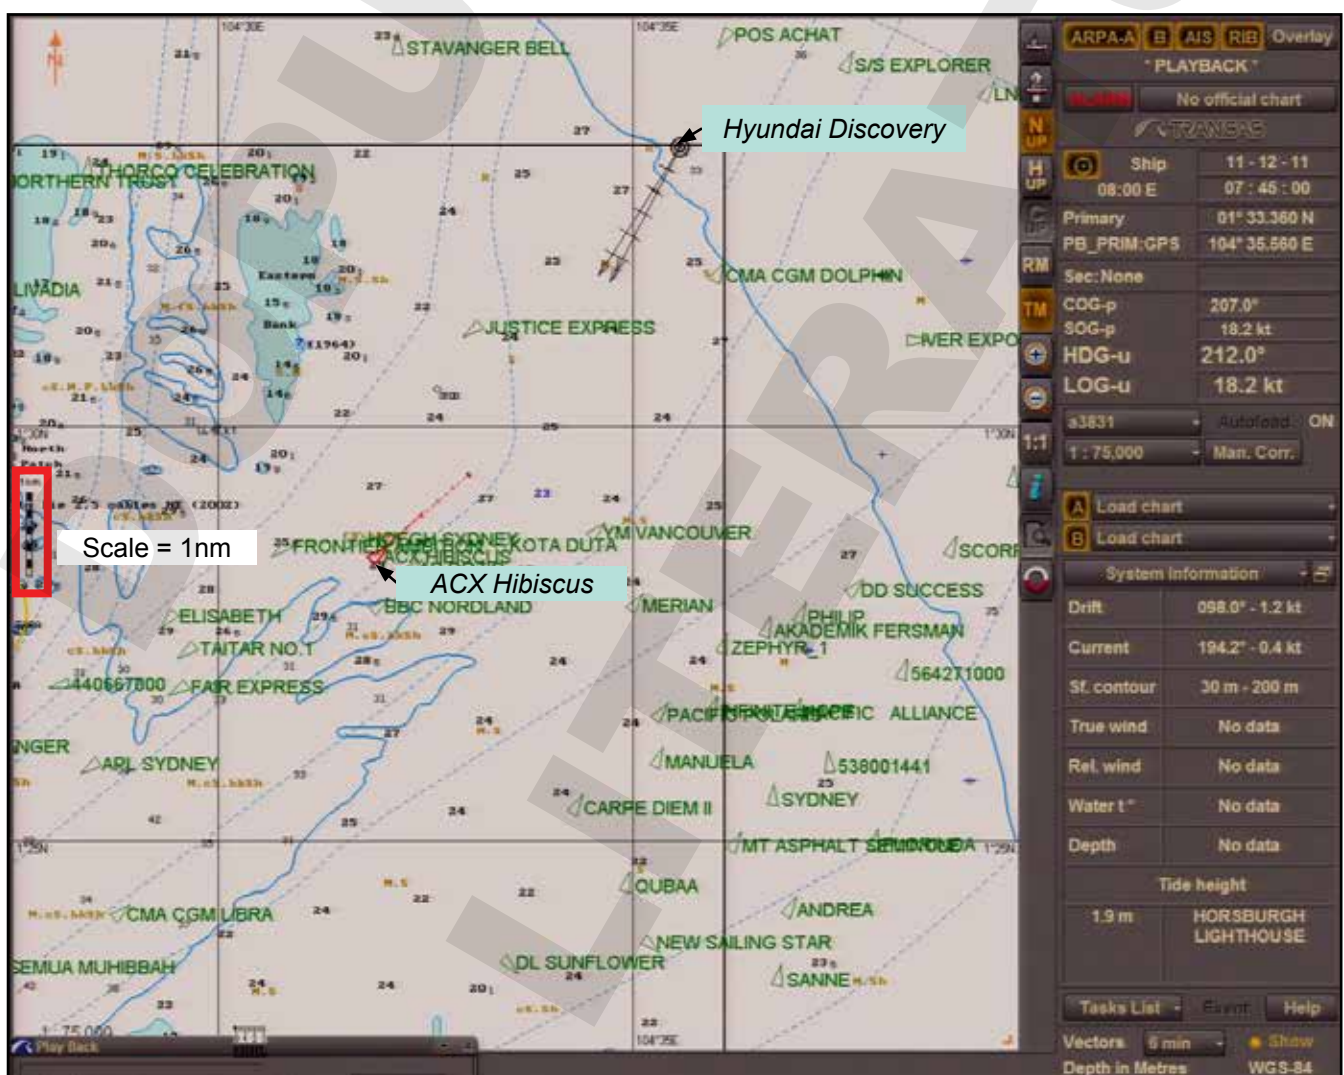
At about 0740 *Hyundai Discovery*'s cadet looked at the AIS information that was displayed on the Electronic Chart System (ECS) and saw that one of the vessels was *ACX Hibiscus*. The cadet told the chief officer that he thought *ACX Hibiscus* would pass clear down *Hyundai Discovery*'s port side. At 0741 the master returned to the bridge; the chief officer mentioned the recent rainfall to the master. The master instructed the chief officer to inform the on-watch engineer at 0800 that the main engine should be available to manoeuvre by 0900. At 0744 *Hyundai Discovery*'s chief officer used the autopilot control to alter course to starboard to a new heading of 209° (**Figure 2**). During the turn *ACX Hibiscus* was lost from sight.

Figure 2: *Hyundai Discovery*'s ECS showing positions of *ACX Hibiscus* and *Hyundai Discovery* at 0744

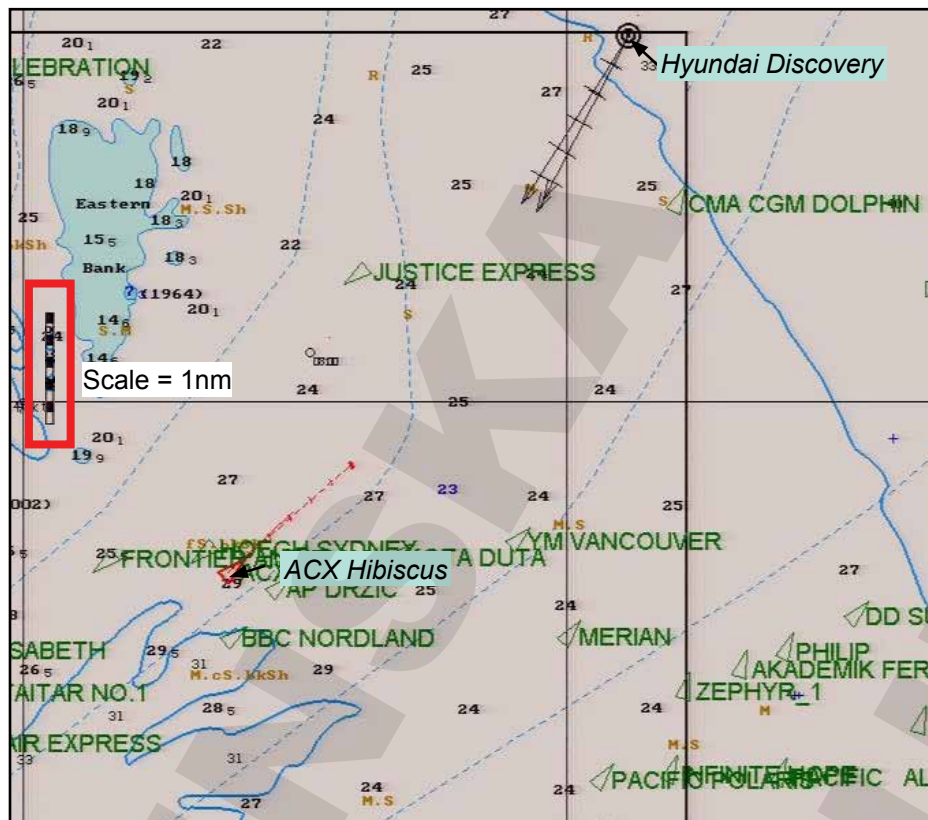
At 0747:00 the ARPA radar display on board *Hyundai Discovery* showed that *ACX Hibiscus* was 5nm right ahead of *Hyundai Discovery*. The radar plot indicated that the ships would be passing close, but clear, down each other's port sides (**Figure 3**). The chief officer on *Hyundai Discovery* used the autopilot control to turn to starboard to a heading of 216° to converge onto his next charted course of 229° and to increase his passing distance from *ACX Hibiscus*. At 0748:30, once close to the charted course, the chief officer turned further to starboard onto a heading of 229°.

Figure 3: Position of ACX Hibiscus and Hyundai Discovery at 0747

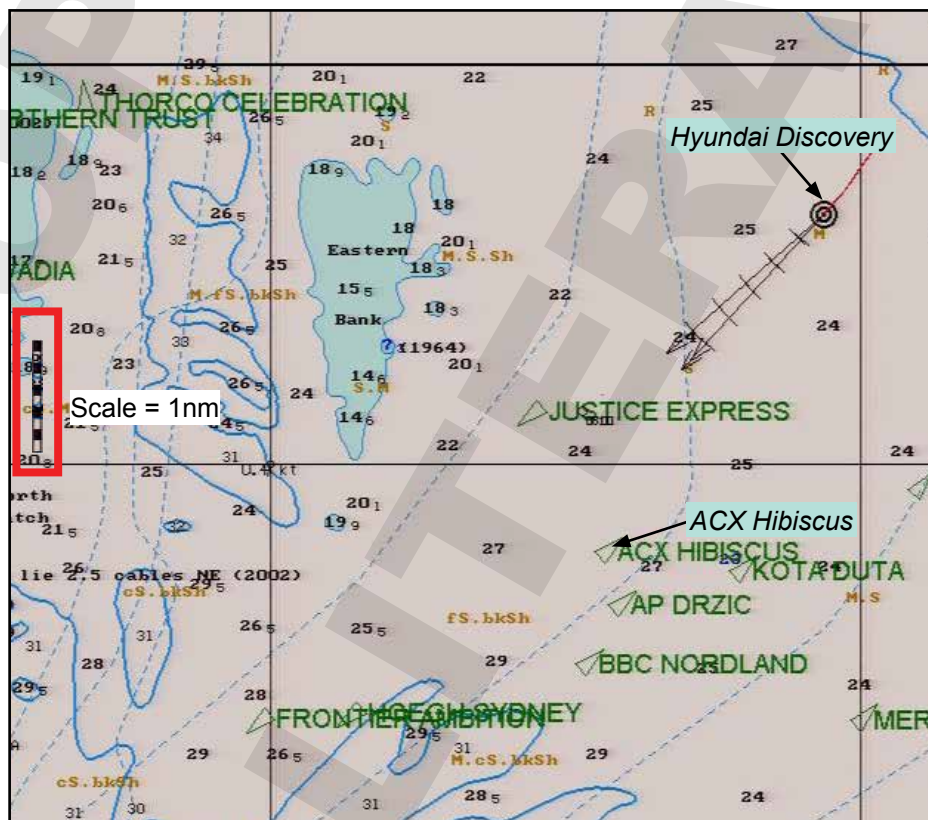
By 0750:00 *Hyundai Discovery* was steady on a heading of 229°, with *ACX Hibiscus* about 15° on the port bow at a range of 3.5nm (**Figure 4**). The ARPA on *Hyundai Discovery* indicated that *ACX Hibiscus*'s closest point of approach (CPA) would be approximately 7 cables on the port side. *Hyundai Discovery*'s chief officer placed the radar's electronic bearing line (EBL) over *ACX Hibiscus*'s radar target to confirm that its bearing was opening to port as he was expecting.

Figure 4: Position of ACX Hibiscus and Hyundai Discovery at 0750

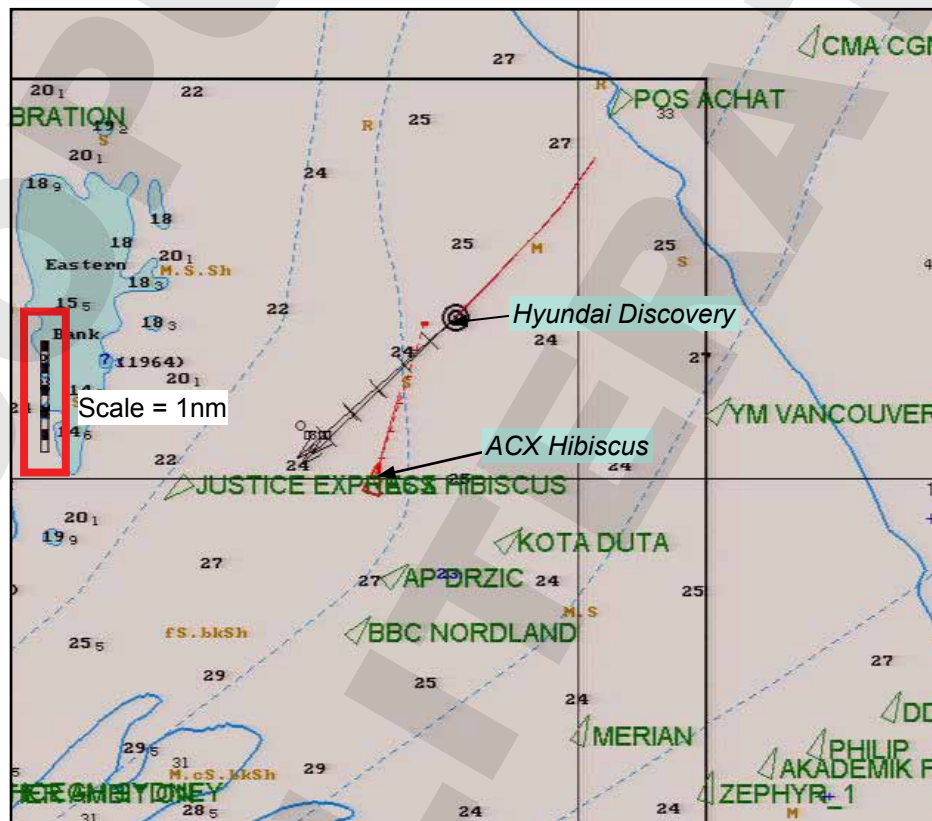
Figure 6: Position of ACX Hibiscus and Hyundai Discovery at 0753:30

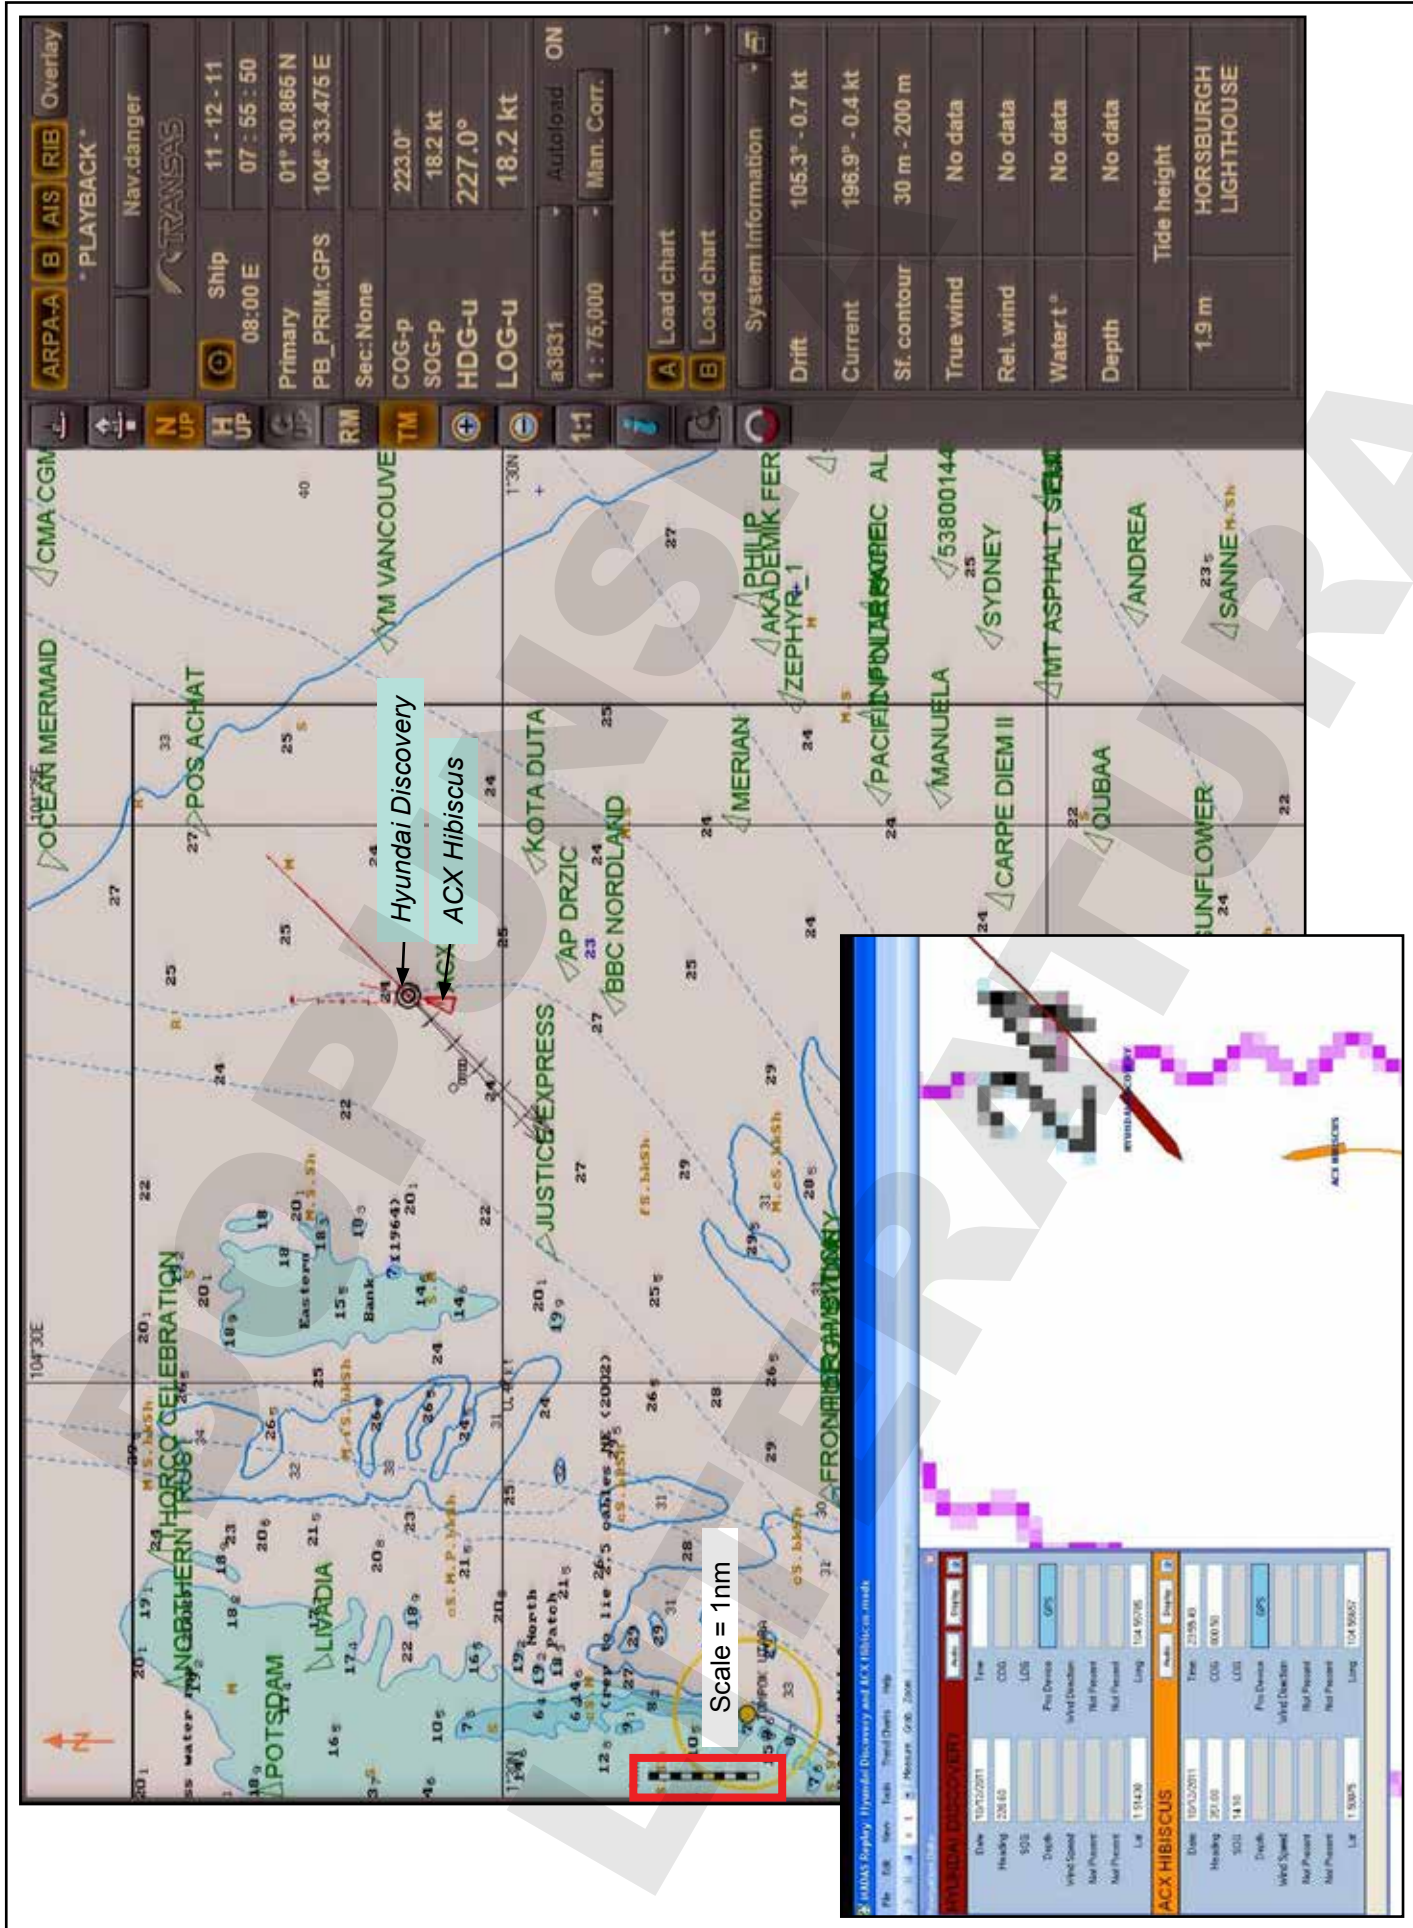
At 0755:13, about 1 minute before the collision, *Hyundai Discovery*'s chief officer ordered the AB to put the helm control into manual steering and he sounded one long blast on the ship's whistle. At 0755:35 *Hyundai Discovery*'s master arrived on the bridge and the chief officer reported the situation with *ACX Hibiscus* to him. *ACX Hibiscus* became visible at about 0755:50 at an estimated range of about 2 cables; the chief officer ordered the helm hard to starboard (**Figure 7**).

Figure 7: Position of ACX Hibiscus and Hyundai Discovery at 0755:50

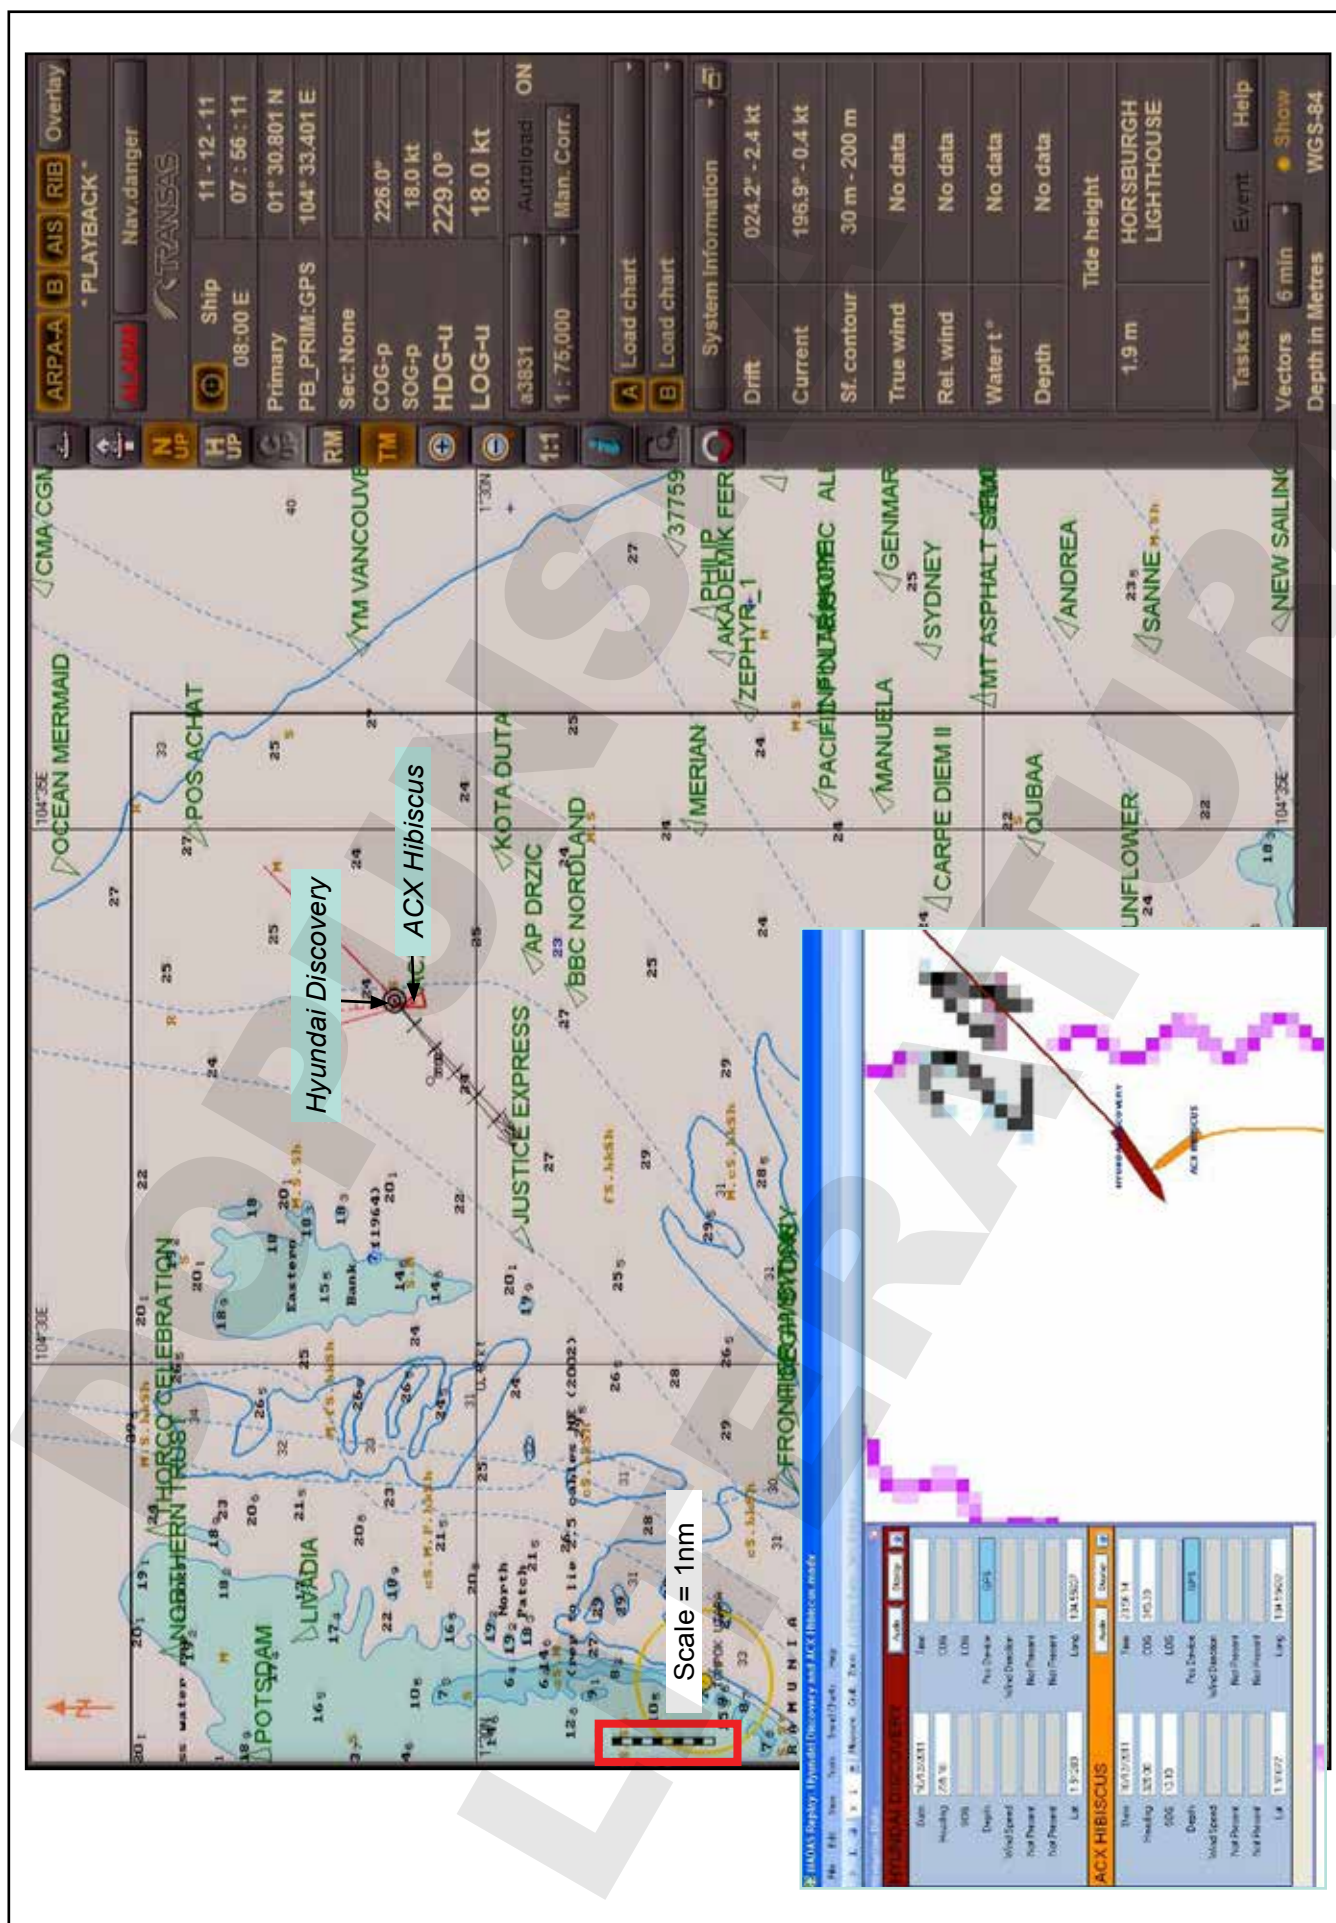
Figure 8: Position of ACX Hibiscus and Hyundai Discovery at 0756:10

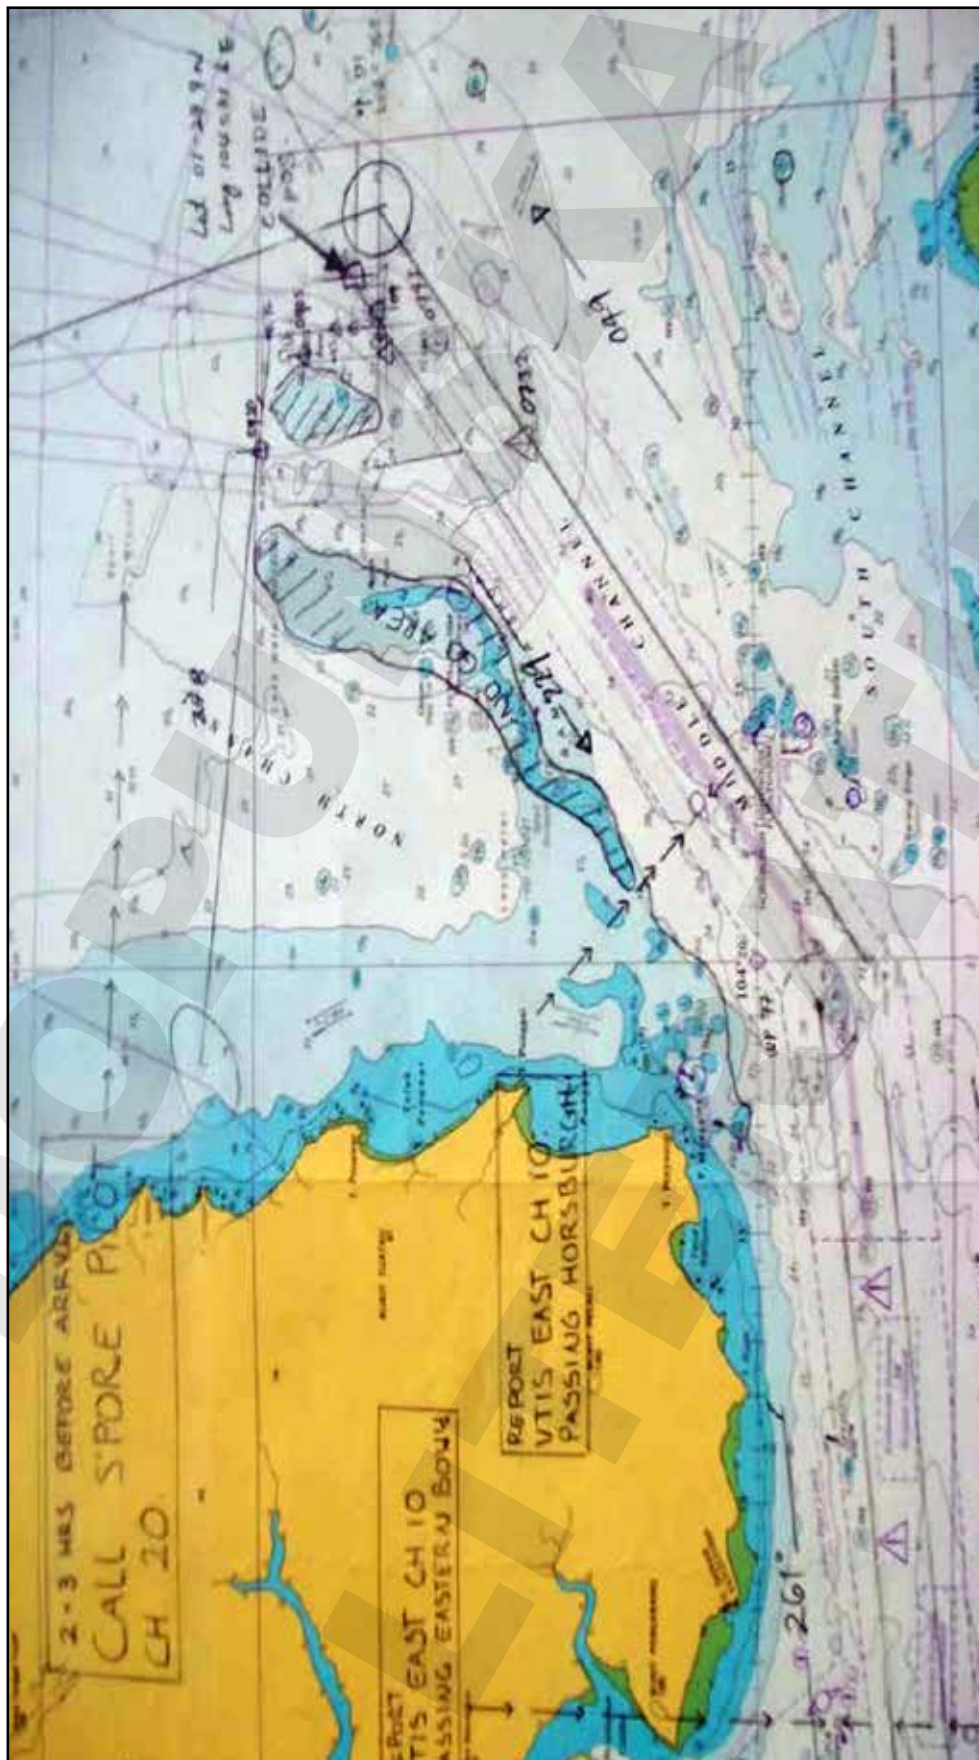
Figure 13: ACX Hibiscus's chart

ACX Hibiscus's primary means of navigation was with approved paper charts (**Figure 13**).

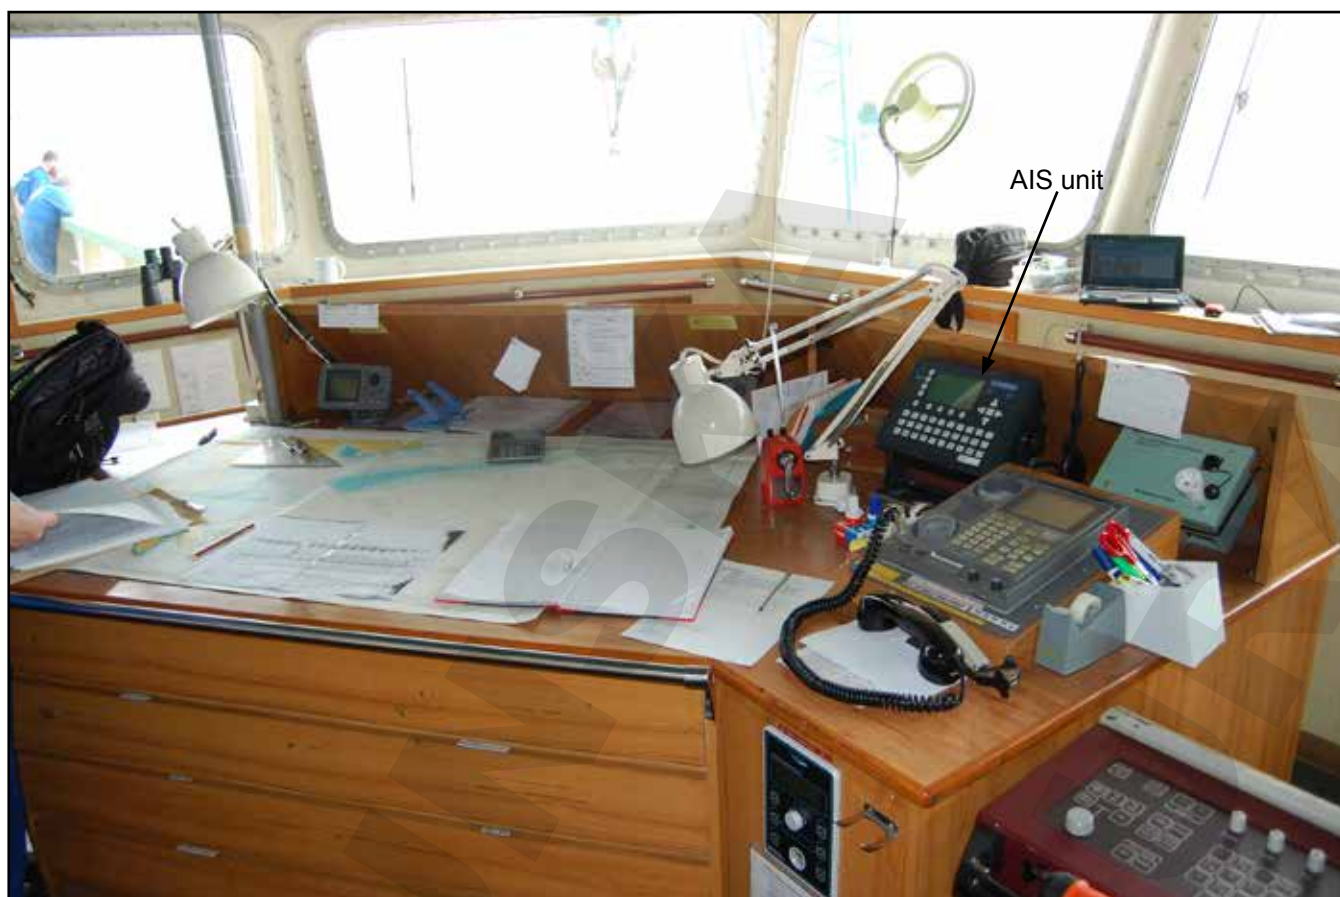
Figure 15: *Hyundai Discovery's* chart table

The primary means of navigation was with British Admiralty paper Standard Nautical Charts (**Figure 15**).

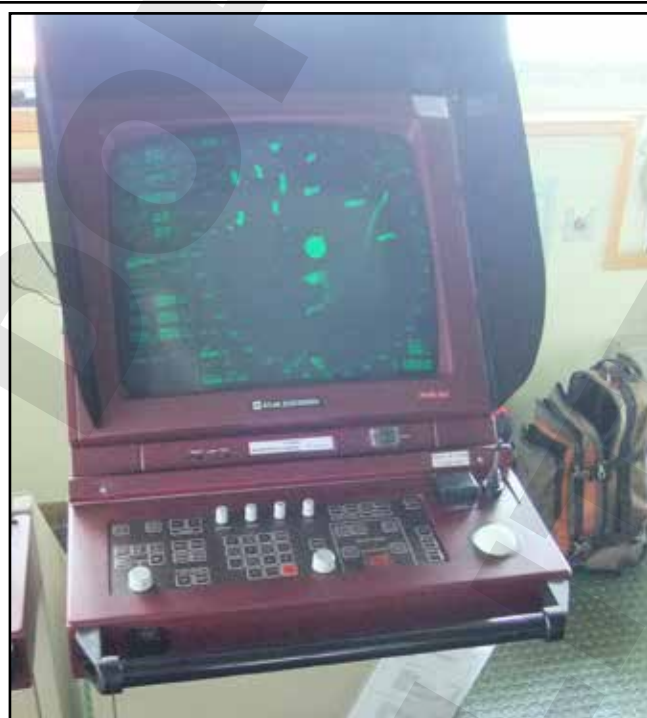
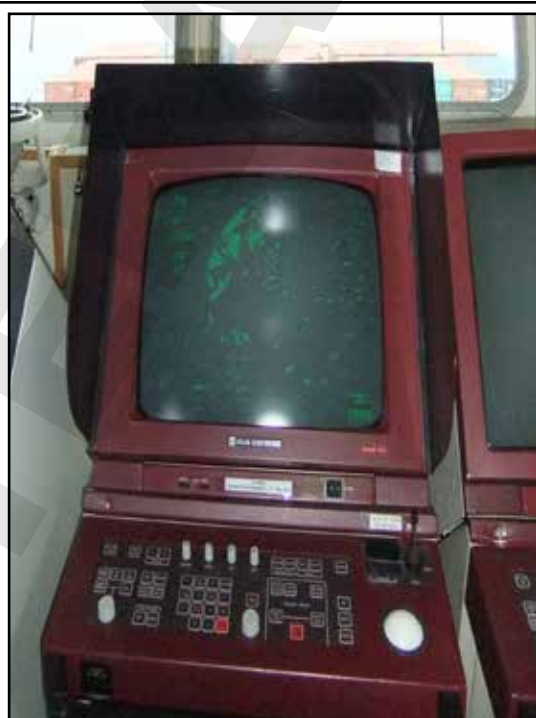
The bridge had two radars, both fitted with ARPA: an 'S band' (10cm wavelength) radar and an 'X band' (3cm wavelength) radar. While both radar displays worked effectively, due to the age of the equipment neither was capable of showing AIS data (**Figures 16a and 16b**).

Figure 16a: *Hyundai Discovery's* port side X band radar

Figure 16b: *Hyundai Discovery's* starboard side S band radar

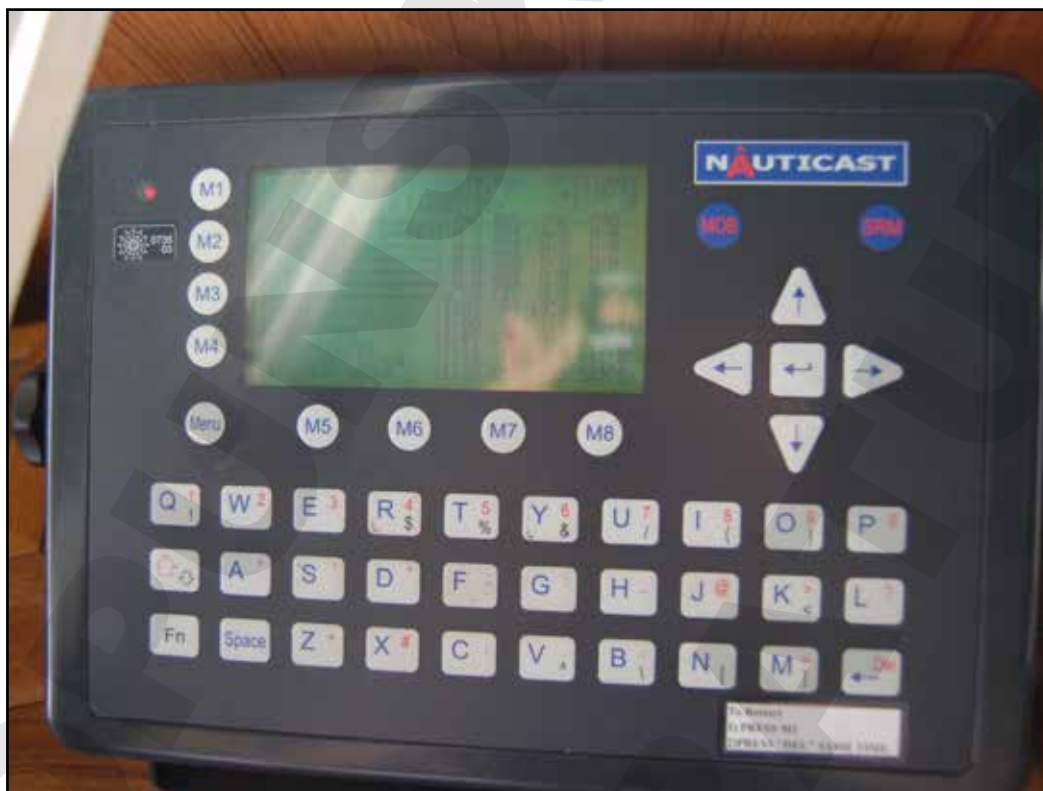
Figure 17: *Hyundai Discovery's* AIS unit

AIS data was shown on a display unit located near the chart table at the front of the bridge (**Figure 17**). The AIS information was also displayed on an Electronic Chart System (ECS) located by the communication station at the aft of the bridge on the port side by the communications desk (**Figures 18a and 18b**). The ECS displayed the ship's Global Positioning System (GPS) position and the AIS data for nearby vessels on an electronic navigation chart. The ECS had not been approved as a primary means of navigation and was provided to help the bridge watchkeepers improve their situational awareness. There were no instructions provided on how watchkeepers should use the combined ECS and AIS displayed information.

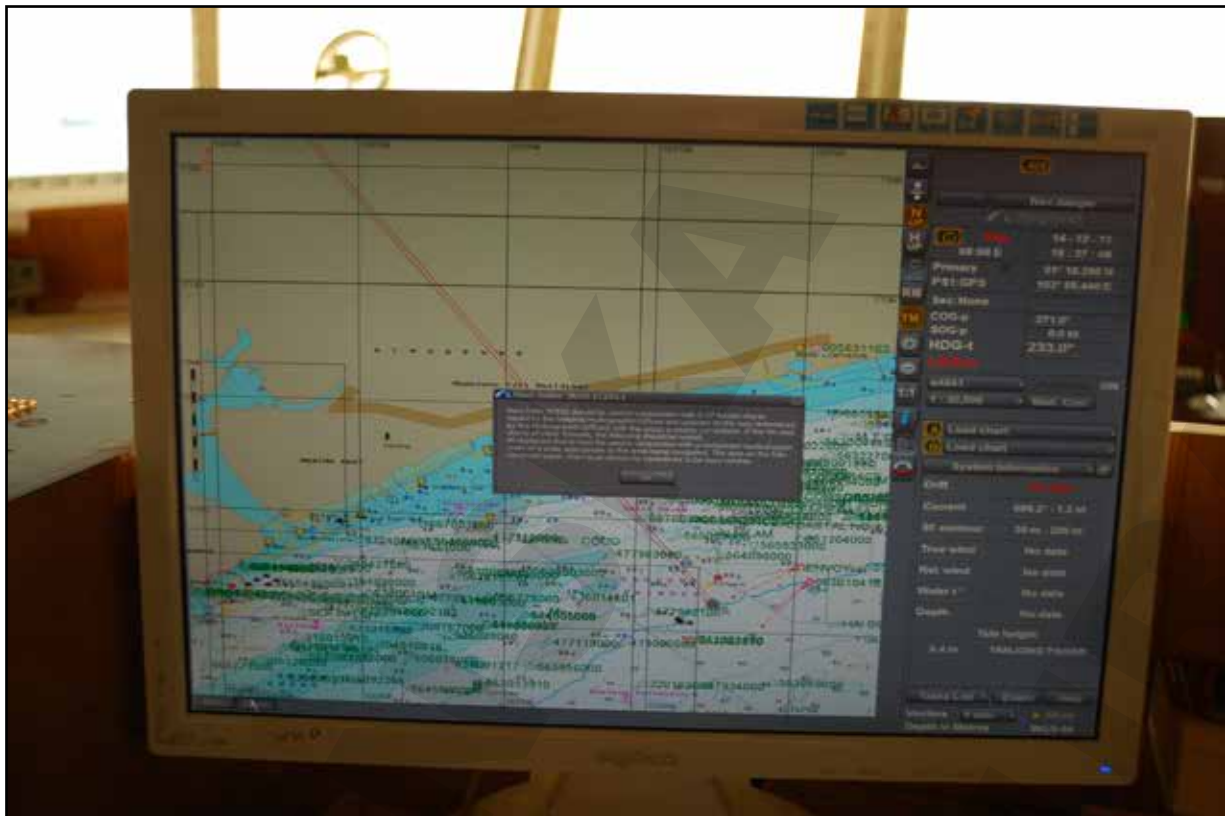
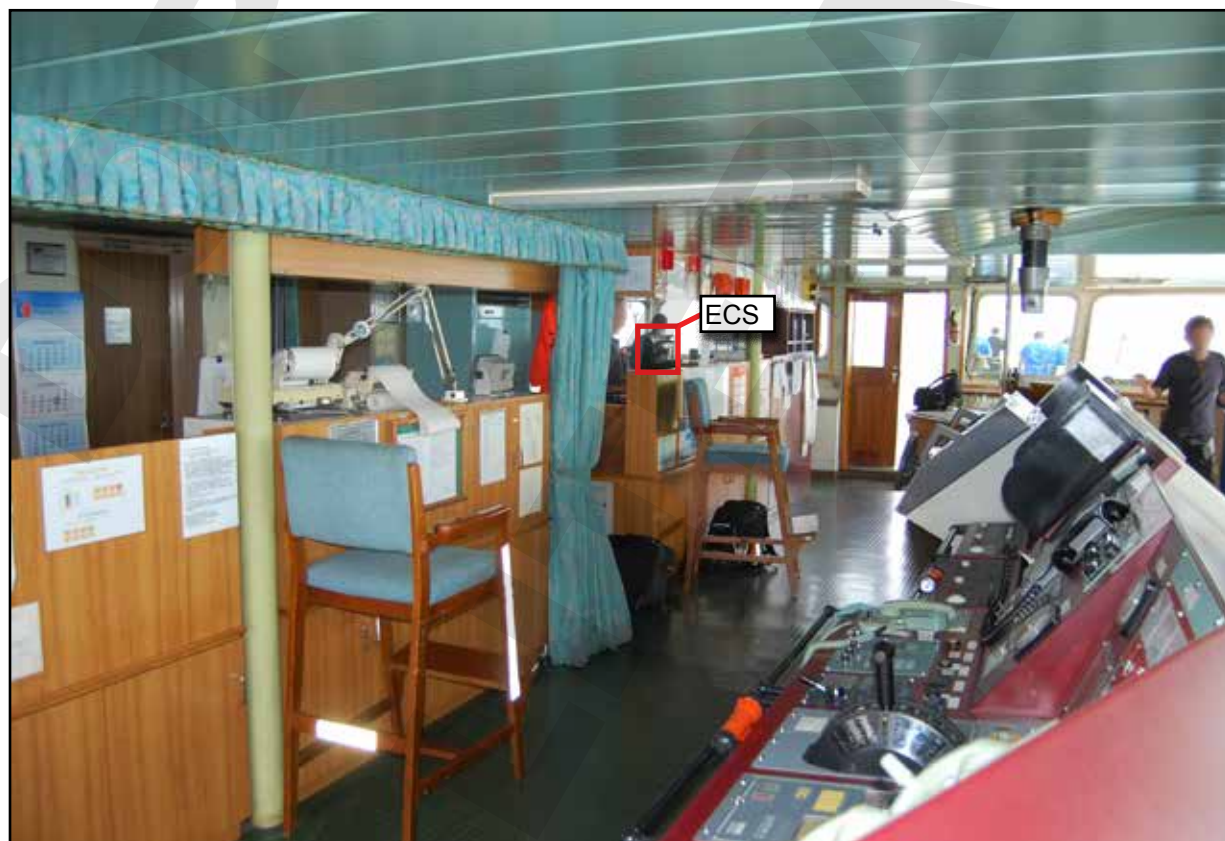
Figure 18a: Hyundai Discovery's ECS - displaying vessel AIS tracks

Figure 18b: Location of Hyundai Discovery's ECS
