Report on the investigation of  
a fatal accident on

***Wellservicer***

3 miles SE of Aberdeen, Scotland

1 April 2009

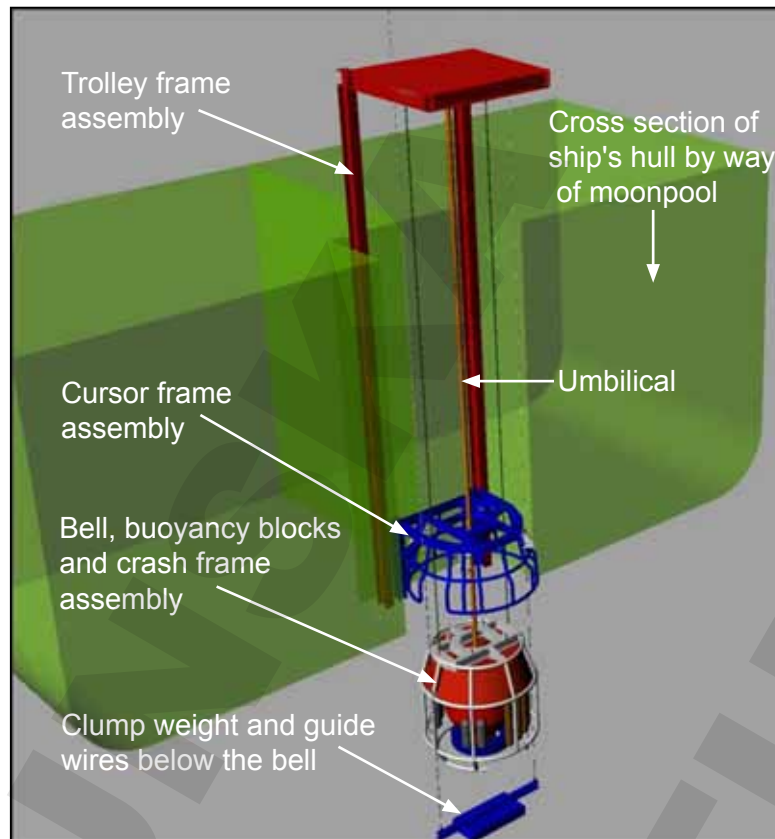
Figure 2a

The project required the bell's recovery system to be converted from a passive to an active cursor system (**Figures 2a and 2b**). In the existing passive system, the dive bell was recovered to the moonpool by means of two overhead wires, which allowed it to mate with its cursor at the ship's keel; the cursor and bell then ran on two vertical rails up to the bell trolley from the bottom of the moonpool. The passive cursor was simply a securing arrangement with no lifting capability. Once mated with the cursor, the bell effectively became integral with the vessel, rolling and pitching with her movements. It was essential that this operation was carried out smoothly and efficiently to prevent damage to the dive bell, or injury to occupants. The bell and cursor were both carried aloft to the trolley (**Figure 3**) by the same wires that hoisted the bell from deep sea level, and they were then secured by bell locking pins (**Figure 4**) before being "trolleyed" to the saturation chamber. Cursor supports (**Figure 5**) were then inserted into the legs of the trolley to take the weight of the cursor as the bell was lowered onto the chamber's "transfer under pressure" (TUP) trunking, where divers transferred from the bell to the chamber below. Taking the weight of the cursor on these supports prevented the 4t cursor resting on, and possibly damaging, the TUP trunking.

Diagrammatic representation of a passive cursor system

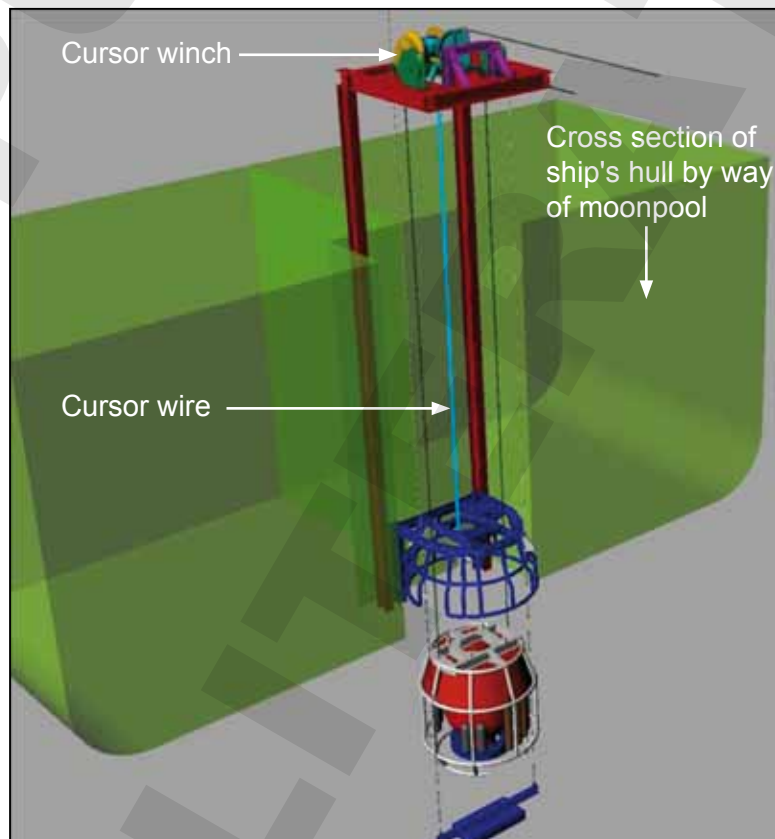
Figure 2b

Active cursors have their own dedicated winch for use in an emergency. In such a situation, the cursor can attach to the bell by means of latch hooks, and carry it aloft in the event of failure of the bell's winch system. To achieve this, the bell has first to be recovered to the moonpool by separate clump wires (**Figure 6**). *Wellservicer* already had such a system in place for her aft diving bell.

Diagrammatic representation of an active cursor assembly (umbilical removed for clarity)

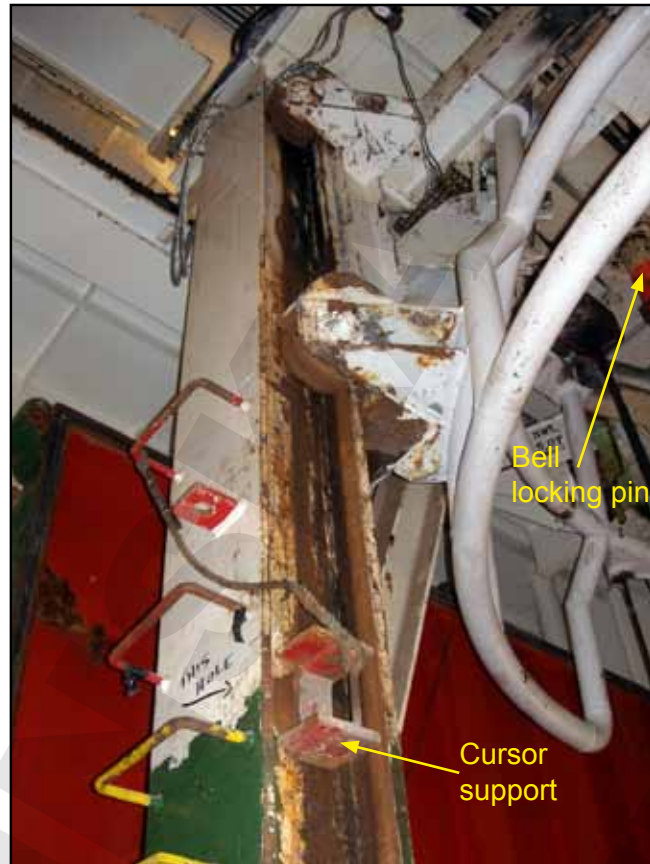
Figure 5

Bell trolley frame port leg, showing cursor support

- In normal diving bell launch and recovery operations, it was routine practice to put the cursor supports in place (**Figure 5**). In the rather different context of the modification process, the need for this routine might not have been evident to riggers focused on the technical challenges of the task<sup>8</sup>.

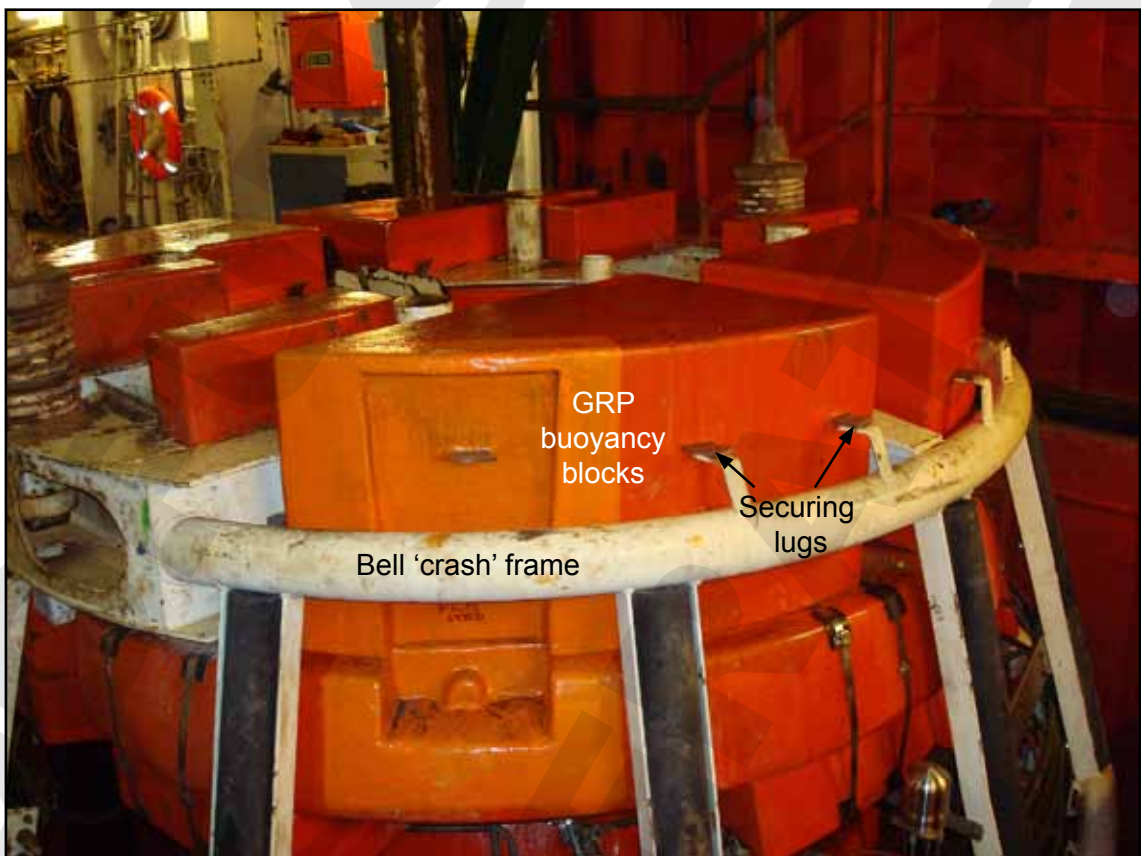
Figure 7

Glass reinforced plastic (GRP) buoyancy blocks attached to the bell (**Figure 7**) needed to be removed for alterations. This was a difficult task due to the close proximity of the cursor and the cumbersome shape of the blocks. It was decided to move the bell and cursor from the TUP trunking to the moonpool, to hang the cursor off from the trolley by means of stops, and to lower the bell to a satisfactory height in the moonpool, thus allowing the blocks to be removed more easily. The bell top also created a convenient working platform to allow work to progress on the cursor suspended several feet above it.

Bell top showing GRP buoyancy blocks

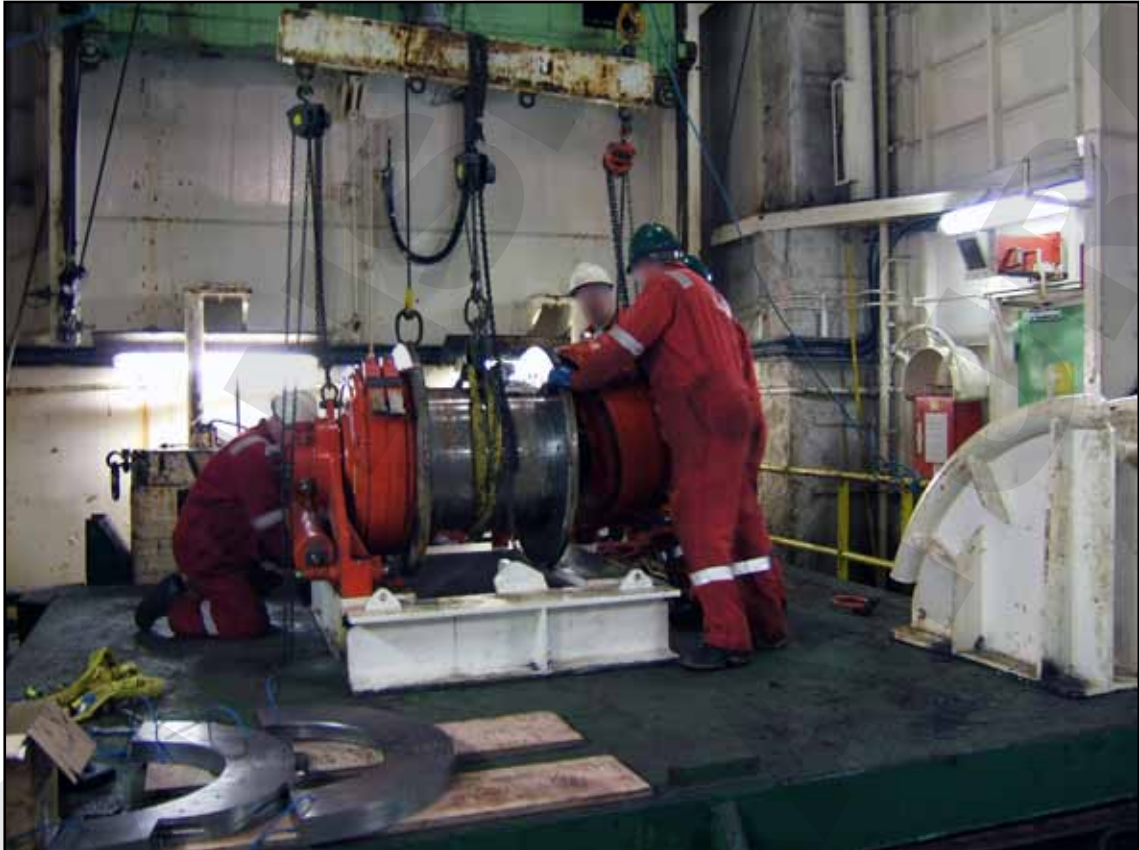
Figure 16

testing also included evaluation of the winch drum braking systems. Following load testing, the winch was stripped down into its component parts again before being transported to the dry dock in Holland. The components were hoisted from the dry dock bottom into the vessel up through the forward moonpool, and then re-assembled on board the vessel (**Figure 16**) before being installed on top of the bell trolley.

Winch being assembled in bell hanger
