Marine Accident Report

**Allision of Hong Kong-Registered Containership M/V *Cosco Busan*
with the Delta Tower of the San Francisco–Oakland Bay Bridge
San Francisco, California
November 7, 2007**

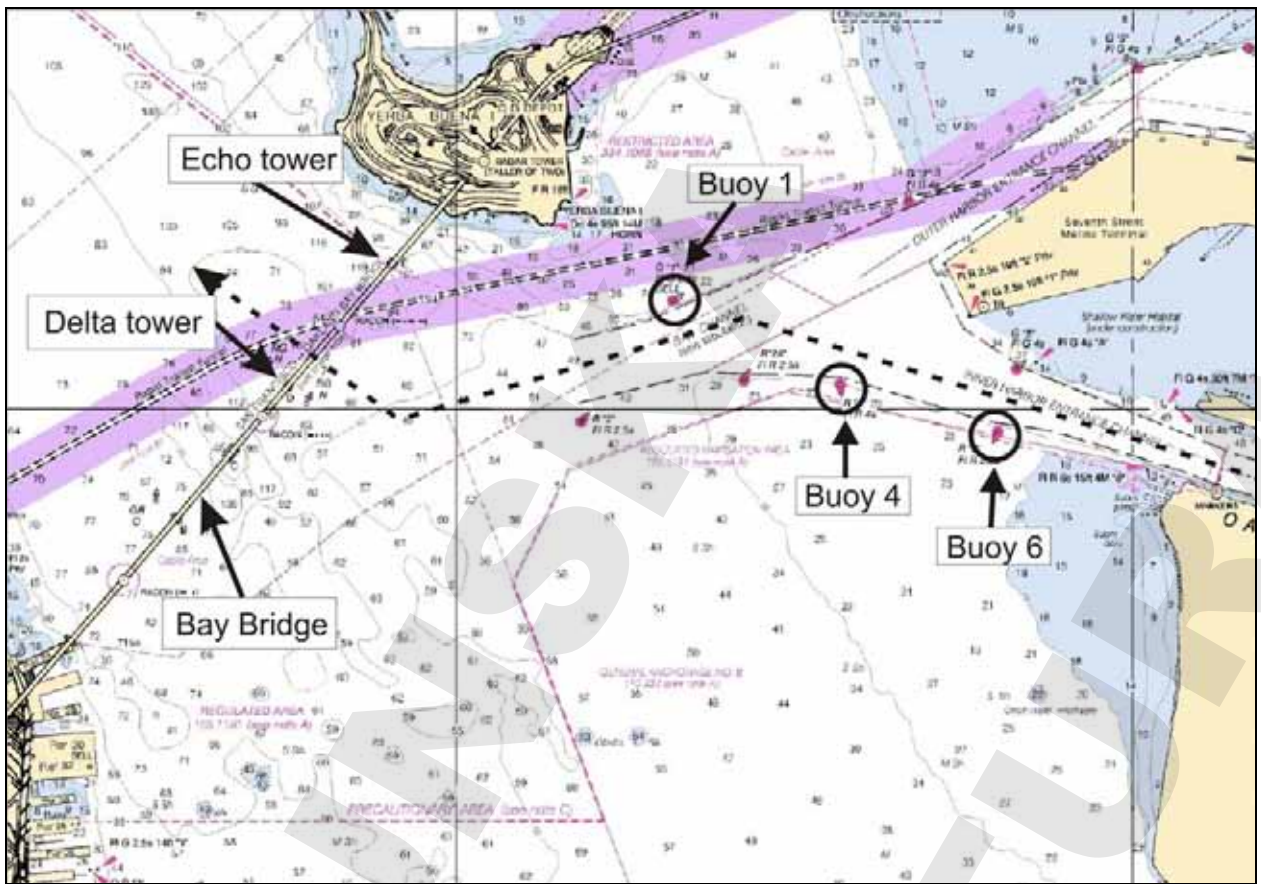
Figure 3. Navigation chart of the accident area with the approximate intended course of the *Cosco Busan* shown by the black dotted line.

About 0823, the pilot began a left turn to the southwest by ordering 10° port rudder. Radar data indicate that the ship at this time was on a heading of 282° and was traveling about 10 knots. A radar image from about 0825 showed that the VRM ring, which the pilot indicated he would normally attempt to keep positioned along the southern edge of Yerba Buena Island, had overlapped the edge of the island.

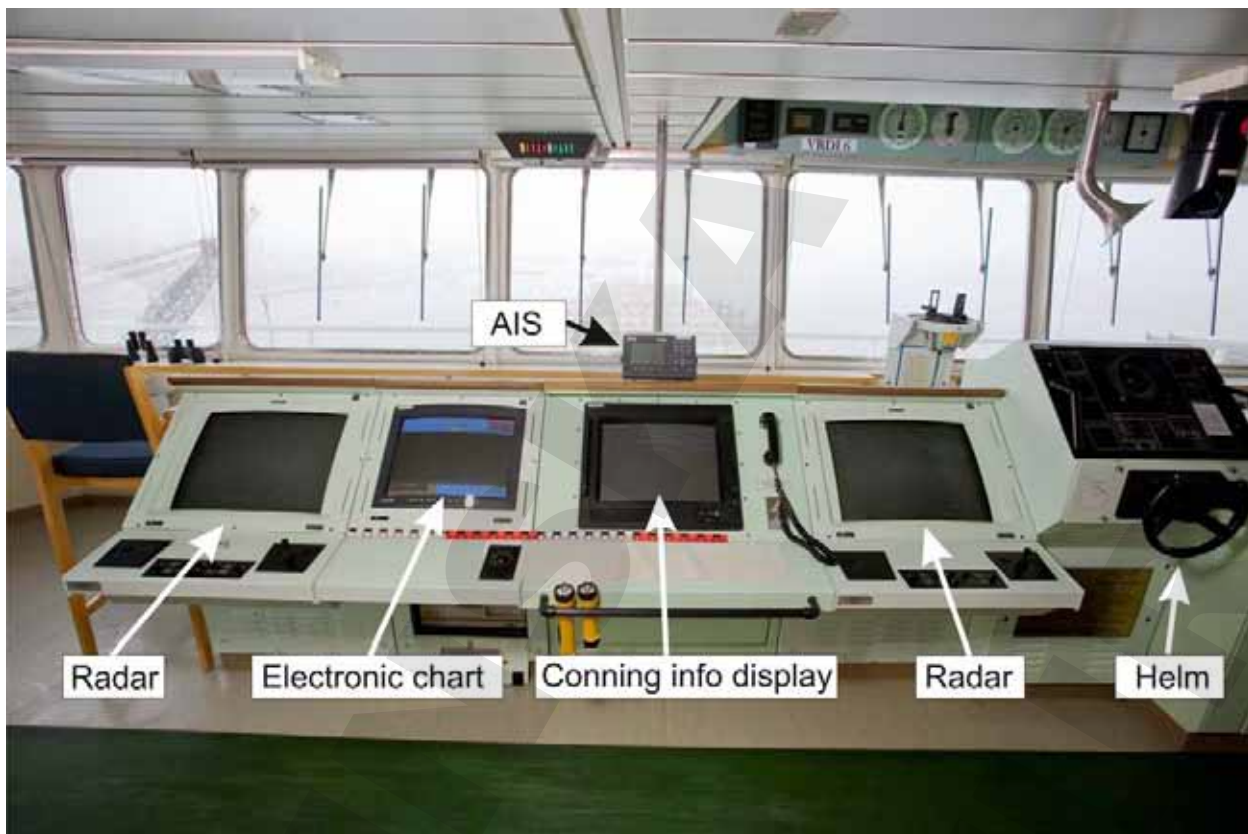
Figure 7. The bridge of the *Cosco Busan* showing primary navigation displays.

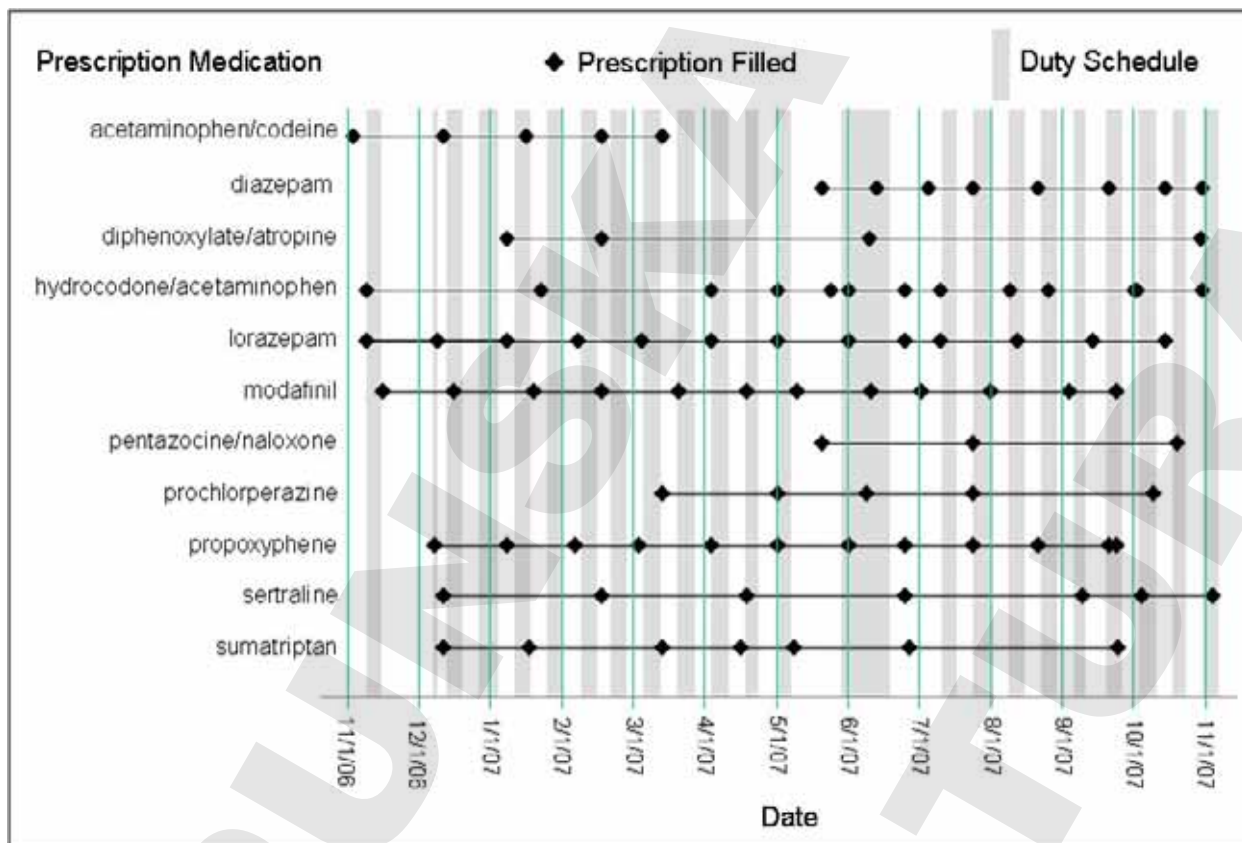
50 pentazocine⁶²/naloxone⁶³ tablets, 100 diphenoxylate⁶⁴/atropine⁶⁵ 2.5/0.025 mg tablets, 27 sumatriptan⁶⁶ 50 mg tablets, 90 modafinil⁶⁷ 200 mg tablets, and 90 sertraline⁶⁸ 50 mg tablets (figure 12).

Figure 12. Graphical display of the *Cosco Busan* pilot's prescription history and duty schedule for the year preceding the allision. Each diamond denotes the filling of a prescription for the medication indicated.

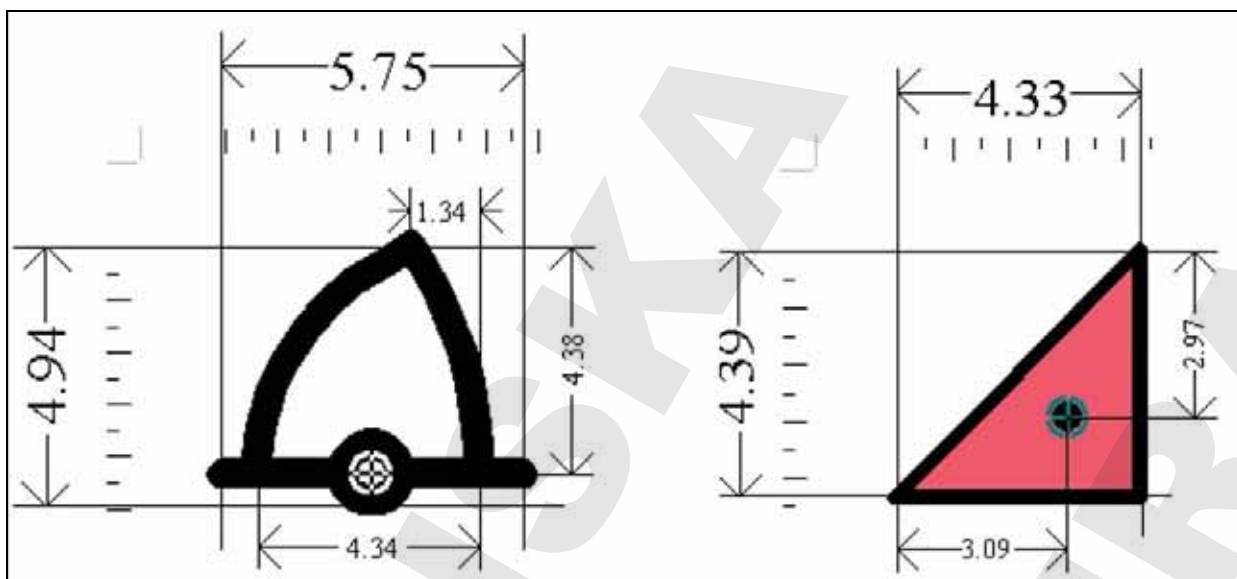
The electronic charts in use on the *Cosco Busan* were C-Map CM-93 vector charts. Although the vessel’s electronic chart system was not a certified ECDIS, the symbols used to signify conical buoys on the CM-93 charts were similar, if not identical, to the symbol for these buoys shown in the International Hydrographic Organization’s (IHO’s) *Presentation Library for ECDIS, Publication S-52, Appendix 2, Annex A*. The paper charts in use on the vessel also displayed conical buoys that appeared identical to those in the presentation library. Figure 15

shows the standard symbols for conical buoys used on IHO-compliant paper charts and on the CM-93 electronic charts (as well as on all ECDIS-certified S-57 charts).⁹⁸

Figure 15. The International Hydrographic Organization (IHO) symbol used to represent conical buoys on paper charts (left) and the simplified symbol for the same buoys as represented, in red, on IHO S-57 electronic navigation charts (right).
