Report on the investigation of
The machinery space fire on board

Oscar Wilde

In Falmouth Bay

Report No 3/2011
March 2011

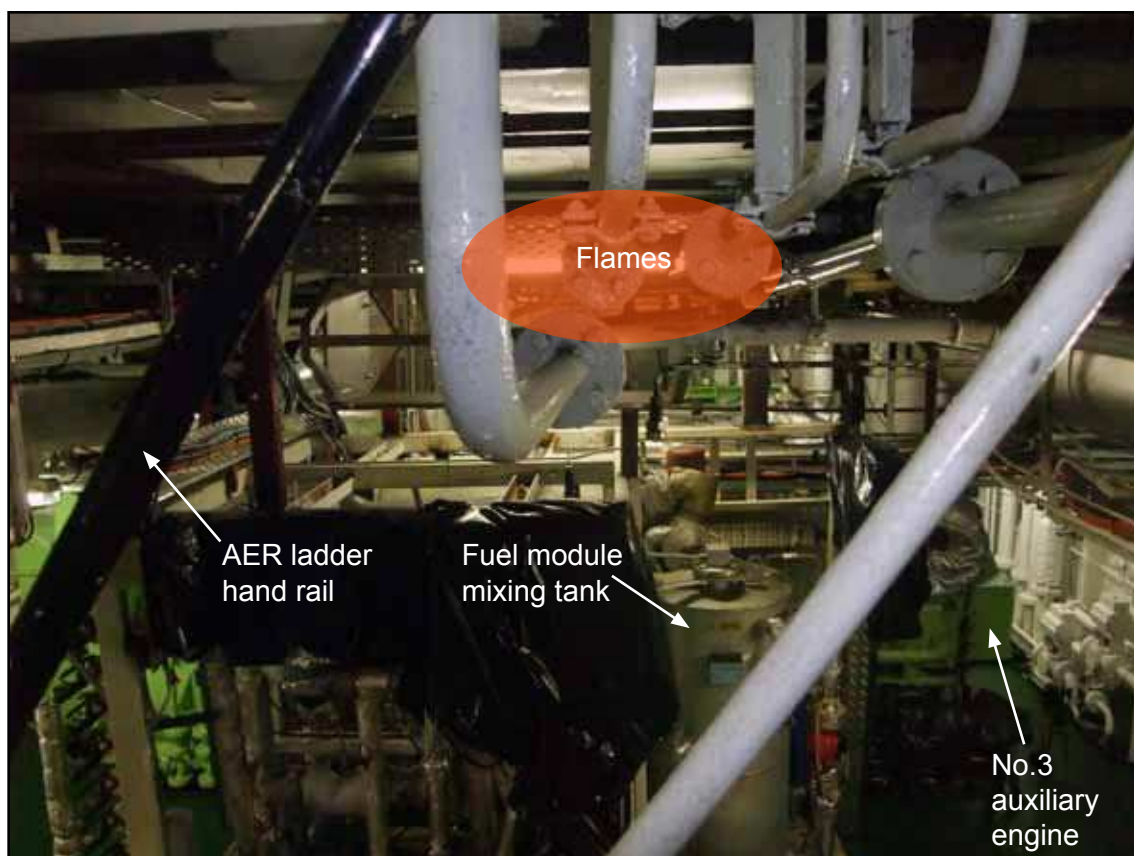
Figure 2

The flame detector initiated alarms on fire detection panels in the engine control room (ECR) and on the bridge. Almost simultaneously, an audible alarm sounded on the *Hi-fog*¹ system's remote release panel in the ECR. The bridge was informed that there might be a problem with No.3 auxiliary engine, and the chief engineer and EOOW went to the auxiliary engine room (AER) to investigate (**Figure 1**). They entered the AER from the lobby area on deck 2. When half way down the machinery space ladder, the engineers saw flames above the fuel module close to No.3 auxiliary engine (**Figure 2**). The space was filling rapidly with smoke and the chief engineer and EOOW had to return to the ECR.

View of the fire from the auxiliary engine room ladder

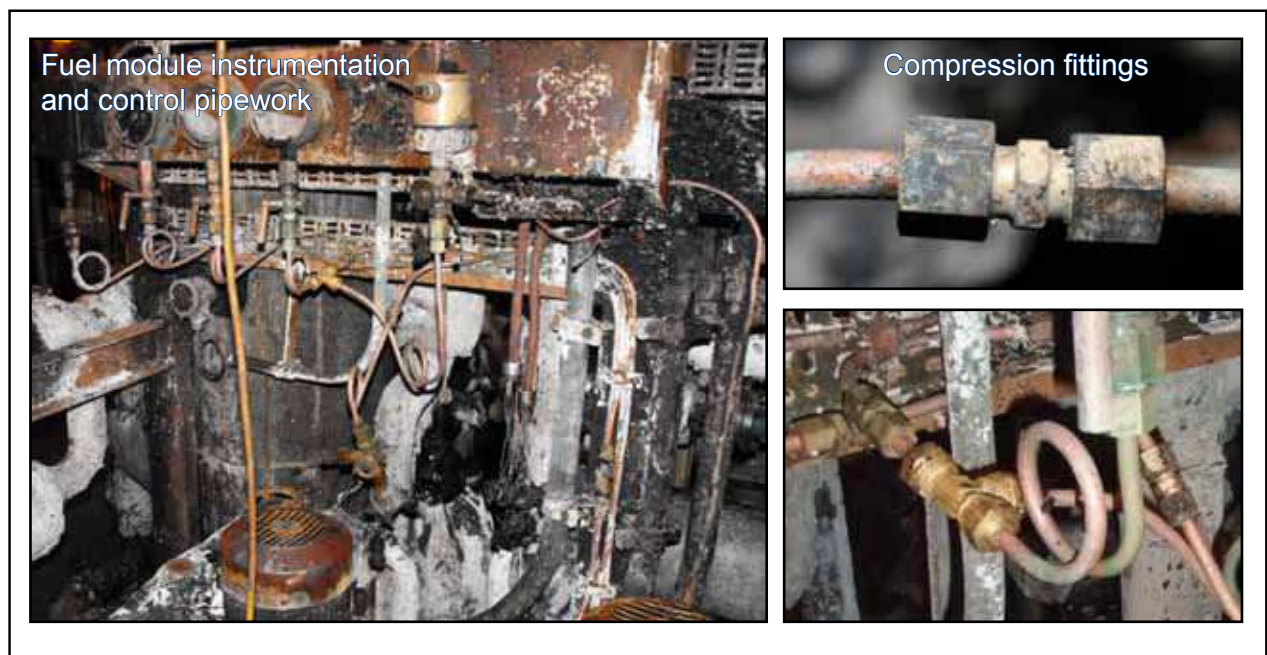
Figure 18

Copper pipework was used extensively on both the auxiliary engine and main engine fuel modules to connect the pressure gauges and sensors to the main fuel oil circuit (**Figure 18**). The copper pipes were interconnected by compression fittings and, although many of the fittings were found to be loose, none of the connections appeared to have failed and no breaks or fractures were identified.

Fuel module copper pipework and compression fittings

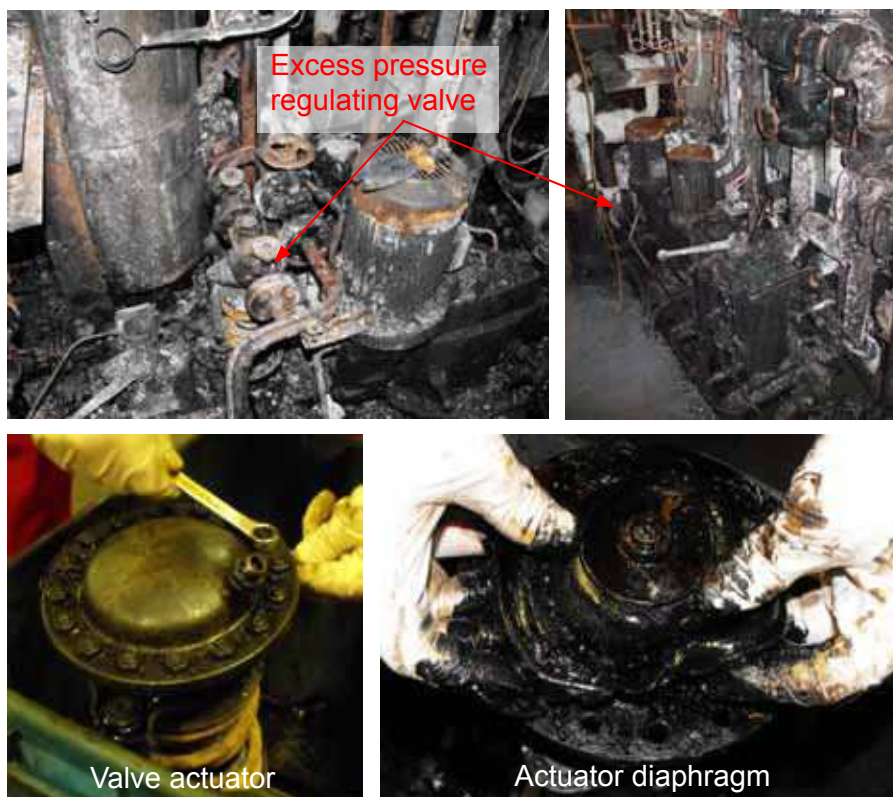
Figure 20

The excess pressure regulating valve's actuator was positioned close to the seat of the fire. The valve was removed and its actuator inspected (**Figure 20**). The rubber diaphragm was in poor condition and had suffered heat damage.

Location of the fuel system's excess pressure regulating valve

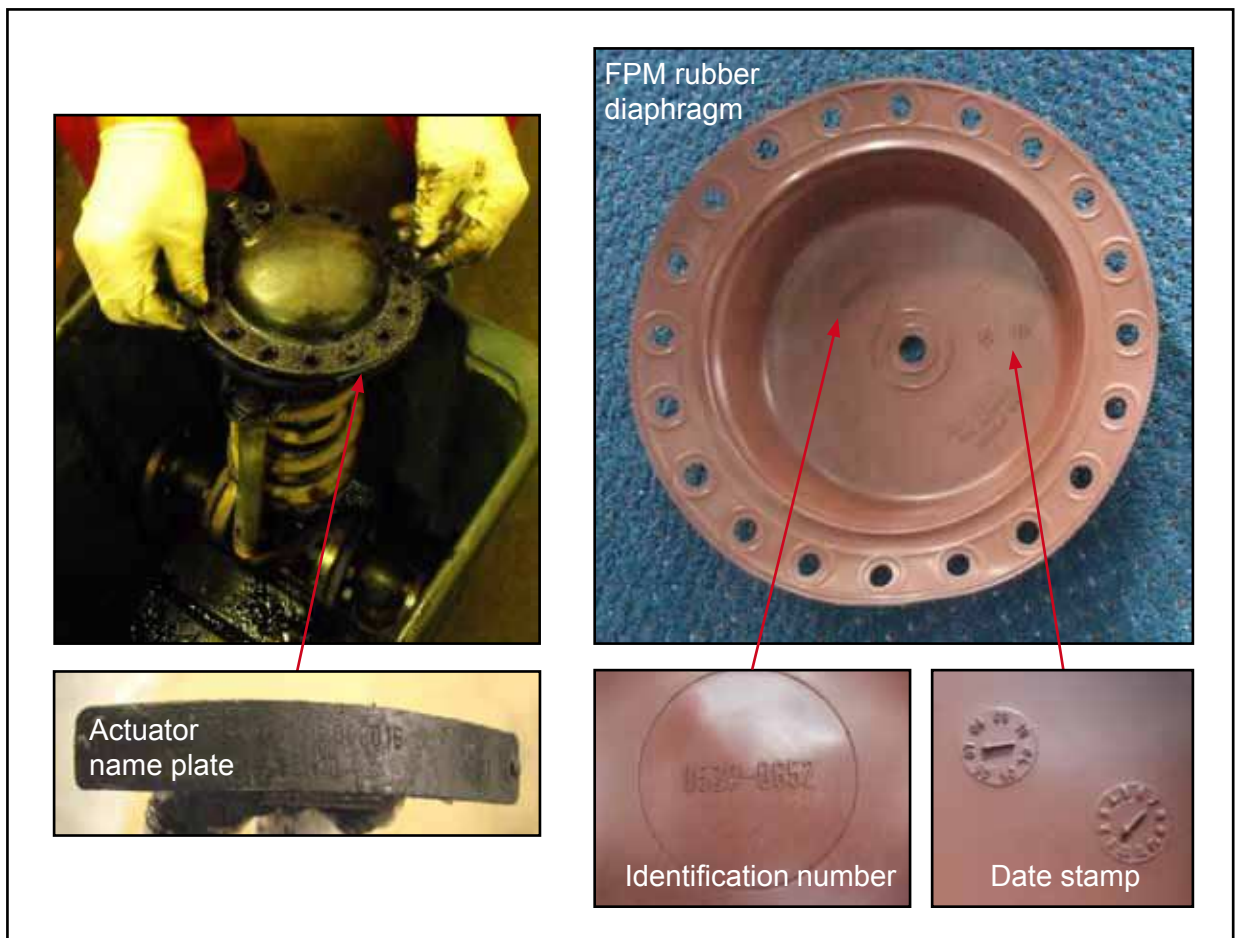
Actuator name plate and diaphragm markings

The test report on the diaphragm removed from the valve actuator identified deterioration of the rubber and a tear in its main flex region (**Annex B**). This damage was remote from the fire damage evident at its outer edge. The diaphragm was made from EPDM rubber and was therefore not suitable for use in fuel oil systems. The actuator had a diaphragm area reducing plate which increased the valves' operating pressure range to 4.5 to 10bar (**Figure 23**). The actuators fitted to the fuel modules on board *Oscar Wilde* were not fitted with any optional safety features.

The information on the actuator tally plates corresponded with that given for EPDM diaphragms and, in the case of the auxiliary engine system, the higher pressure range. No date stamps were found on any of the diaphragms. Neither Irish Ferries, nor the vessel's previous owners, had any record of the actuators being replaced or overhauled. Samson advised that the absence of date stamps on the diaphragms indicated that they were likely to be about 10 years old.

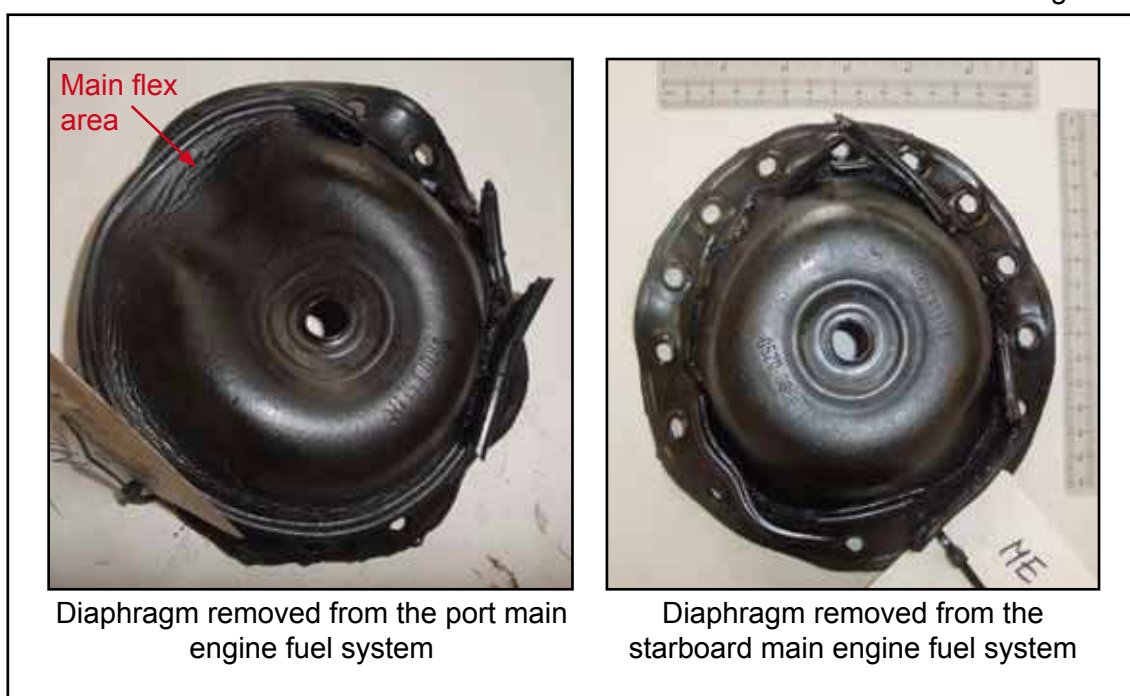
Figure 24

Main engine actuator diaphragms

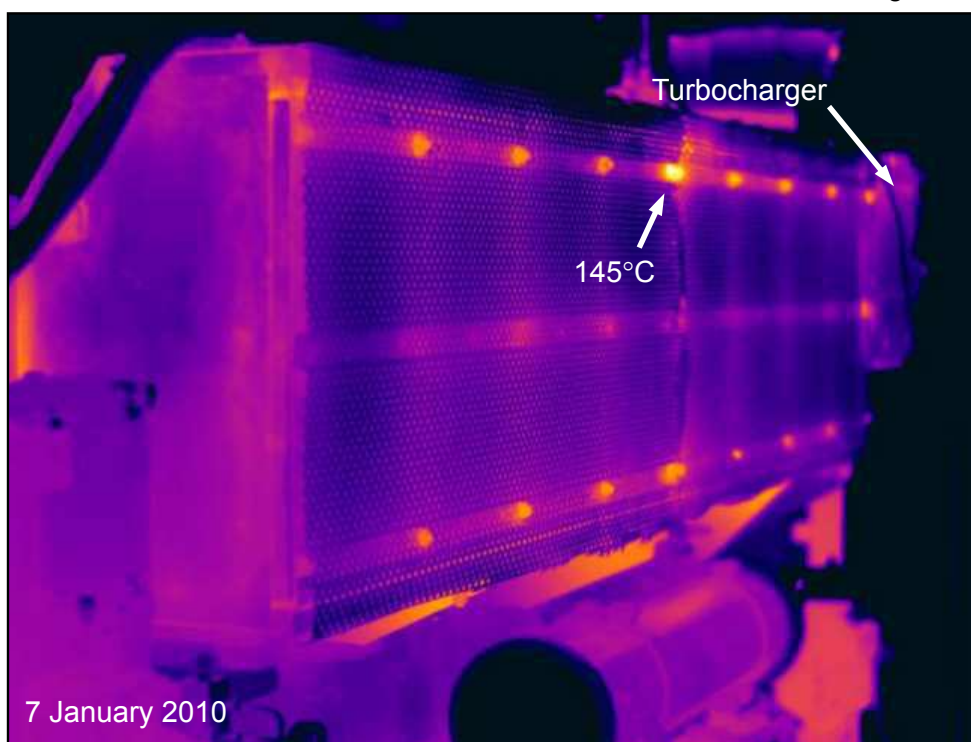
Figure 27

A thermal survey of the ship's electrical distribution system was carried out by a specialist contractor prior to the docking period. The main and auxiliary engines were not included in the work package but, at the request of the chief engineer, thermal images were taken of the auxiliary engine exhaust shields (**Figure 27**). These images identified hot spots, but information relating to the loading on the engines at the time of the survey was not available and no images were taken of the turbocharger or the outboard side of the engine. Work was carried out on the main and auxiliary engines during the docking period that would have required the removal of lagging and heat shields. However, a thermal survey was not carried out prior to the ship returning into service.

Thermal image taken of number three auxiliary engine exhaust manifold shielding prior to docking period

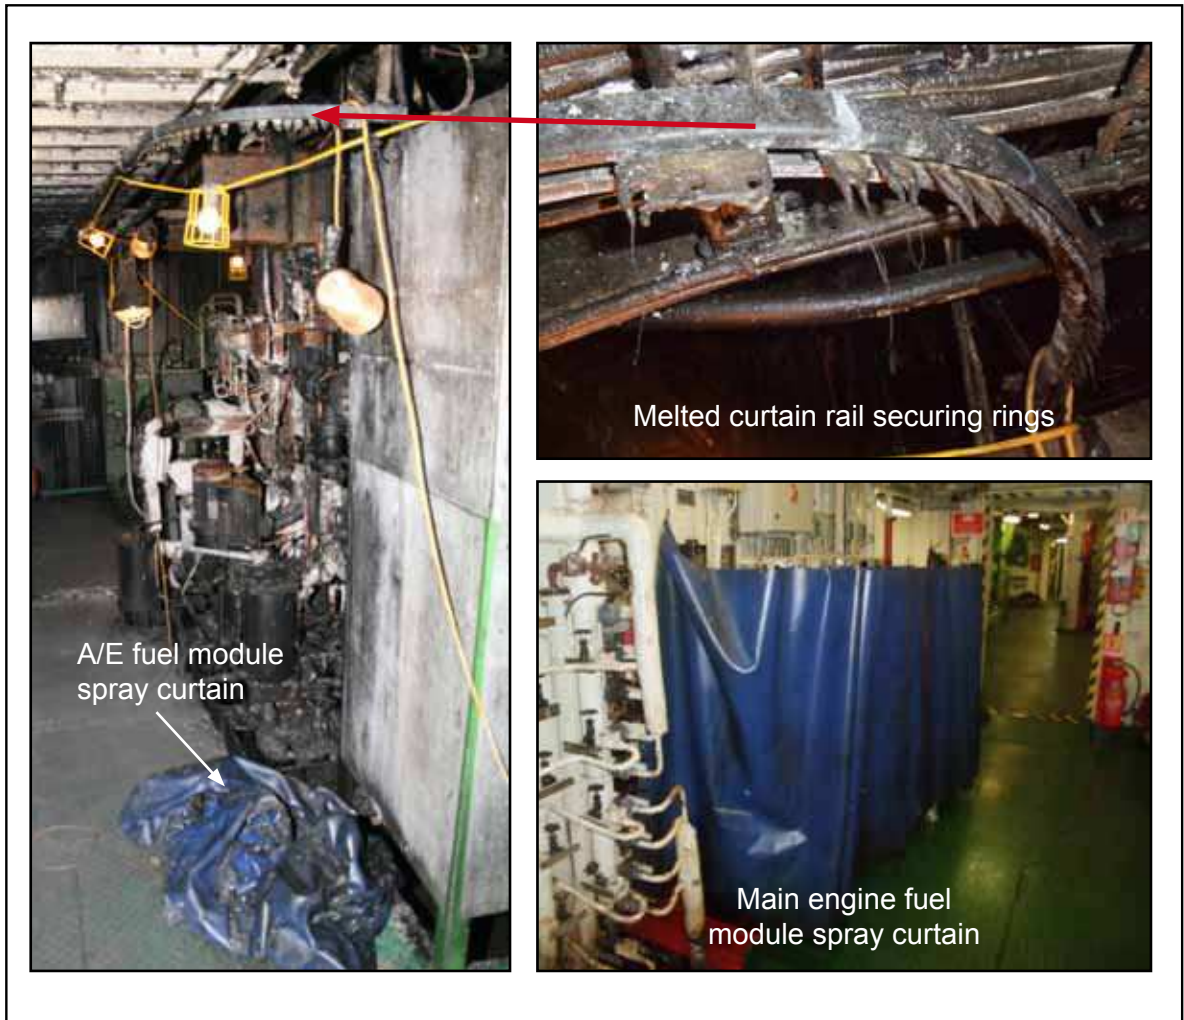
Figure 28

SOLAS also requires precautions to be taken to prevent any oil that escapes under pressure from any pump, filter or heater from coming into contact with heated surfaces. To help meet this requirement the vessel's previous owners had installed fuel spray curtains around the main and auxiliary engine fuel modules. The auxiliary engine fuel module's spray curtain securing rings had melted during the fire, and the curtain was found on the deck at the forward end of the module (**Figure 28**).

Fuel spray curtain

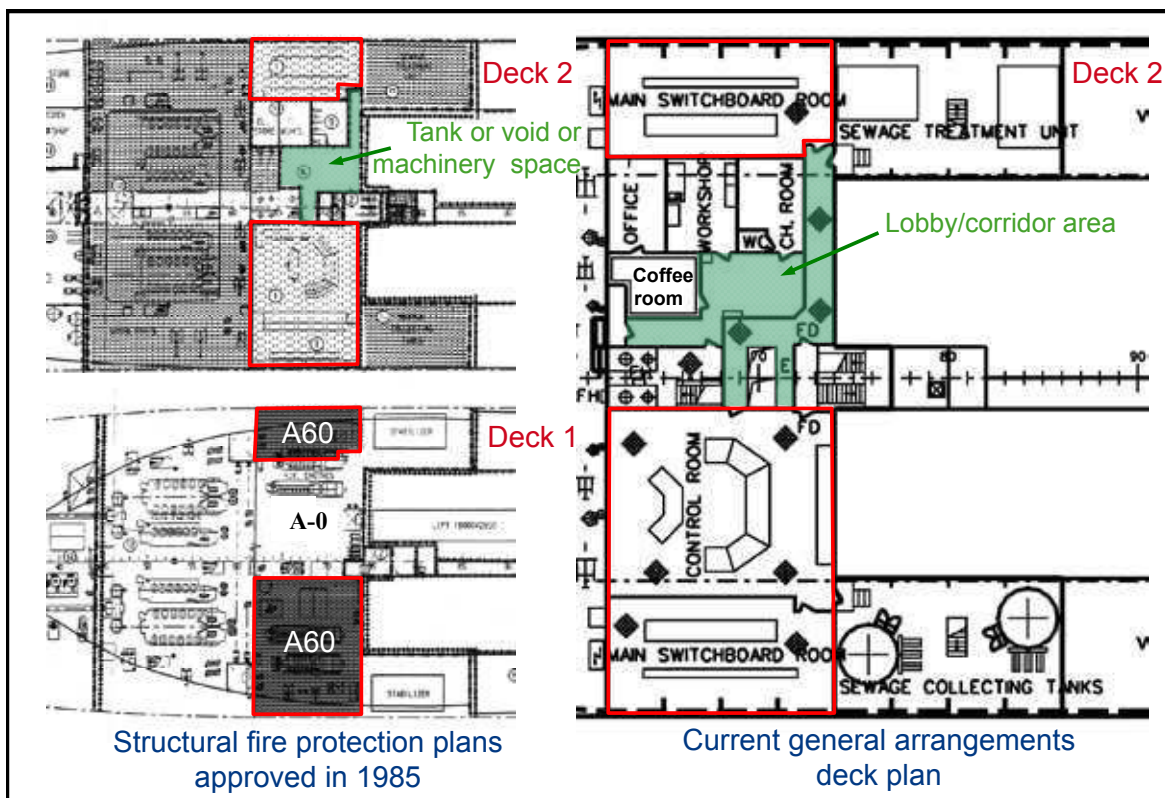
The deck between the ECR and the AER was provided with A-60 structural fire protection. The ECR was positioned directly above the seat of the fuel module fire, but minimal heat transfer was evident on its deck.

Structural fire protection plan

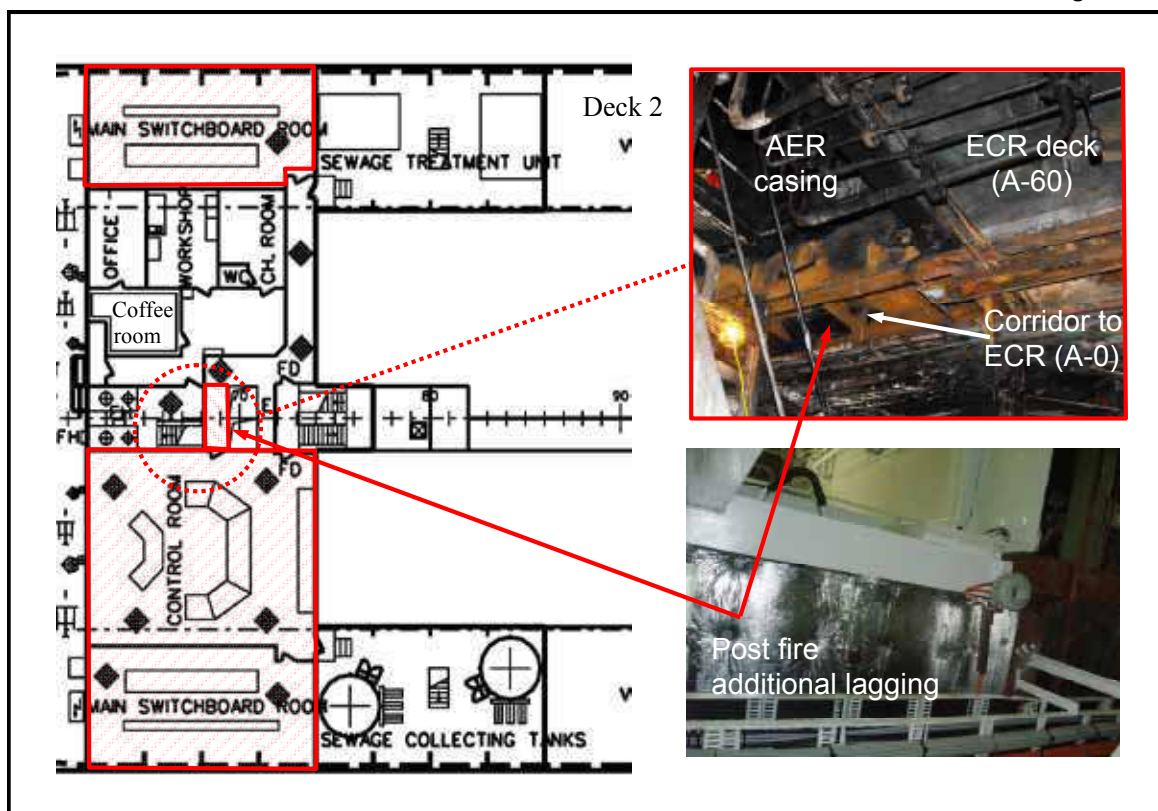
The lobby and corridor area on the port side of the ECR was classified as a *tank, void or auxiliary machinery space having little or no fire risk*. As such, the deck and bulkhead boundaries between it and the AER required A-0 structural fire protection. Therefore, no thermal insulation was provided. Some of the compartments had changed use over time; an electrical store had been converted to an office and a coffee room had been provided for the engineers (**Figure 29**). The deck between these areas and the AER also had no thermal insulation. Following the fire, and prior to *Oscar Wilde* returning into service, Irish Ferries fitted an additional section of A60 insulation to the deck between the AER and the corridor area next to the ECR (**Figure 30**). This additional insulation has subsequently been extended to cover the whole of the AER boundary.

Additional thermal protection fitted prior to the vessel returning to service

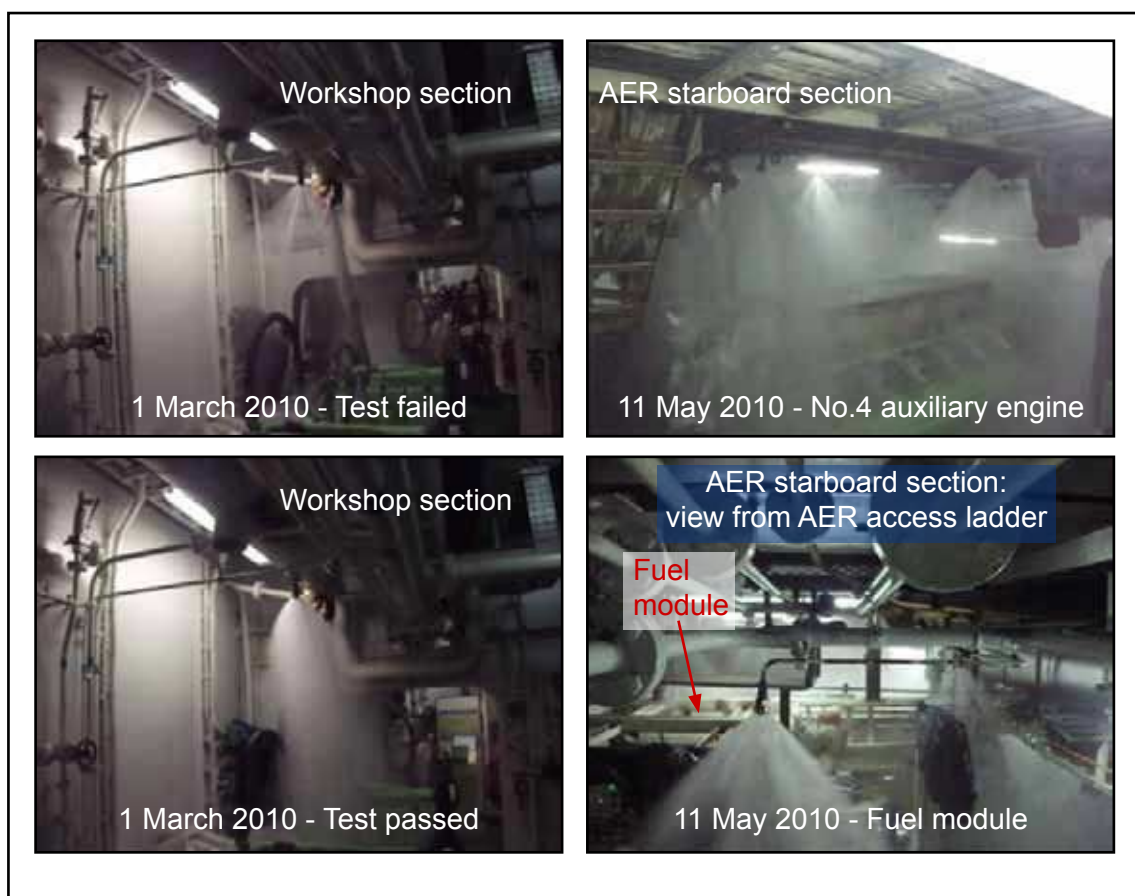
Figure 33

- the initial stand-by pressure was equal to the gas bottle pressure of 195bar
- the gas bottle low pressure alarm was set at 100bar
- the automatic CCTV function did not work
- the water-mist coverage appeared to be less substantial over the fuel module compared to the auxiliary engines (**Figure 33**)
- one gas cylinder was sufficient to conduct the test.

Hi-fog system discharge tests

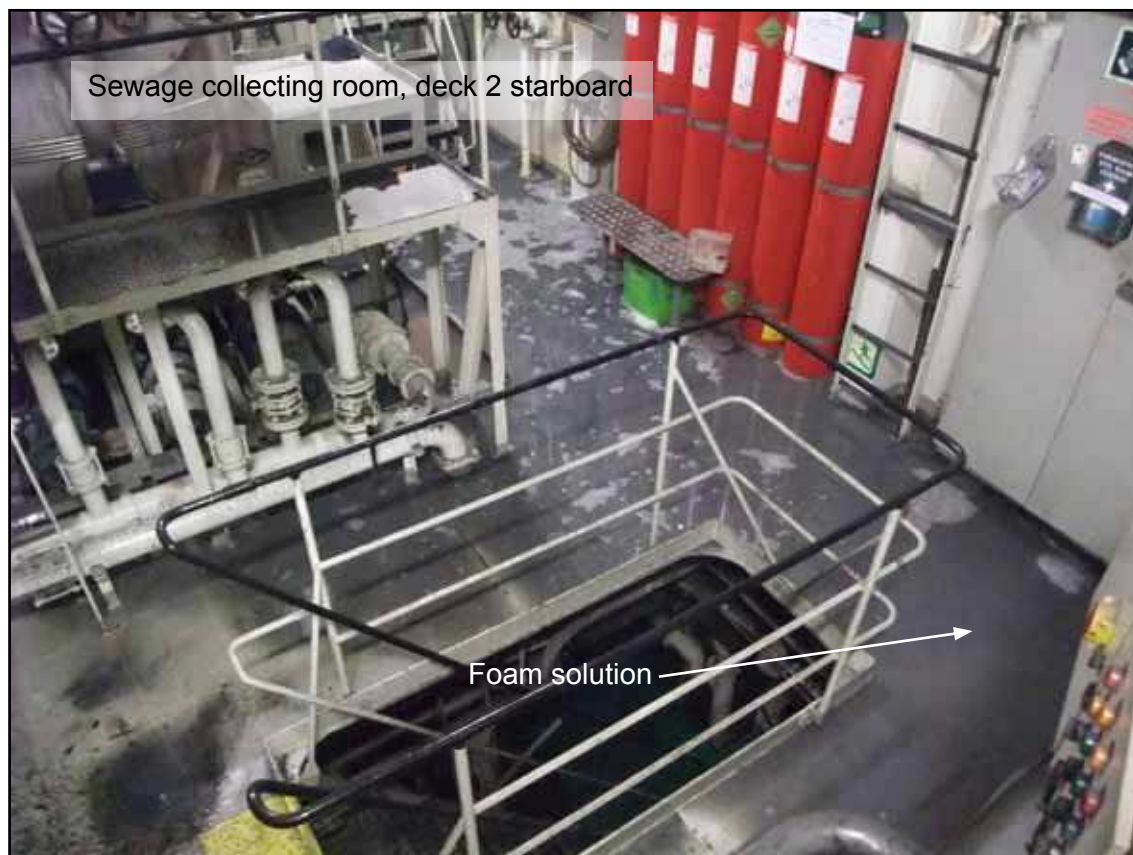
Following the fire, the system’s control valves were found to be in the correct position for a discharge into the AER. The foam storage tank was empty but no high-expansion foam was found in the AER. There was evidence that foam solution had entered the compartment via the foam generators. Liquid was dripping from some of the generator nozzles, areas of soot had been washed from the bulkheads immediately behind some of the generators, and soapy liquid was found in several machinery save-alls remote from any of the *Hi-fog* spray heads and fire-fighting efforts (**Figure 35**). Samples collected from the sewage treatment and collecting tank save-alls contained approximately 98% sea water and 2% *Hotfoam* concentrate.

Hotfoam solution delivered to the AER

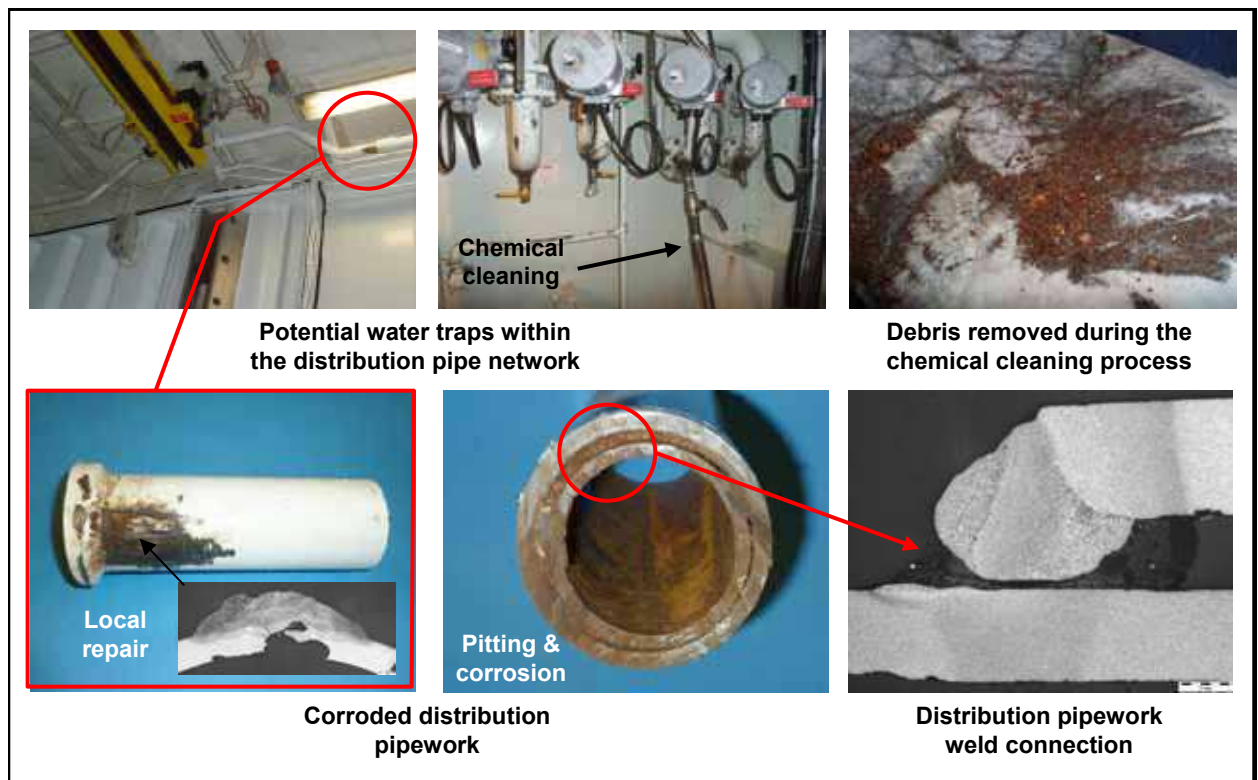
Figure 37

The distribution pipes were heavily corroded and contained debris, particularly in sections where liquid could become trapped (**Figure 37**). Analysis of a removed section of distribution pipe showed that it was made from mild steel and had not been galvanised or zinc coated. It was heavily corroded, had suffered a localised pinhole failure, and had not been effectively welded to its adjacent pipe (**Annex E**).

Hotfoam system distribution pipework

The distribution pipework was chemically cleaned and was proved clear of debris before being tested to the satisfaction of the class and flag surveyor. The manufacturer's investigation report included the following recommendations:

- *Installation of drainage valves at lowest points in distribution piping (already done on distribution manifold only)*
- *Reinstall new distribution piping to avoid water traps as mentioned in 6 and to guarantee corrosion resistance of piping*

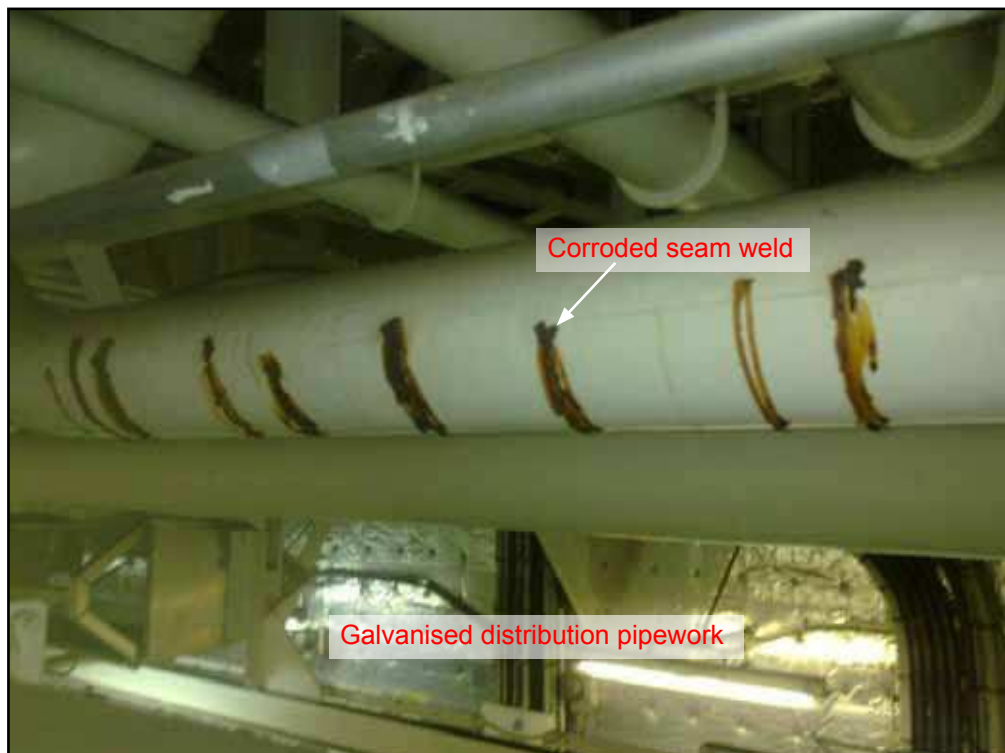
Figure 38

As a result of its findings on board *Oscar Wilde*, Wilhelmsen carried out several enhanced surveys of *Hotfoam* systems fitted to other vessels. Its service engineers closely inspected the distribution pipework and foam generator nozzles and identified that water traps were common, and that corrosion was prevalent within the dry pipe systems. They also found that welded seams within galvanised systems were particularly prone to corrosion (**Figure 38**). In addition, many foam generators could not be accessed to allow nozzles to be inspected, particularly on the larger tankers.

Hotfoam system survey on other vessels

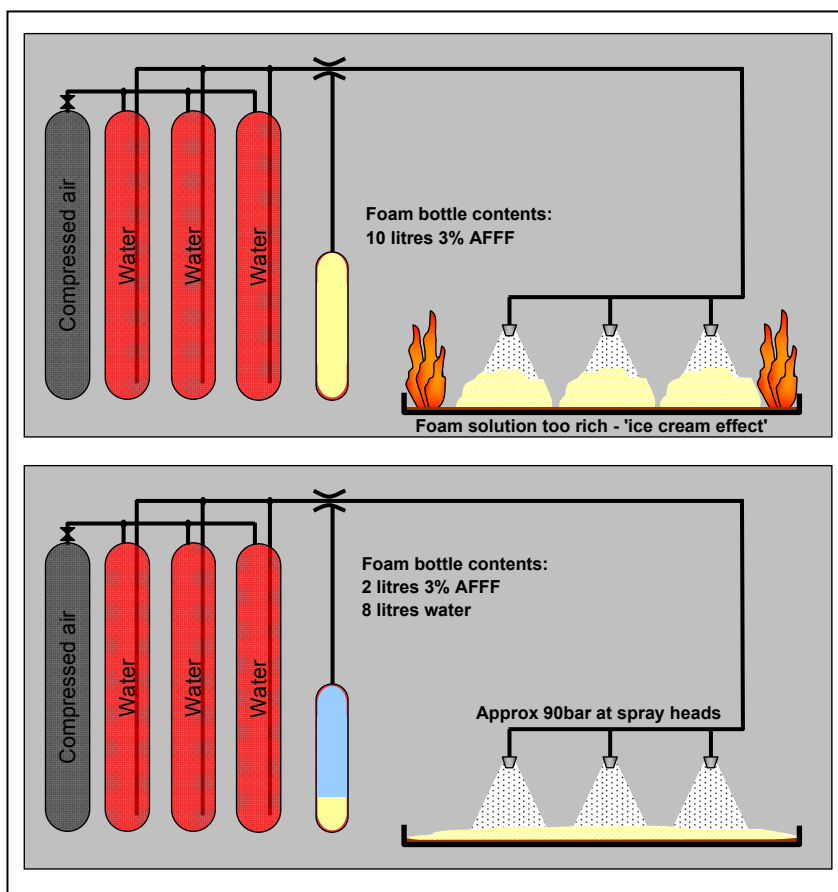
Figure 39

Foam concentrate

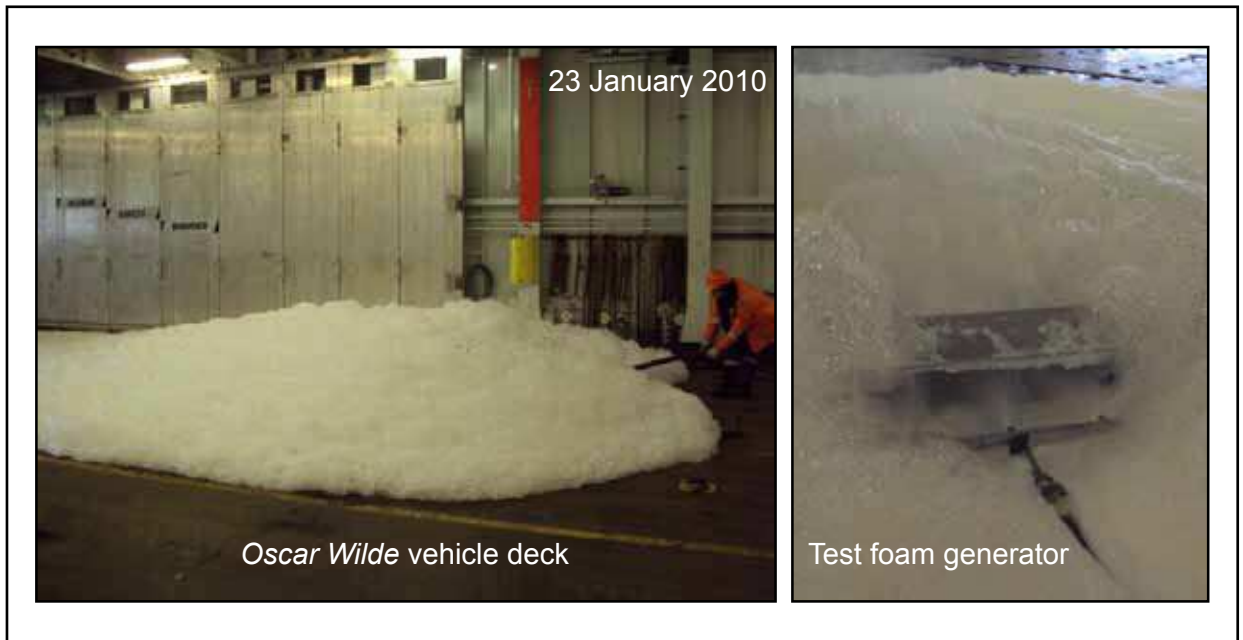
Figure 40

A Wilhelmsen service engineer last conducted the annual maintenance on 15 May 2008; again no defects or shortfalls were identified (**Annex H**). The foam concentrate test certificate stated that the foam tank had been filled in March 2002. The manufacturer recommended that the concentrate be renewed every 5 years.

Hotfoam system discharge test

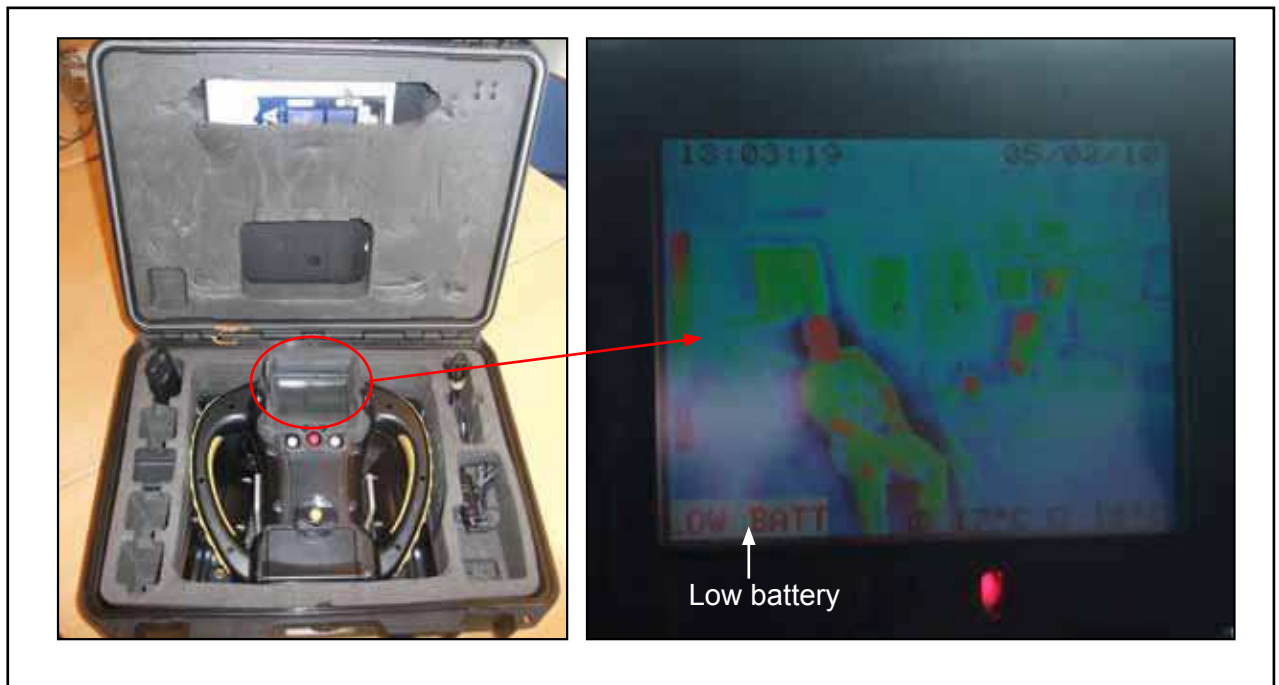
Figure 41

The ship held a thermal imaging camera which was located at the deck fire party's muster point. It was standard practice to take the camera to a scene of a fire. On this occasion, the fire party forgot to take the camera to the lower hold and it remained unused in the fire store throughout the incident. After the fire, it was found that the camera's battery had not been charged prior to sailing and only had sufficient charge to power the camera for 1 to 2 minutes (**Figure 41**).

Thermal-imaging camera

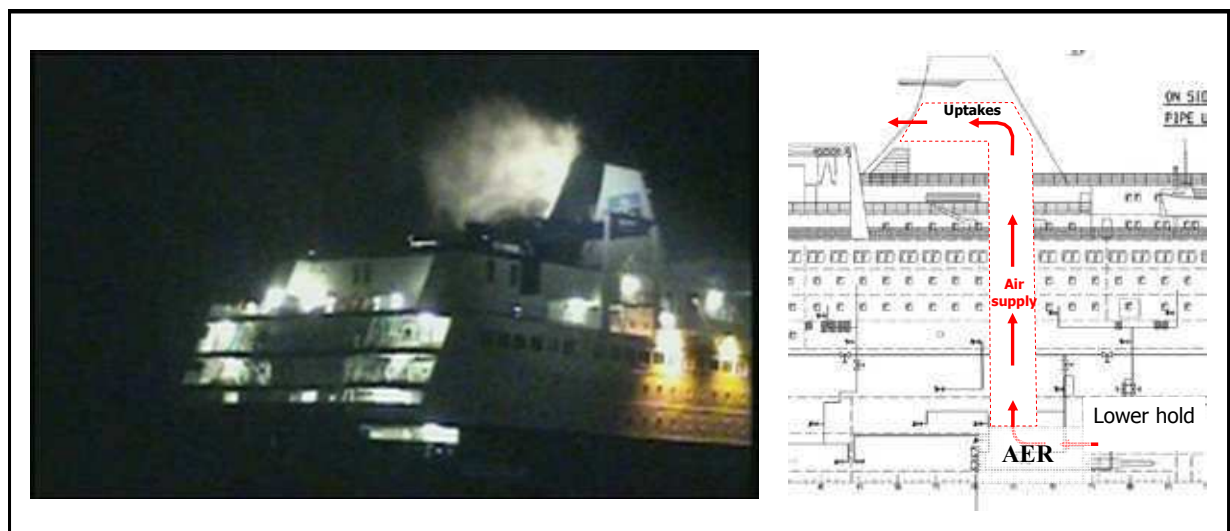
Figure 42

However, when the OSC opened WTD3 a draught was induced from the vehicle deck, through the AER, as the hot combustion gases rose up the funnel casing and escaped through the exhaust louvres. In addition, as the vehicle deck ventilation dampers had not been closed, the 25 knot winds over the deck of the anchored vessel served to create a forced draught through the compartment (**Figure 42**). The OSC was aware that the draught was keeping the smoke out of the lower hold, but the implications of fanning the fire were not considered. Consequently, the air flow from the lower hold ventilated the compartment before it had been adequately cooled, and contributed to the fire's re-ignition.

Air supply from the lower hold to the AER
