# Marine Accident Report

Fire Aboard Small Passenger Vessel *Conception*  
Platts Harbor, Channel Islands National Park, Santa Cruz Island,  
21.5 miles South-Southwest of Santa Barbara, California  
September 2, 2019

**National Transportation Safety Board. 2020. *Fire Aboard Small Passenger Vessel Conception Platts Harbor, Channel Islands National Park, Santa Cruz Island, 21.5 miles South-Southwest of Santa Barbara, California, September 2, 2019. Marine Accident Report NTSB/MAR-20/03.* Washington, DC.**

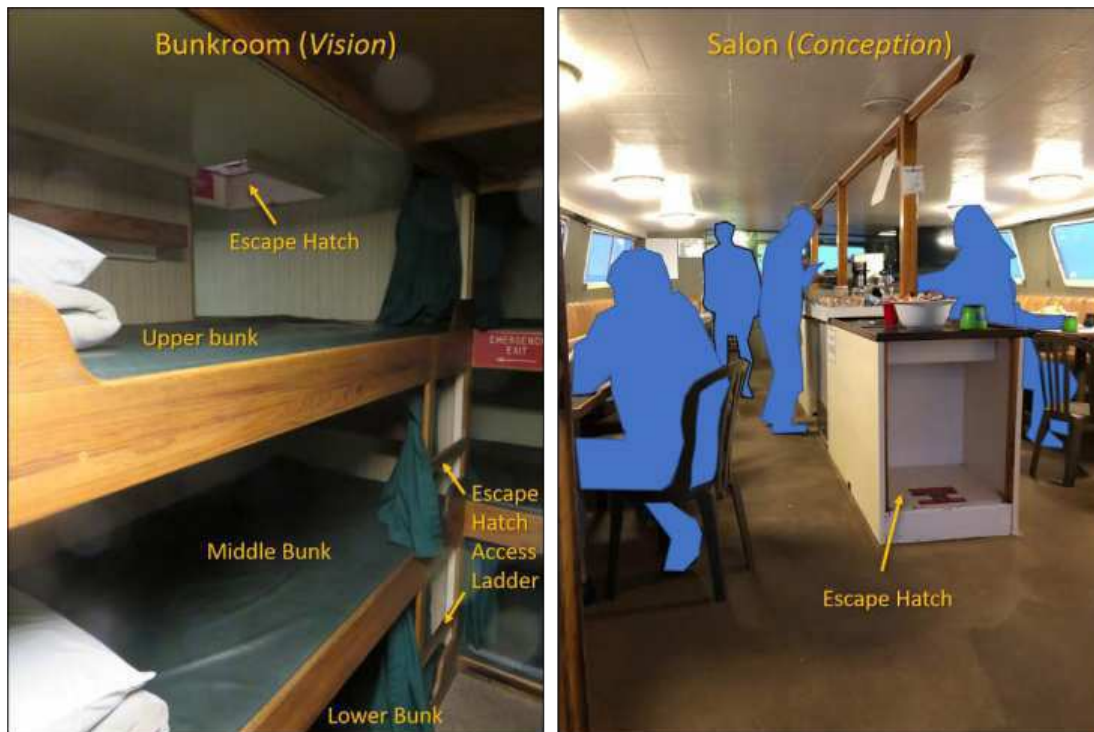
**Figure 6.** Photo left is the escape hatch, viewed from the bunkroom, on the *Vision*, a Truth Aquatics dive vessel with arrangements nearly the same as the *Conception*. (Source: NTSB) Photo right, taken during a previous voyage, shows the escape hatch, viewed from aft in the salon, on the *Conception*. (Source: J. Palmer, annotated by NTSB)

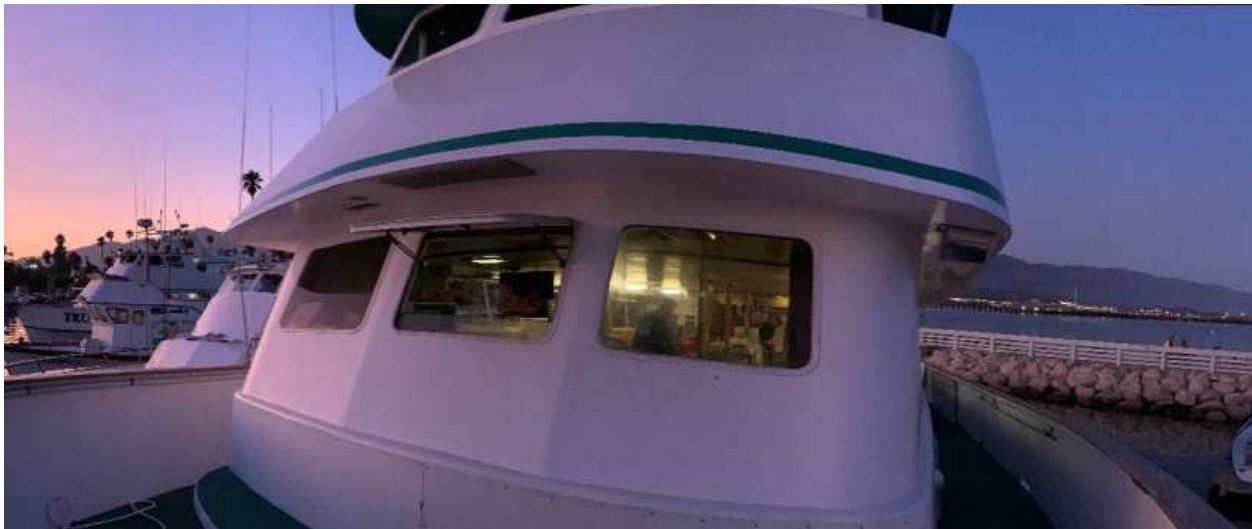
The first deckhand had also exited the wheelhouse via the port wing station. Once on the main deck, he looked aft and saw that the port exterior passageway was blocked by smoke and flames coming out of the salon windows and wrapping around the sun deck above. He proceeded to the bow and tried to open the center window on the forward bulkhead of the salon, which looked into the galley area, in an attempt to reach the passengers. The center window was the only window on the front of the salon that was designed to open, but it was secured from the inside by threaded knobs (it was not a designated emergency exit). The deckhand, aided by the second galley hand, struggled to pry the window open, but could not. The two crewmembers told investigators that the window was warm, but not hot, and when they looked through the window, the view was completely obscured by thick, black smoke.

**Figure 9.** Preaccident photo of *Conception* forward salon windows. In this photo, the center window is open. However, during the accident, the window was closed and secured as the crew attempted to access the space. The port and starboard windows were not designed to be opened. (Source: T. Thompson)

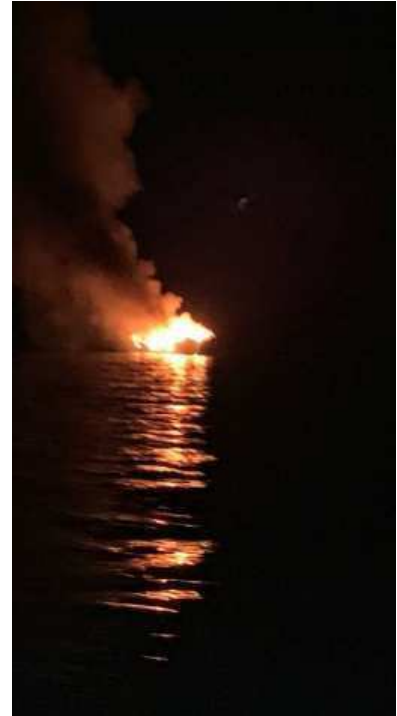
After the three crewmembers got the engine on the skiff running, they drove to where the two galley hands had swum away from the *Conception* and helped both into the boat. The first deckhand then took the controls and drove the skiff over to the anchored sportfishing boat *Grape Escape*. When they arrived at the vessel, the crewmembers yelled and banged on the hull and back door to the salon until the *Grape Escape*'s owners were awakened. The *Grape Escape* owners described their first sight of the *Conception* as "completely on fire from one end to the other. It was already completely engulfed. There wasn't a spot on that boat

**Figure 10.** Cell phone photo of *Conception* on fire, taken from sportfishing boat *Grape Escape*. (Source: S. Hansen)

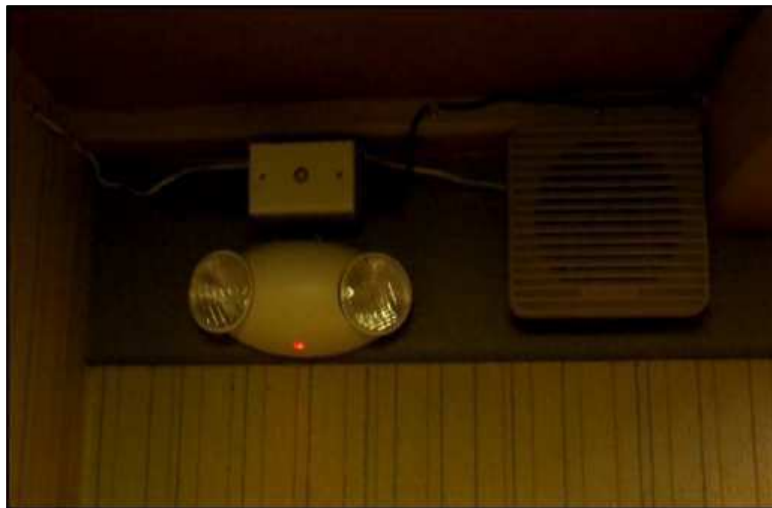
**Figure 14.** Bunkroom emergency lighting on board the similar vessel *Vision*. The lighting was of the same make and in a similar location as was on board the *Conception*. Also note the public address system speaker to the right of the lights.

**Emergency Lighting.** The *Conception* had emergency lighting in the bunkroom. It was mounted near the main stairs going up to the galley/salon at the top of the forward bulkhead of the bunkroom, and was designed to automatically activate, in the event of the loss of the vessel's service supply power, to provide lighting along the escape path to the main deck from accommodation spaces below. The emergency lighting was powered from the ship's service 120-volt AC system, and if this source was lost, batteries internal to the unit would supply power for lighting.

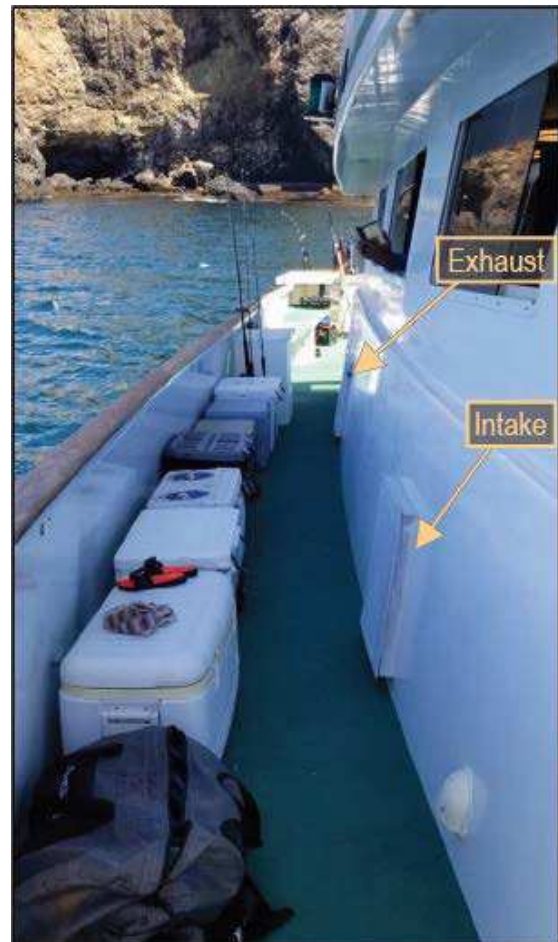
**Figure 15.** The starboard-side main deck of *Conception*, looking aft from forward of the galley. Arrows indicate the location of the bunkroom ventilation intake and exhaust ducts. Note the sliding windows. (Source: R. White)

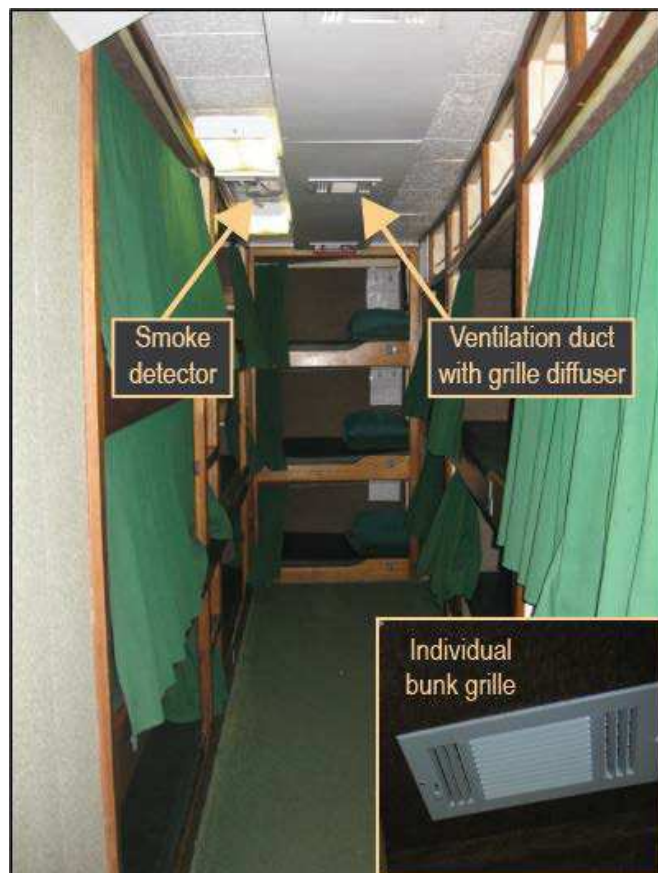
**Figure 16.** Port side of the *Conception*'s bunkroom looking aft, with inset of grille/diffuser. (Source: M. Ryan; Inset: S. Landis)

The air conditioning unit, which was the primary means of cooling and ventilation for the bunkroom, was located under the bunkroom deck boards, just port of midship, underneath bunks 30U, 31M, and 32L (see [figure 5](#) for the bunkroom layout) in the vessel's bilge area. The unit was sized for the space and was estimated to be 4–5 tons. The direct expansion package unit consisted of an evaporator coil, blower fan, compressor, and seawater-cooled condenser. The system was designed to pull air from the space through a diffuser and filter element, located at the forward end of the space, directly at the bottom of the stairs. The blower fan would draw ambient air across the evaporator coil and discharge the cool conditioned air through a network of flexible insulated distribution ductwork located in the bilge. This ductwork connected to permanent ducts and passageways built into the framework of the bunkroom. Each bunk was fitted with a grille/diffuser that could be opened or closed dependent on need. Similar grille/diffusers and ductwork were positioned on the overhead between the rows of bunks on both the port and starboard sides.

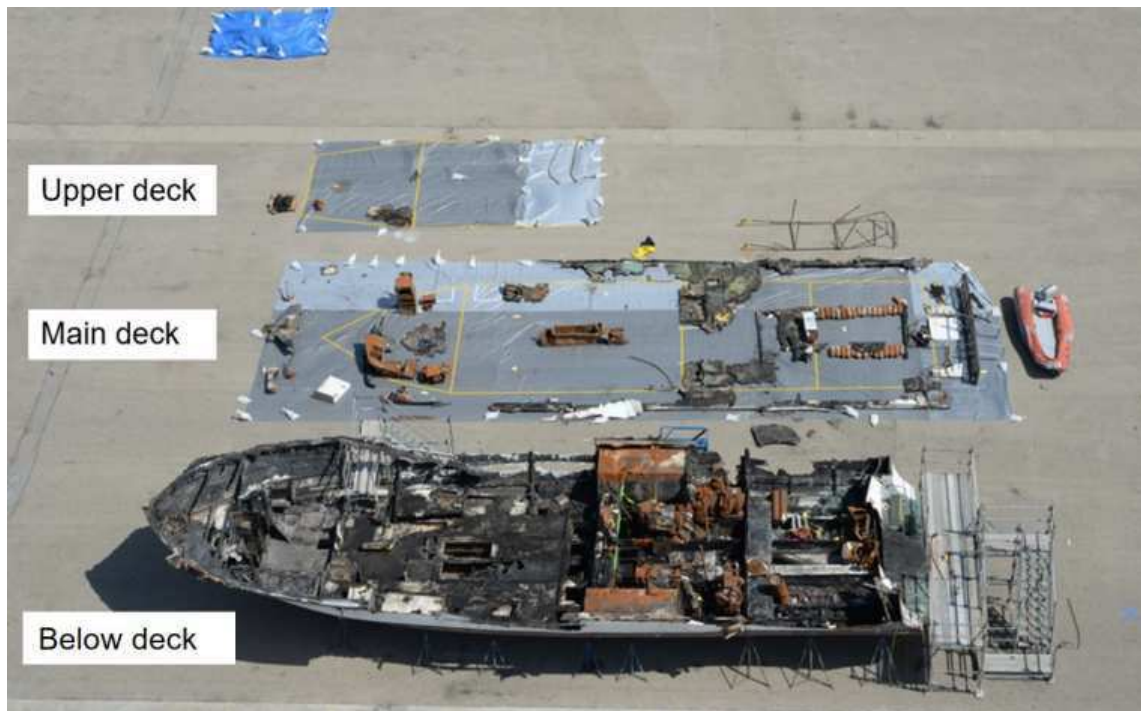
On September 25–27, the NTSB examined the wreckage and debris recovered from the seafloor and surface. The wreckage and debris were laid out by the ATF and FBI in a secure parking lot into three sections consisting of the main hull with the below deck spaces, the main deck, and the upper deck ([figure 19](#)). There were also bags full of items that had been floating in the water and/or collected from the seabed. The ATF and FBI, with Coast Guard assistance, placed the recovered items and portions of structure that could be identified in their corresponding places for each of the three sections of the wreckage representing the three decks. Identifiable engine room machinery and equipment, such as the generator and sewage tank, were placed back in their original position in the engine room within the hull. For the main deck and upper deck portions, an outline was made on tarpaulin underlays, and the items and structure were placed within the

outlines in the areas where they belonged. Very little structural material remained from the upper deck and the main deck.

**Figure 19.** *Conception* wreckage layout at Port Hueneme. (Source: FBI Evidence Response Team)

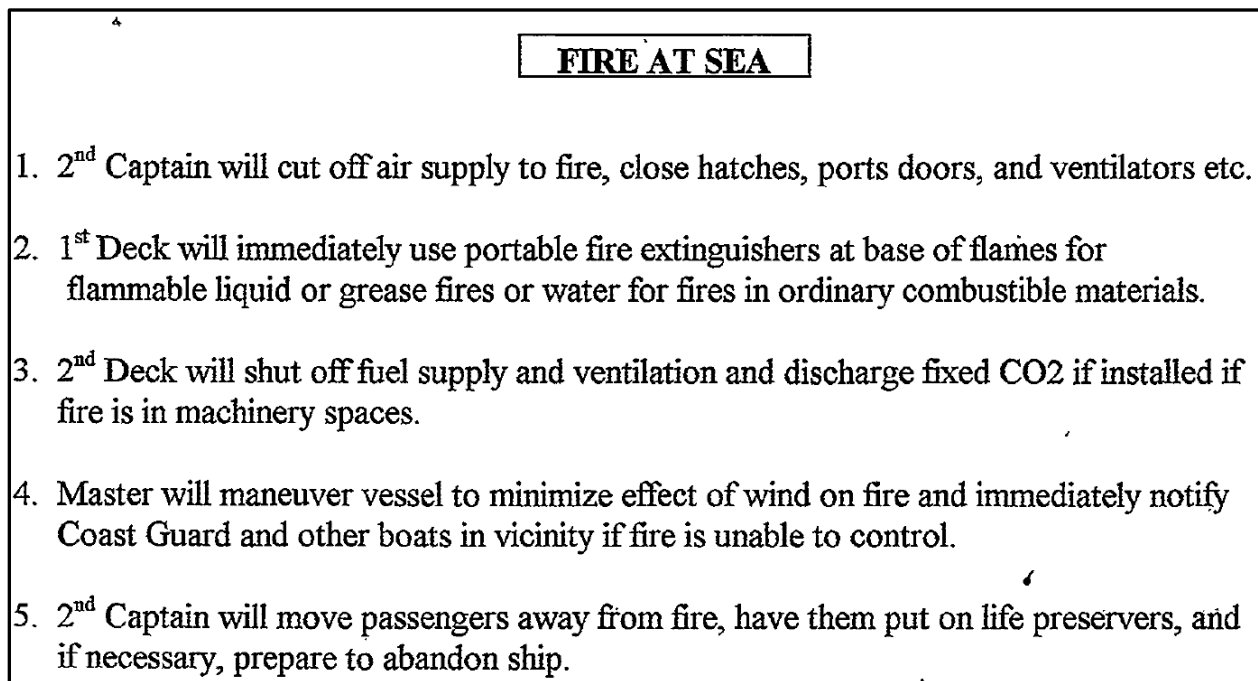
For onboard fires, the station bill required the second captain to cut off air supply to the fire and close hatches, ports, doors, and ventilation dampers, while the first deckhand was to use portable fire extinguishers to extinguish the fire. The second deckhand was tasked to shut off the fuel supply and ventilation to the engine room and discharge the system for any fire in machinery space. The captain’s task was to minimize the effect of wind on the fire and to immediately notify the Coast Guard and other boats in the vicinity if the fire was unable to be controlled. The second captain was also responsible for moving passengers away from the fire, having them don lifejackets, and, if necessary, have them prepare to abandon ship. There were no specific emergency duties assigned to the first or second galley hands. Additional procedures were discussed in Truth Aquatics *Loss Control Program*.

**Figure 24.** Fire at sea emergency instructions/station bill from the *Vision*.

Although the station bill was required to be posted by regulation, none of the crewmembers on the *Conception* at the time of the accident were aware of any posted station bill. The first galley hand was unfamiliar with the concept of a station bill when asked by investigators. The second captain stated that he understood that his role in a fire emergency was to start the fire pump and/or launch the skiff.

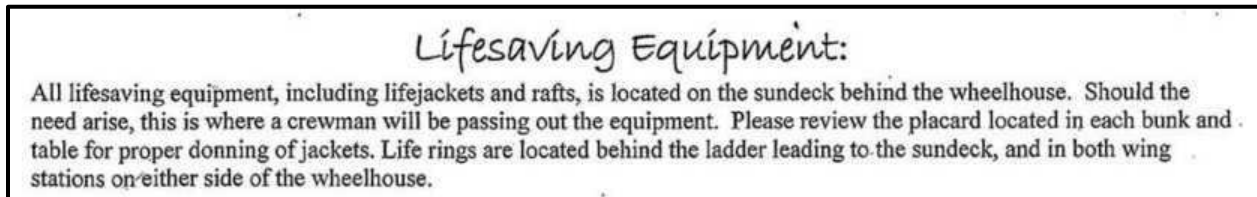
As an alternative to the safety orientation announcements, New T regulations (all vessels) permitted the use of a card or pamphlet, delivered to each passenger before getting under way, with the information that would have been provided in a safety briefing. If using the pamphlet, an abbreviated announcement must be made prior to getting under way. A "Welcome Aboard" card was available in the *Conception* salon, containing general information that would "serve as your pre-departure safety briefing," as well as the location of lifesaving equipment. Placards in each bunk provided lifejacket donning instructions. During interviews, surviving crewmembers did not report that an announcement was made prior to getting under way for the accident voyage.

**Figure 25.** Truth Aquatics "Welcome Aboard" information specific to pre-departure safety briefing. (Source: Truth Aquatics)

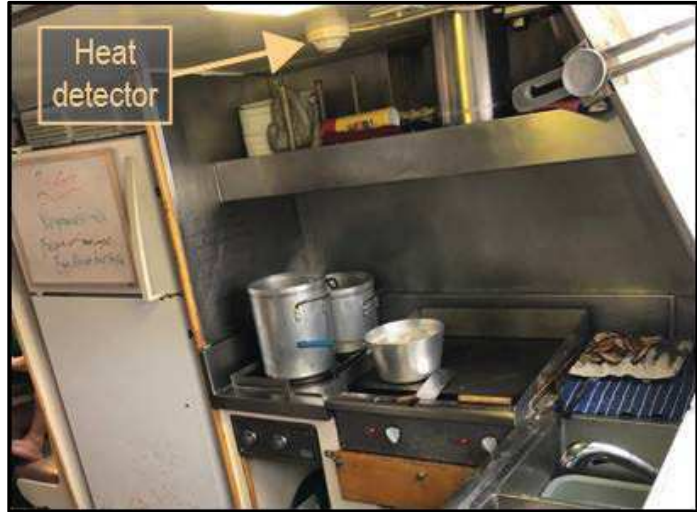
Neither Old T nor New T regulations required the salon and galley compartment to have smoke detectors installed. Heat detectors were installed in the engine room and galley. The smoke and heat detectors were not interconnected to other alarms or a central operating station in the wheelhouse. In the engine room, the heat detector, if activated, would initiate the carbon dioxide fixed fire-extinguishing system for the engine room. The galley detector was not connected to the range hood fan or any damper, nor was it required to be.

**Figure 26.** Photo of the galley of the *Conception* taken from the forward centerline window. (Source: NTSB eyewitness submission)

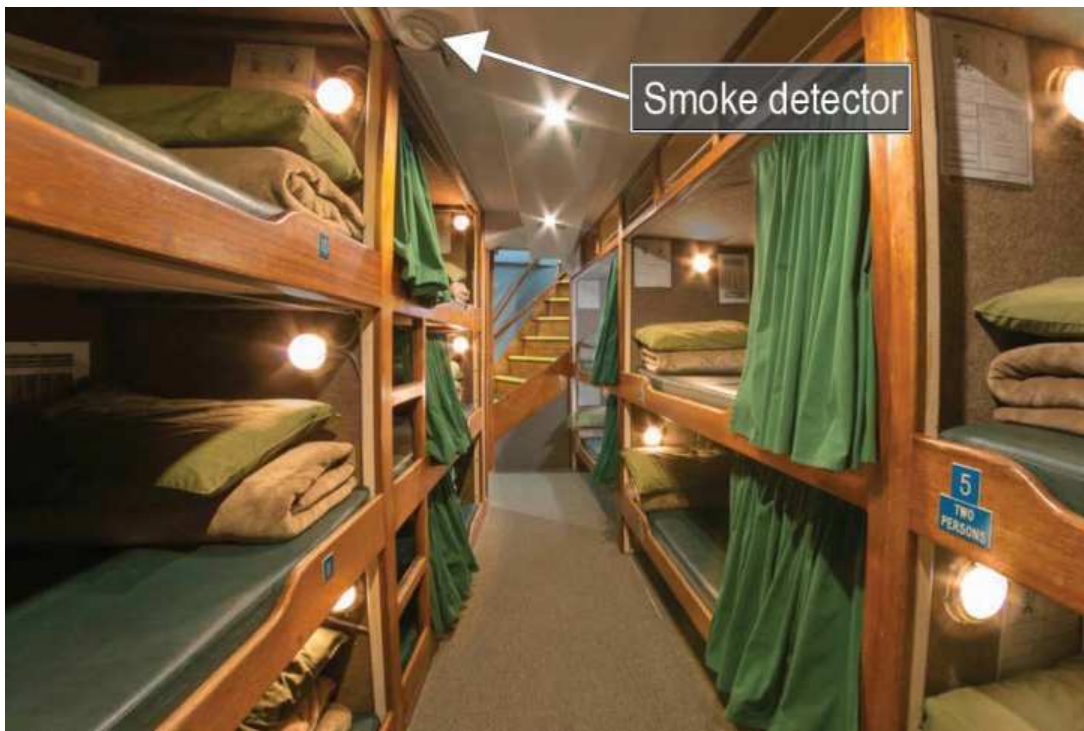
As required by 46 *CFR* 181.405(c), which applied retroactively to existing vessels with an overnight accommodation space, the bunkroom area contained two independent modular smoke detectors, installed in the overhead on the port and starboard aisles between the bunks. Investigators were informed by the vessel owner that the smoke detectors in the bunkroom were hardwired into the vessel’s electrical system, with a 9-volt battery backup. The smoke detectors were not interconnected to other alarms or a centralized system in the wheelhouse. Based on photos and video, the smoke detectors appeared to be common consumer-type smoke detectors, as specified in the regulations. The smoke detectors in the bunkroom were the only ones required to be on board. There were no additional smoke detectors installed on board.

**Figure 27.** Interior view of *Conception* bunkroom. (Source: Truth Aquatics; annotated by NTSB)

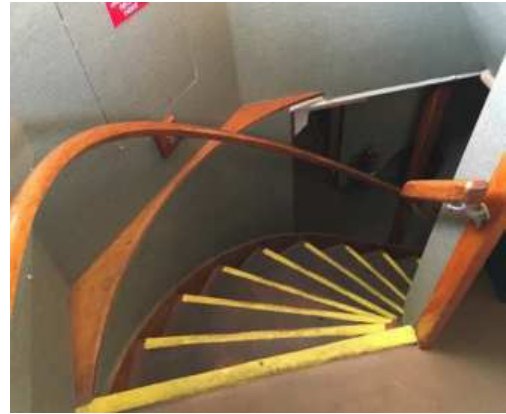
From the *Conception*’s bunkroom, there were two means of escape, both leading to the salon above: (1) the spiral stairs forward in the bunkroom ([figure 28](#)), and (2) the escape hatch installed centerline at the aft end of the bunkroom ([figure 29](#)). The hatch, marked with a two-inch plastic sign, was accessible from either aisle by climbing a wooden ladder, located in the corner where the aftermost middle and aft athwartship tiers of bunks were, onto the upper bunk; crawling to the centerline; and then pushing the plywood escape hatch up and out of the way. The hatch opened below the centerline countertop in the salon. Investigators measured the *Vision*’s escape hatch, which, according to the owner, was similar to the *Conception*’s escape hatch. The opening dimensions were approximately 22 inches by 22 inches through the main deck, with the aft-facing vertical opening having a clearance of about 35 inches from the main deck to the countertop above, or 28 inches from the top of the 7-inch main deck coaming. The two means of escape were at opposite ends of the bunkroom (so as to minimize the possibility of one incident blocking both escapes) and did not pass through a watertight door, thereby fulfilling the regulations applicable to the *Conception*. In the available documentation and inspection history of the vessel, no deficiencies or modifications were found related to the emergency escape hatch or the bunk ladders to the hatch.

**Figure 28.** Staircase from the main deck galley/salon leading down to the bunkroom on the *Conception*. (Source: NTSB eyewitness submission)

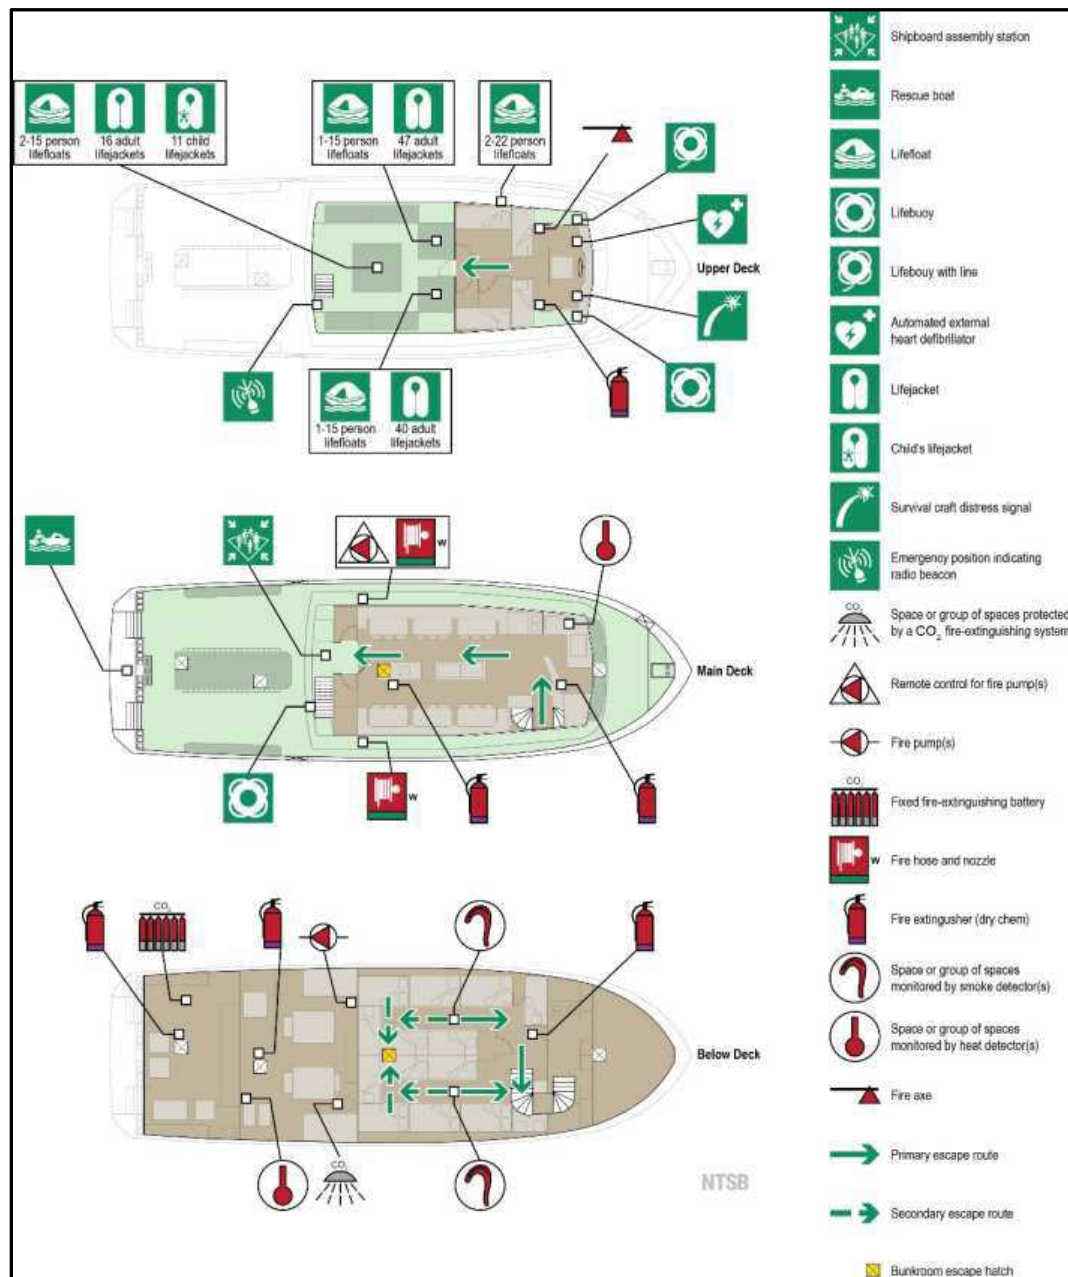
Three small restrooms, each with a single toilet and a small sink, were located just aft of the salon. Aft of the portside restroom door, a sign posted on the bulkhead identified the location as the muster area. Exterior walkways on either side of the salon and restrooms extended from the bow to the aft open deck. Fire hose stations were located on both port and starboard walkways adjacent to the restrooms (see [figure 30](#) for the location of all firefighting equipment and lifesaving appliances).

**Figure 30.** Locations of firefighting equipment, lifesaving appliances, and evacuation plan for the *Conception* at the time of the accident (compiled from the investigation and drawn by the NTSB).

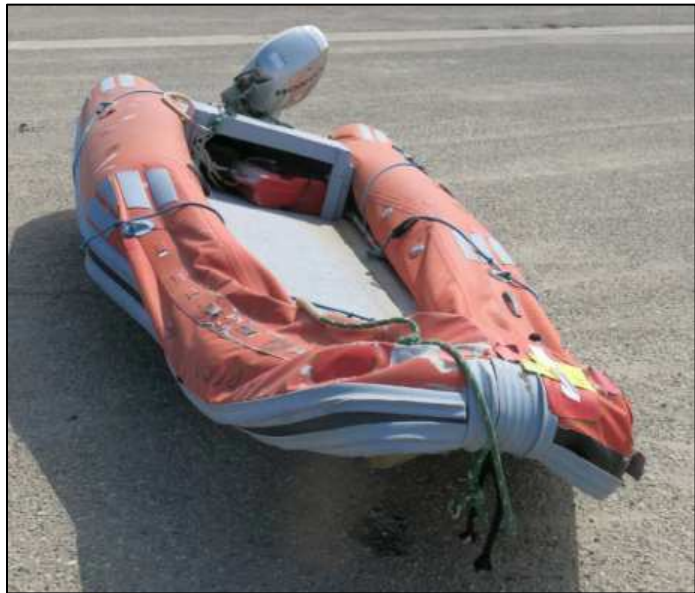
**Figure 31.** Postaccident photo of the *Conception* skiff.
