Transport Accident  
Investigation  
Commission

# Final Report

**Marine inquiry MO-2019-203**

**Bulk log carrier *Coresky OL***

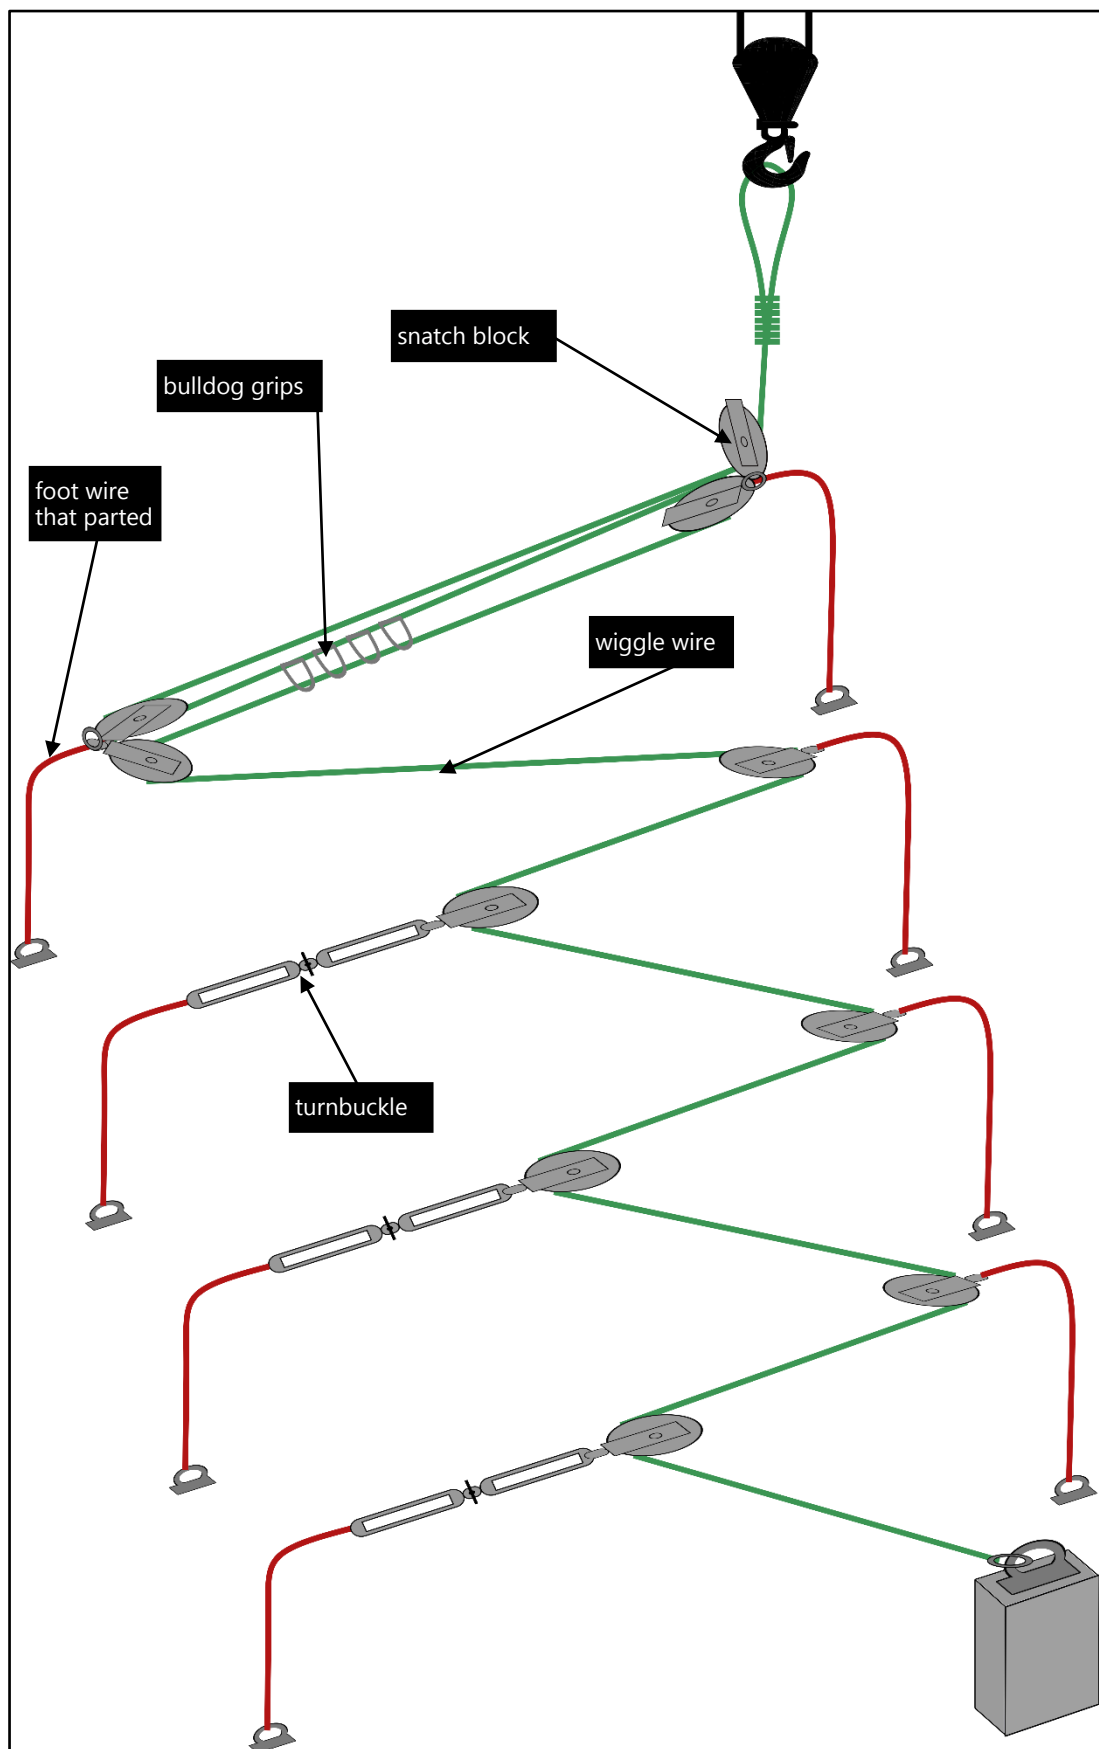
**Figure 4: Simplified securing layout as described in the vessel's cargo securing manual**

- 2.25 A wiggle wire, secured at one end to a deck fitting, was required to be run through a series of snatch blocks, which were secured to foot wires on one side of the vessel and to turnbuckles on the other side (see Figure 4).

- 3.15 The diagram in the guidance material also showed turnbuckles (see Figure 4) between the wiggle wire and the foot wires. Turnbuckles allow tension to be increased or decreased manually in a controlled manner. However, at the time of the accident turnbuckles had not been rigged between the wiggle wire and the foot wires. Instead, blocks had been attached directly to the foot wires. As a result, it was not possible to increase the tension in the wiggle wire manually after the initial tension had been applied. If turnbuckles had been rigged, it would have been unnecessary for the crane to apply more than just the initial tension and reduced the likelihood of a foot wire becoming overloaded.

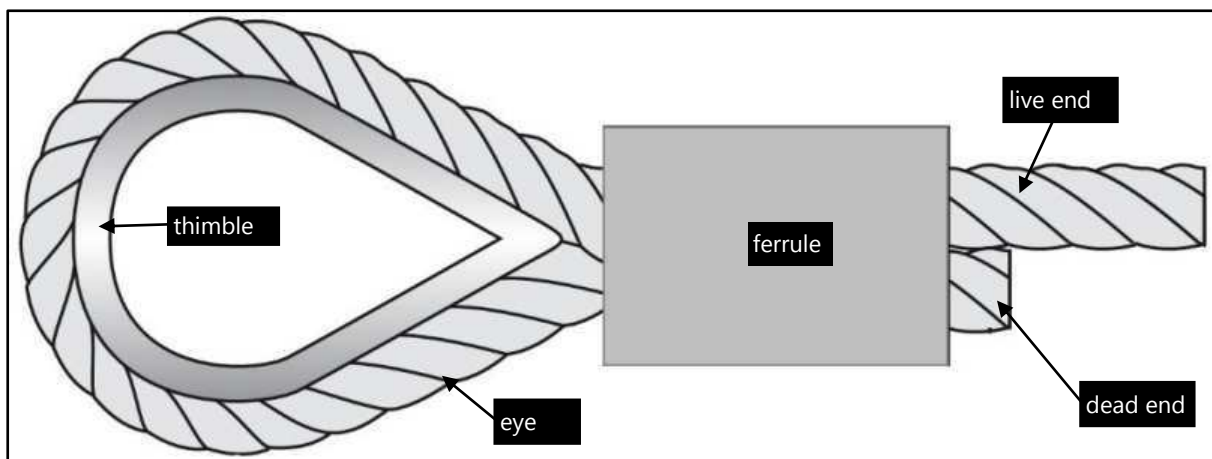
**Figure 5: Diagram of the end of a foot wire**

- 2.28 The foot wire that parted was constructed from a coil of wire manufactured by Nantong Steel Wire Rope Group, China in May 2014.
- 2.29 The wire was 24 millimetres in diameter and made from hot galvanised steel, with six strands of 24 wires containing fibre cores. It was certified as having a minimum breaking load of at least 269 kilonewtons, equivalent to 27.4 tonnes. The foot wire was 15.5 metres long and had an eye constructed using a steel thimble<sup>14</sup> and an aluminium ferrule<sup>15</sup> at each end (see Figure 5).
- 2.30 The vessel's cargo securing manual defined the maximum securing load of re-usable wire ropes, such as foot wires, to be 30% of their breaking strength. By calculation, the maximum securing load of the foot wire that parted was 8.22 tonnes.

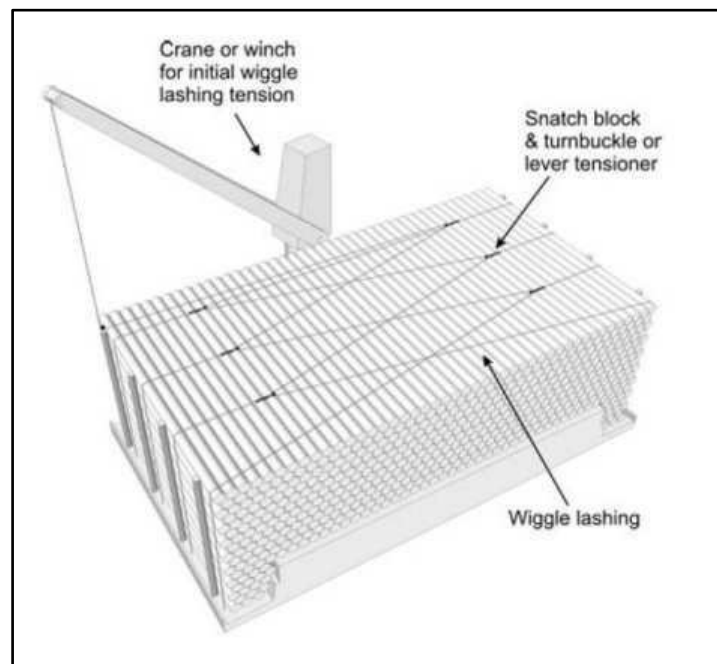
**Figure 9: Extract from the 2011 Code of Safe Practice for Ships Carrying Timber Deck Cargoes**

- 3.20 The cargo securing manual contained a copy of the IMO's 'Code of Safe Practice for Ships Carrying Timber Deck Cargoes – 1991'. However, the most current version of the code had been adopted on 30 November 2011.
- 3.21 A number of changes had been made to the code between 1991 and 2011. Significantly, the 2011 version of the code explained:
- the need for turnbuckles to be rigged between wiggle wires and foot wires
  - that a crane or winch was to be used only to apply the initial tension to wiggle wires.
- 3.22 An extract from the 2011 edition of the code, explaining the arrangement for wiggle wires, is shown in Figure 9.

- 3.23 The explicit reference to apply only the initial tension would have provided the crew with the guidance necessary to minimise the likelihood of inadvertent overload and reinforce the need to use turnbuckles, which would have allowed the crew to better assess the amount of tension throughout the securing system.
- 3.24 The implementation of the 2011 version of the code, and the procedural changes contained within it, would have also prompted the operator to conduct a review of the log-securing operation and update procedures and instructions within the SMS.
- 3.25 Although the vessel's SMS had been audited by the classification society and by internal auditors, the audits had not identified that the vessel was using an out-of-date IMO Code of Safe Practice for Ships Carrying Timber Deck Cargoes. As a result, the
