Report on the investigation of the loss of
42 containers from the container ship

Ever Smart

700 miles east of Japan, North Pacific Ocean

30 October 2017

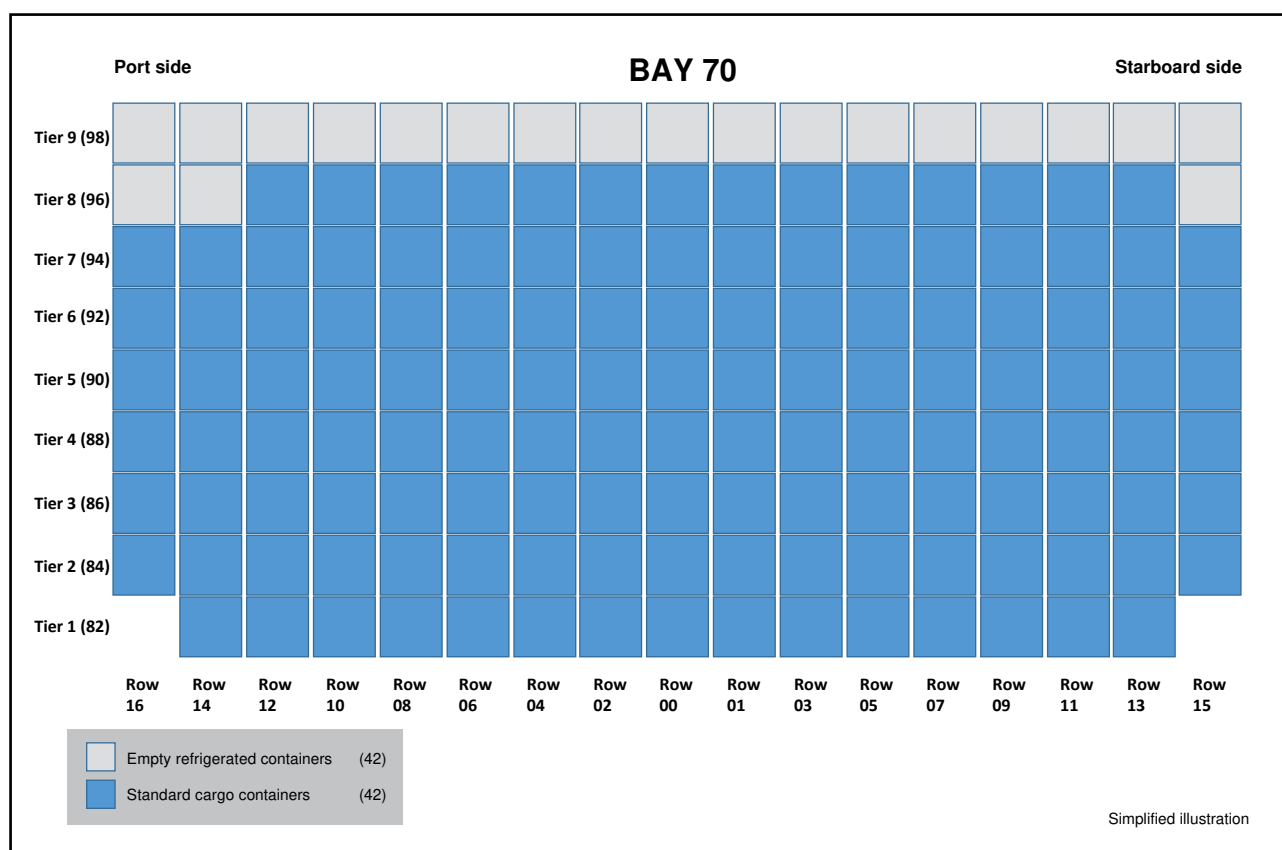
Figure 6: Simplified illustration showing the locations of the empty refrigeration containers in bay 70

According to the stack weight tables contained in *Ever Smart's* CSM, when bay 70 is fully loaded with 151 containers (**Figure 7**) the gross mass of each container in tiers 8 and 9, and 5, 6 and 7 in the outer stacks should not exceed 4t. This was not the case; the tare weight of the empty refrigeration containers in tier 9 of the stow and tier 8 of the outer stacks was between 4.6 and 4.8t (**Figure 30**). The rest of the containers in tier 8 weighed between 7.4 and 9.8t. The weights of the containers in tiers 5, 6, and 7 of the starboard outer stack were 9.6, 8.6 and 7.6t respectively. The weights of the containers in tiers 2, 3 and 4 were 9.6, 9.3t and 8.2t respectively, and were all well below the weights given in the stack weight table.

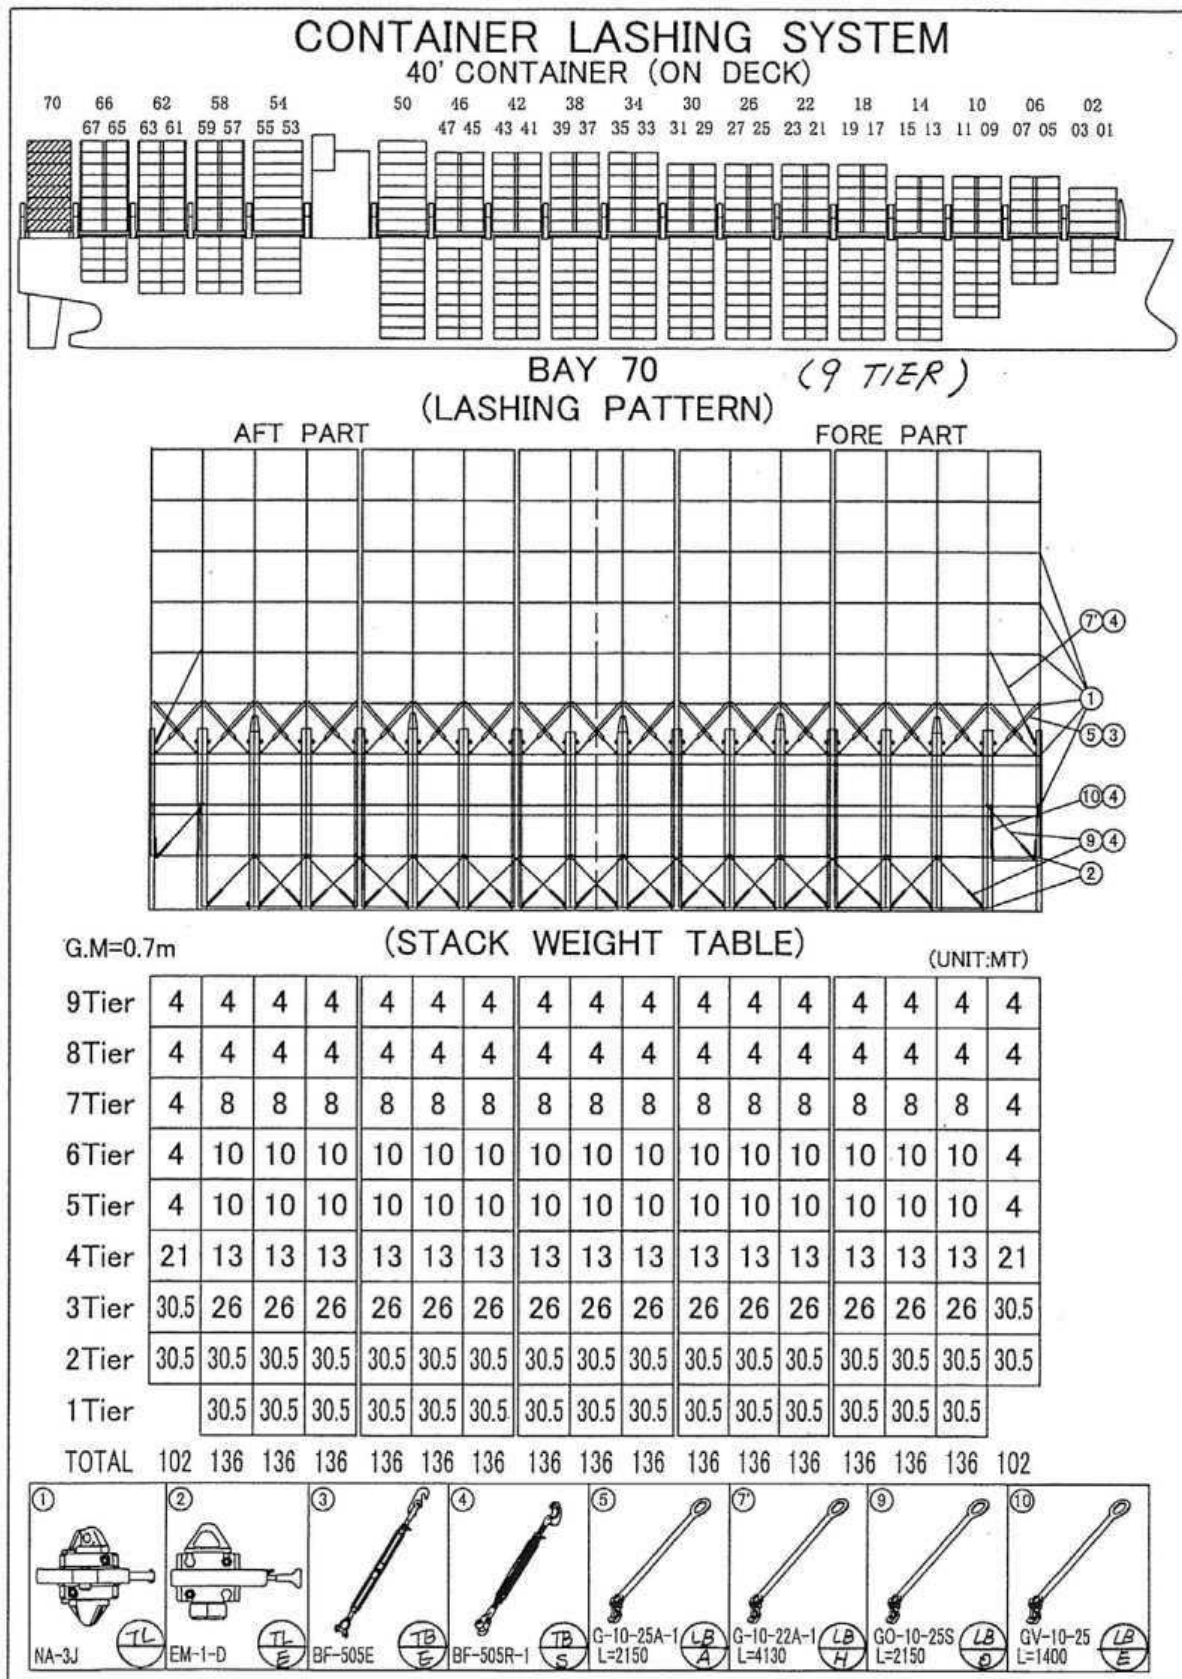
Figure 7: Container lashing sytem manufacturer's container lashing pattern and stack weight table for bay 70 when loaded with 151 containers for GM 0.7m

The guidance contained in the CSM required Bay 70's lashing rod securing hooks to be attached to the bottom corner castings of the containers in tiers two, three and five, and the top corner castings of the containers in tier four (**Figures 7 and 8**) when loaded eight or nine tiers high. When the containers in bay 70 were loaded eight high in the outer stacks, the CSM lashing plan required an extra lashing to be secured to the inner casting of the tier six containers. (this was also the case for bays 66, 62, 58, 54 and 50). These additional lashings are often referred to as wind lashings. Wind lashings were not fitted to any of the outer stack containers in the bays aft of the accommodation block.

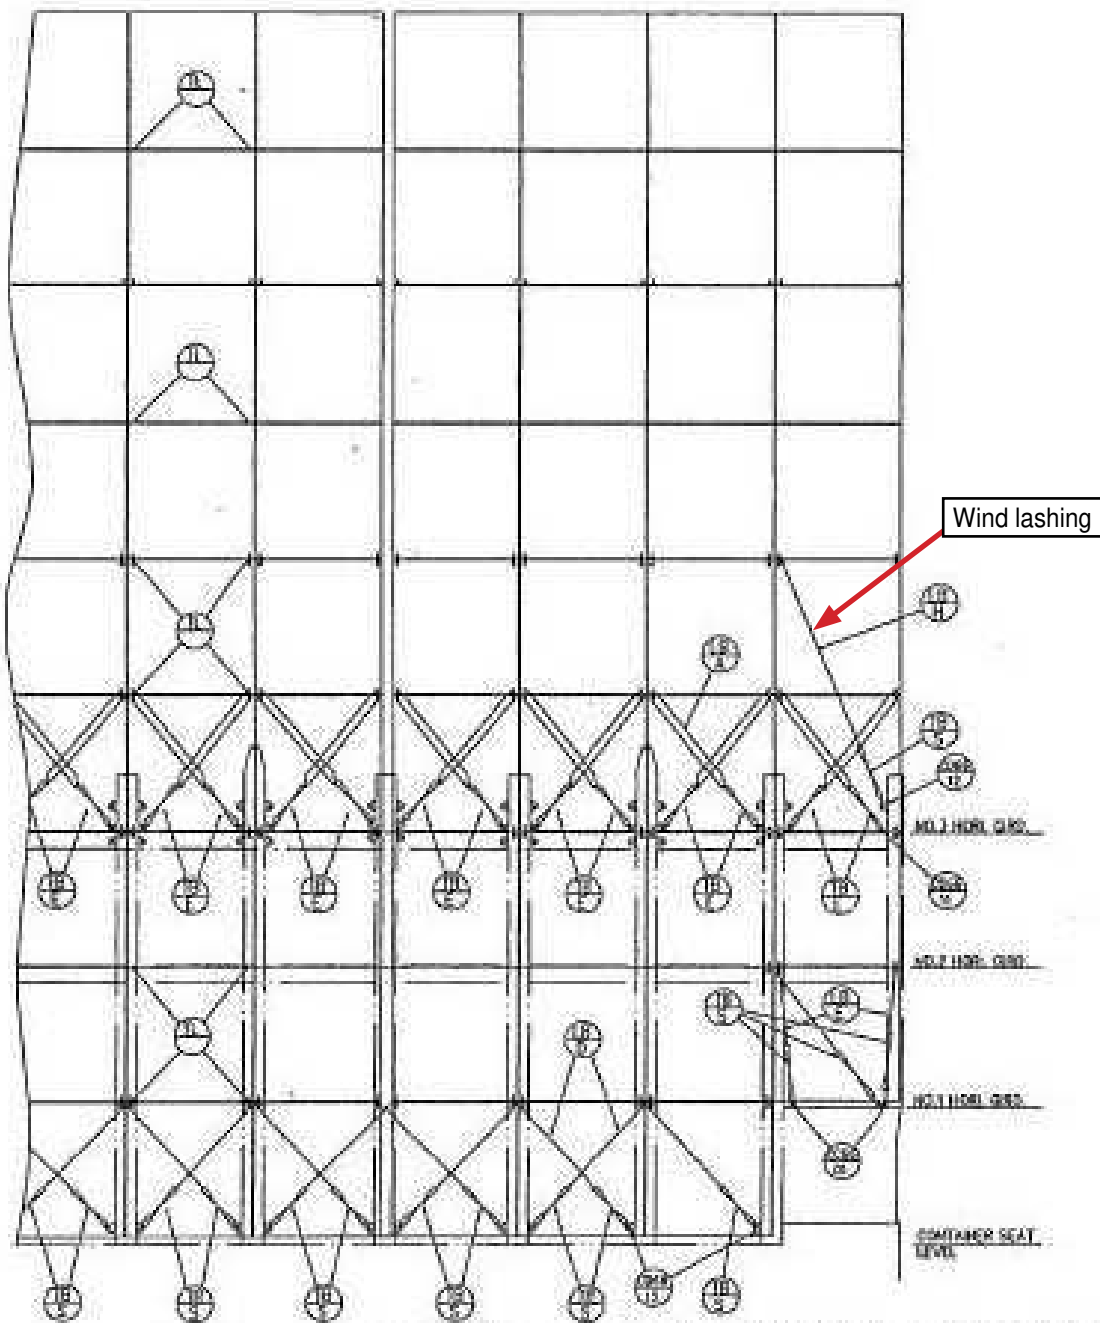
Figure 8: Cargo securing manual location of fixed securing devices drawing for bay 70 when outer stack is loaded eight containers high (to tier 9)

In case of 8 tiers on the side most row, only 8ft 6in container can be stowed (Figure 8).

In case of 8 tiers on side most row, Only 8' - 6" ft container can be stowed.

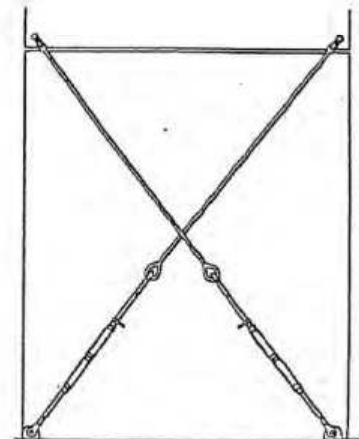
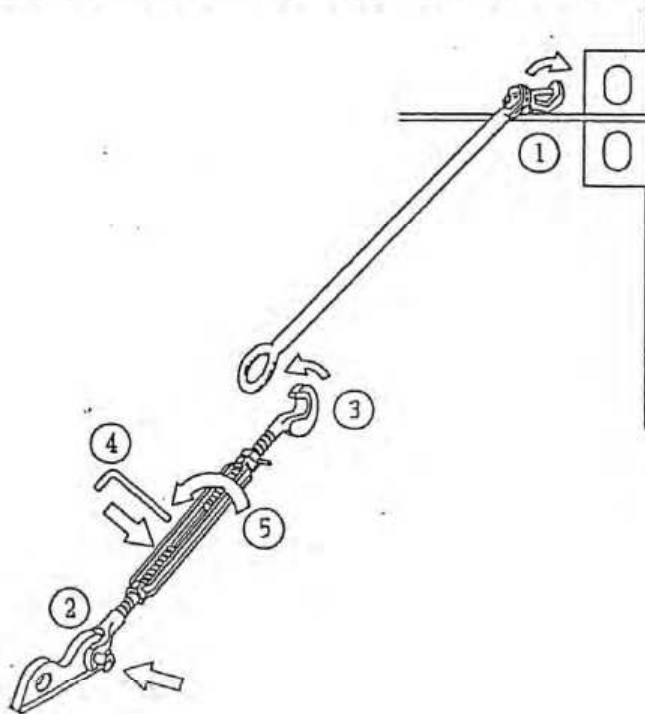
Figure 15: Cargo securing manual instructions for attachment and tightening of turnbuckle and lashing rods

The lashing rod turnbuckles were attached to anchor points on the deck and the top level of the lashing bridges at the forward and aft end of each bay. The lashing rod hooks were attached to the corner castings of the containers and then to the turnbuckles. The lashing rods were tightened using a 400mm long L-shaped bar to rotate the turnbuckles. Once tight, the turnbuckles should have been locked in position by tightening their locking nut (**Figure 15**).

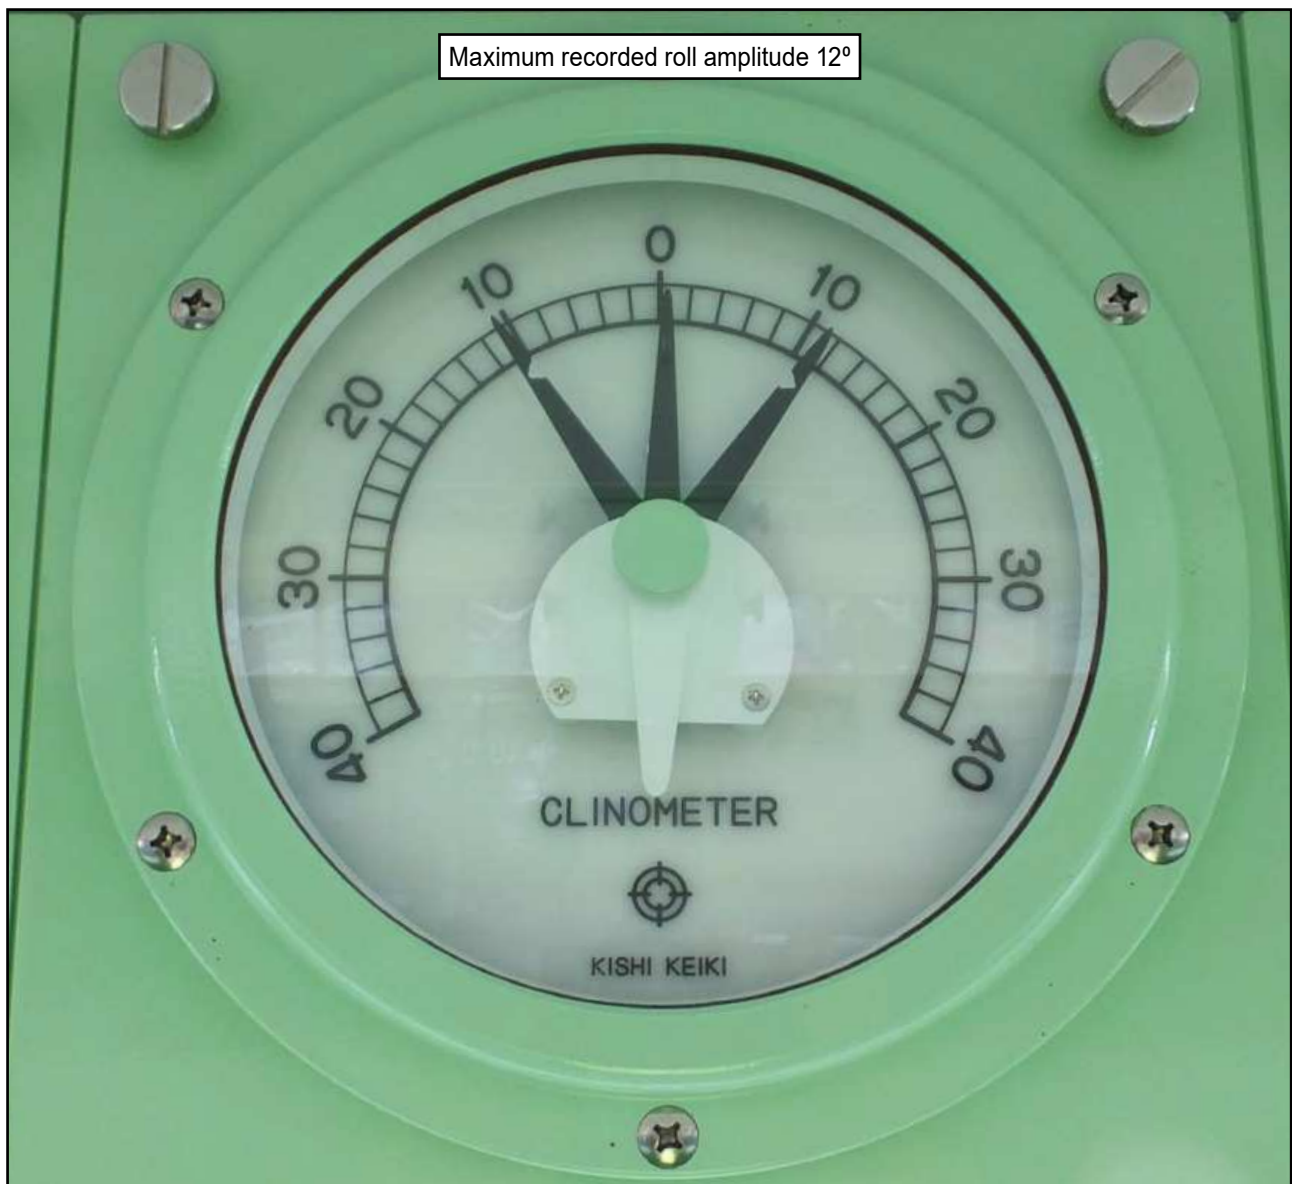
Figure 25: Bridge inclinometer

Ever Smart had an inclinometer on the bridge to indicate roll angle (**Figure 25**). There were no other instruments or sensors to help the bridge team to gauge ship movement or assess the acceleration forces acting on the cargo.

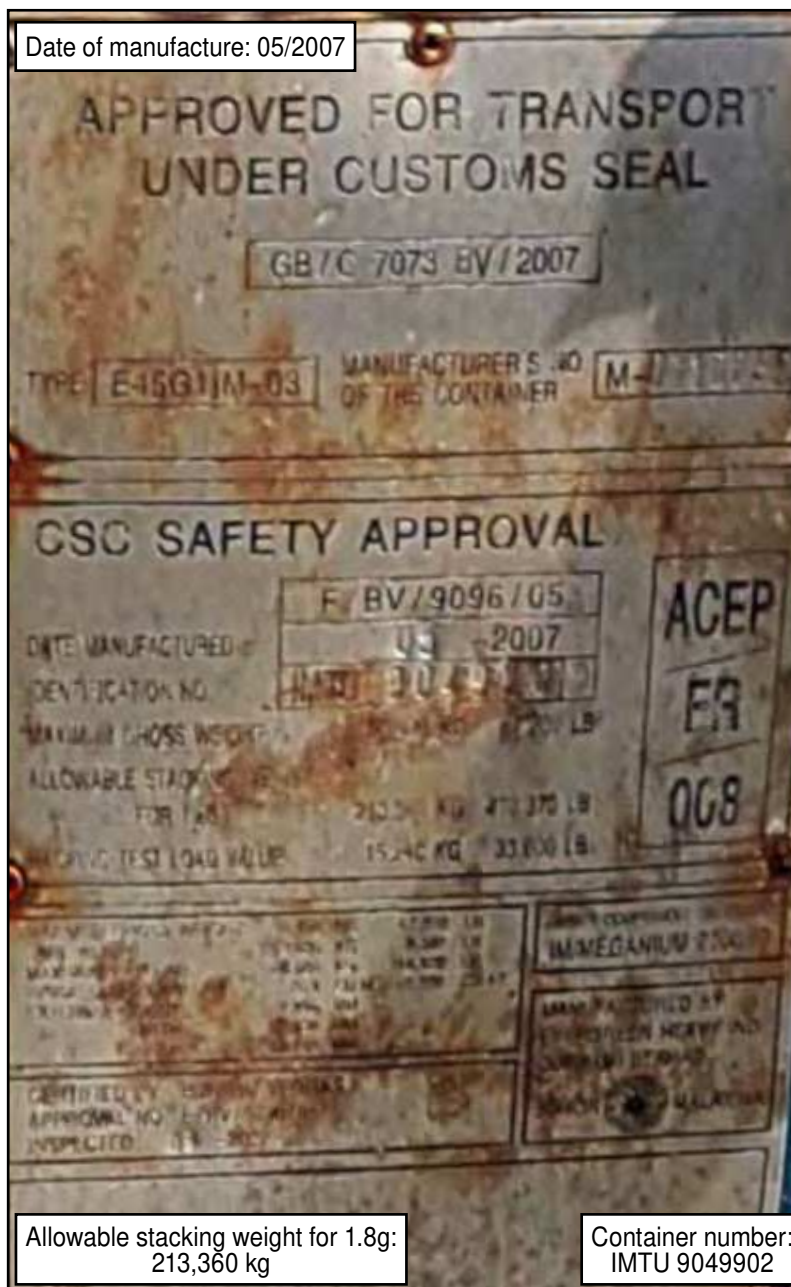
Figure 26: CSC plate and Classification Society approval certificate for the container stowed at the bottom of Bay 70's starboard outer stack

Containers constructed and tested in accordance with ISO 1496 are considered to have met the requirements of the CSC and are fitted with a safety approval plate (CSC plate) that includes load limits⁸ (**Figure 26**).
