**Independent investigation into the grounding  
of the Chinese registered bulk carrier**

***Shen Neng 1***

**on Douglas Shoal, Queensland**

**3 April 2010**

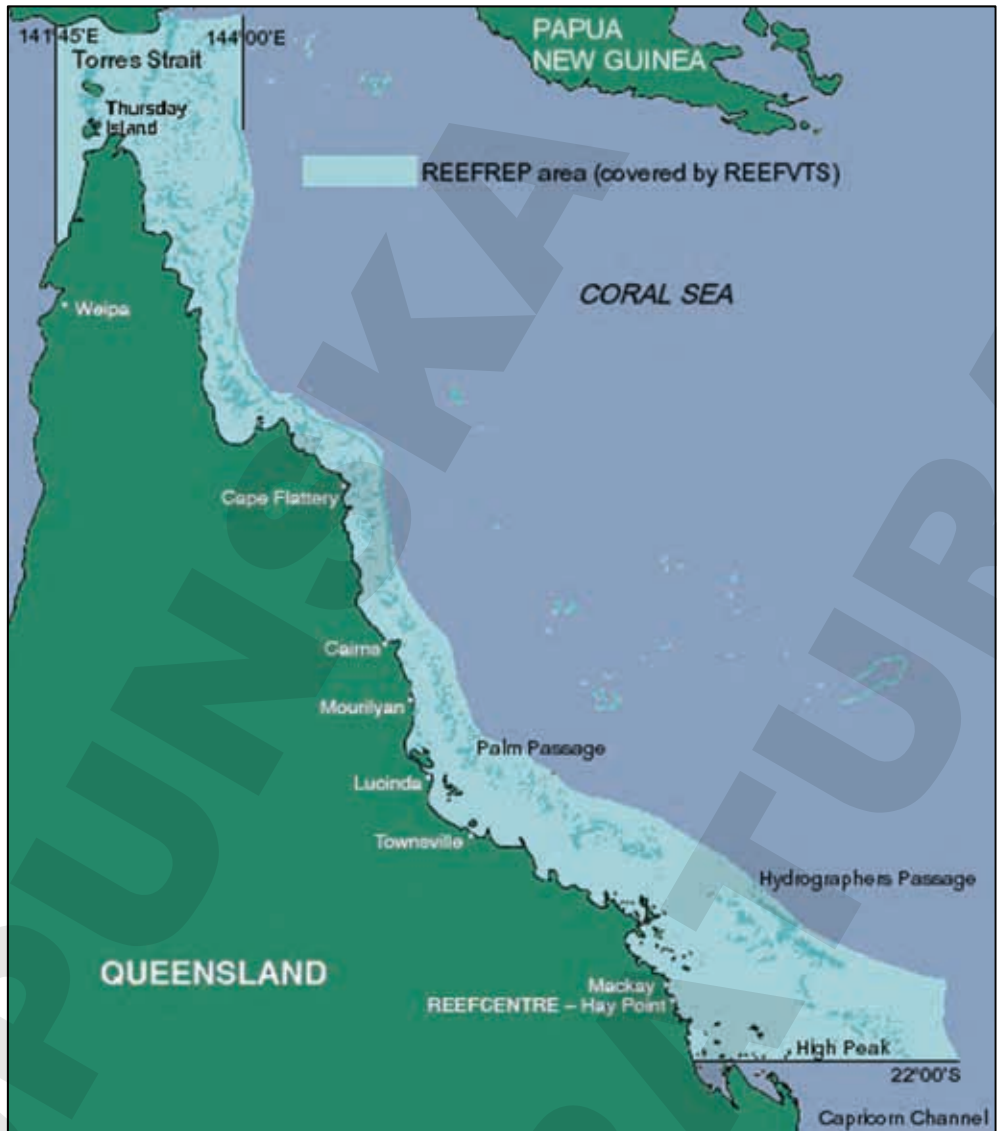
**Figure 2: Area covered by REEFVTS at the time of the incident**

At the time of the incident, REEFVTS provided VTS coverage of the Torres Strait and the northern part of the GBR. The southern limit of the REEFVTS area was at latitude 22°S, near High Peak Island, about 120 miles north of Gladstone (Figure 2).

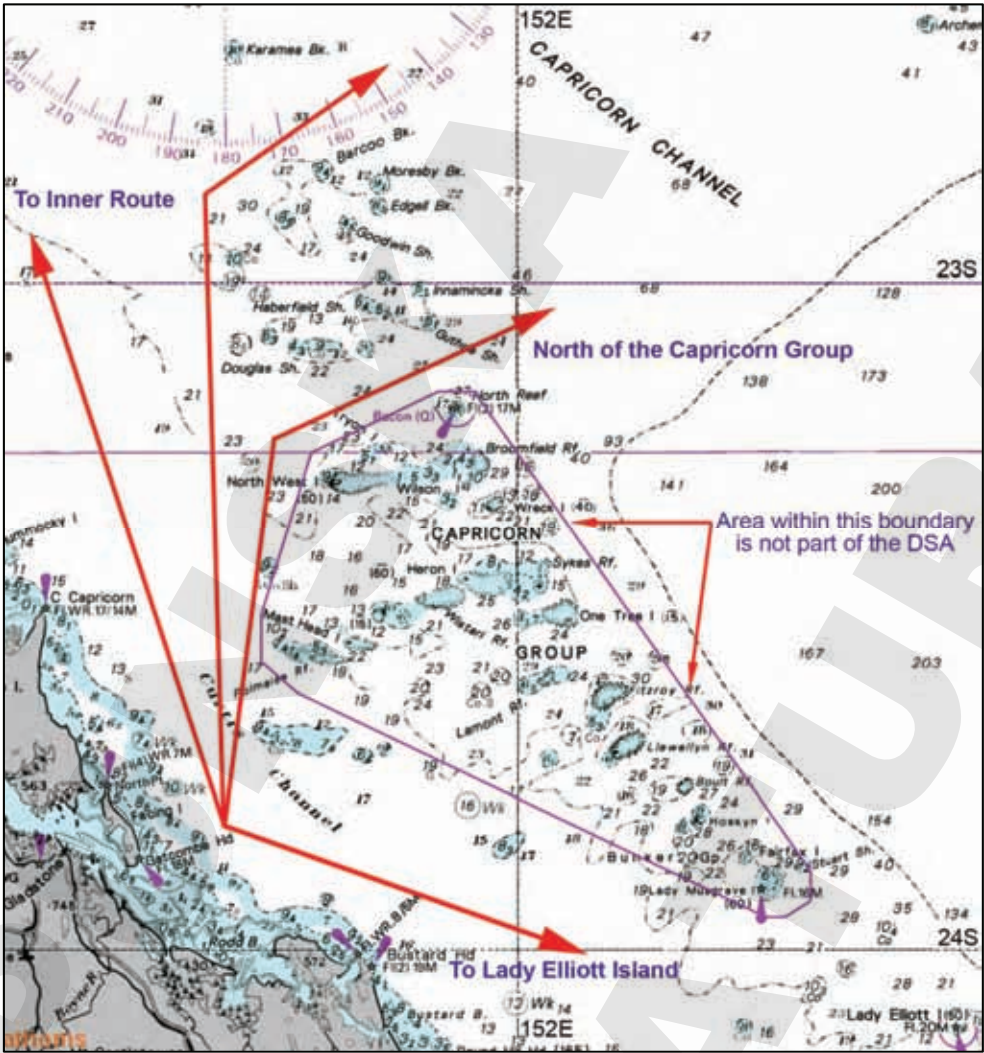
Figure 3: Route options for ships departing Gladstone

Ships departing Gladstone have a choice of routes which will take them out of the GBR Marine Park (Figure 3). Which route a ship uses is principally determined by its destination and draught.

Another navigable passage to the north-northeast of Gladstone is between the Capricorn Group and Guthrie and Douglas Shoals (Figure 3). A powerful navigation light, with a racon<sup>14</sup>, is located on North Reef to assist in the safe navigation of ships through this passage. This passage is within the DSA and it is estimated that about half of the ships entering or exiting the GBR area off Gladstone use this passage, with the other half entering or exiting via Lady Elliott Island (Appendix A).
