Report on the investigation of  
the death of a third officer struck by a freight vehicle  
on the stern ramp of the ro-ro freight ferry

## ***Seatruck Progress***

Brocklebank Dock, Liverpool

15 May 2019

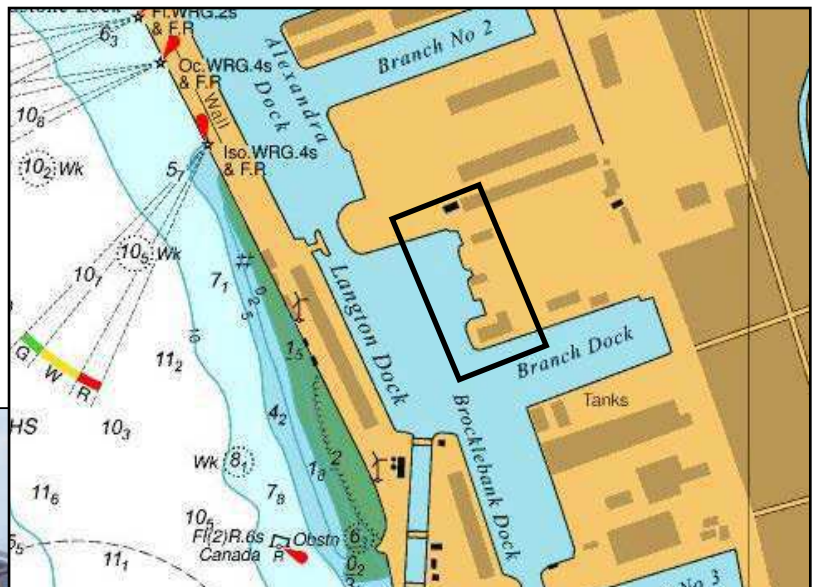
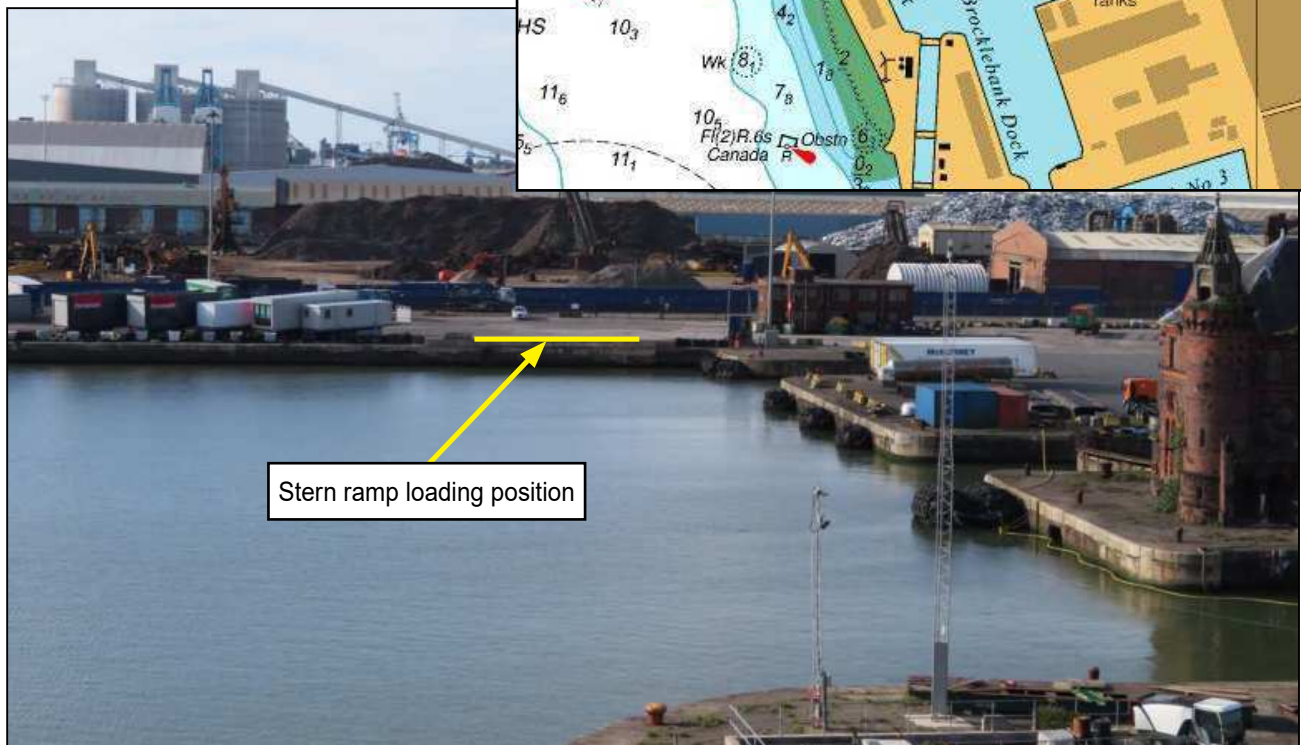
**Figure 1: Brocklebank Dock**

At 1826 on 15 May 2019, the Isle of Man registered ro-ro freight ferry *Seatruck Progress* berthed at Brocklebank Dock, Liverpool, England (**Figure 1**) following passage from Dublin, Ireland. The stern ramp was lowered on to the dockside (**Figure 2**) and the relieving master and chief officer, who had been waiting on the quay, boarded. Cargo discharge commenced and the relieving master went to his cabin while the relieving chief officer went to the cargo control room (CCR) on the port side of the ferry's main vehicle deck, where the third officer (3/O), Bartosz Wronski, was working. The outgoing chief officer soon joined his relief in the CCR and started to hand over his duties. Meanwhile, the 3/O left the CCR and drove the outgoing master's car off the ferry and parked it on the quay outboard of the stern ramp's starboard side.

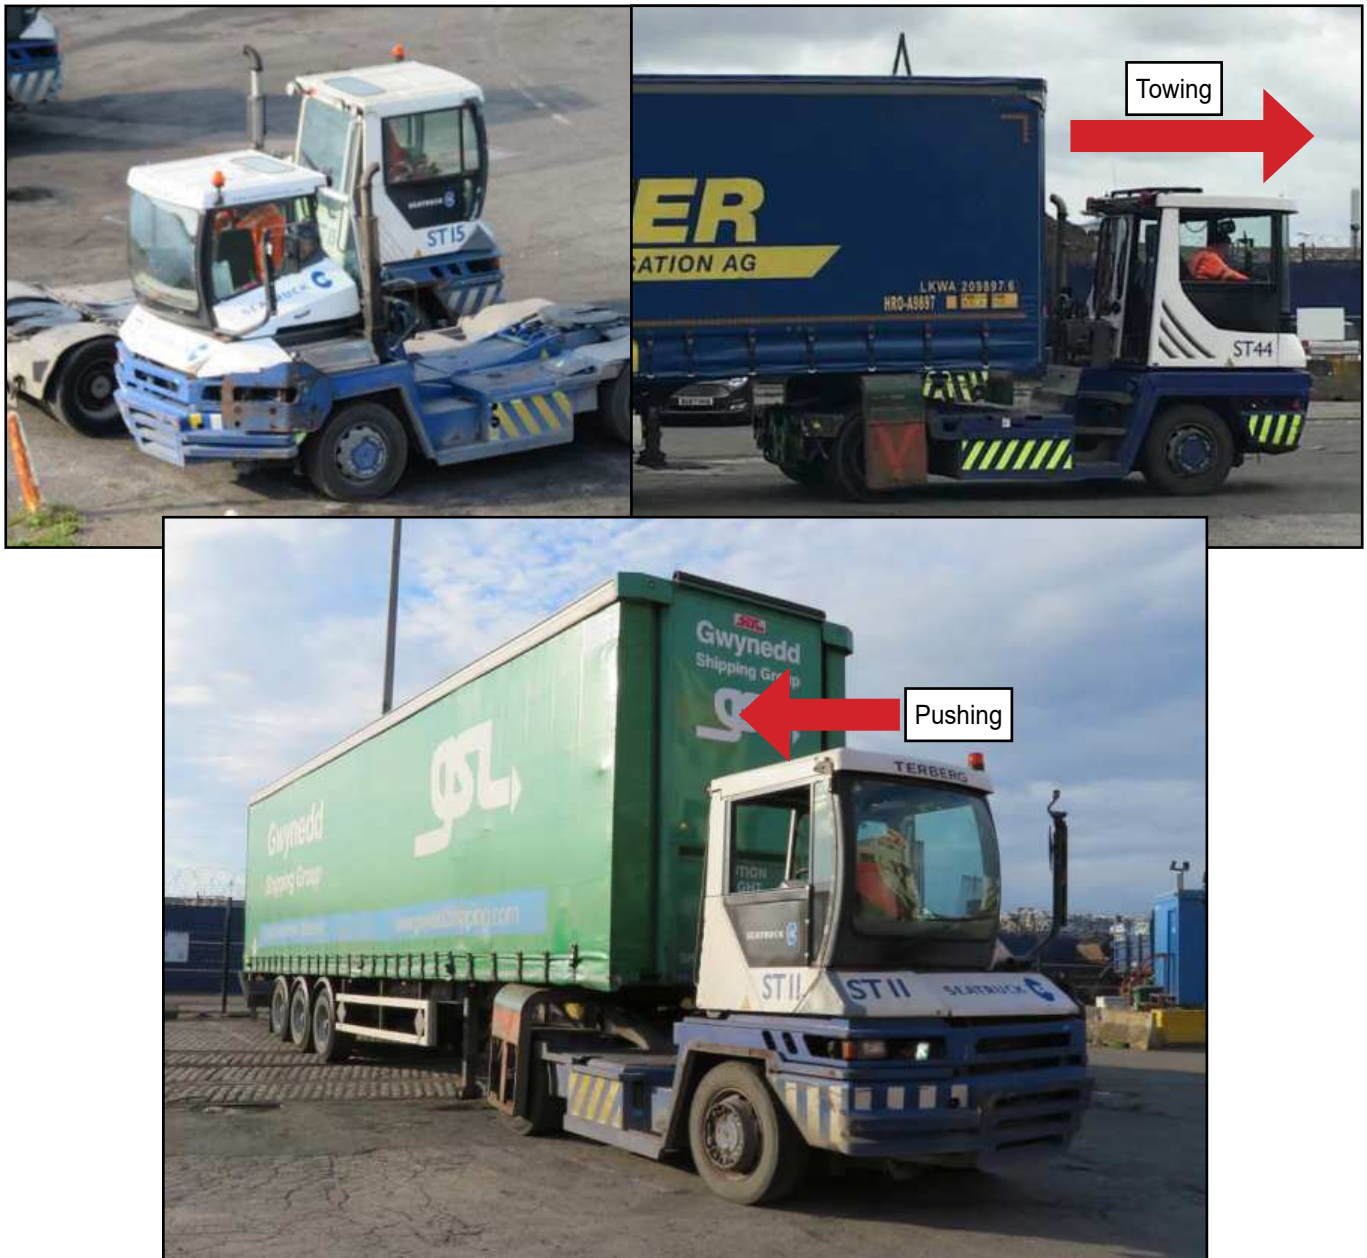
**Figure 11:** Tractor unit with semi-trailer

The tractors used to load and unload unaccompanied semi-trailers at Brocklebank Dock were manufactured in the Netherlands by Terberg Group B.V. The terminal had 45 Terberg RT222 tractor units that were specifically designed for use on board ro-ro freight vessels. The driver's seat and console were offset to the right-hand side of the cab (**Figure 11**) and could be rotated through 180°.
