SAFETY INVESTIGATION REPORT

REPORT NO.: 13/2020

May 2020

MV RIGA
Fatality following entry into cargo hold
in position 42° 09.6' N 016° 24.6' E
27 May 2019

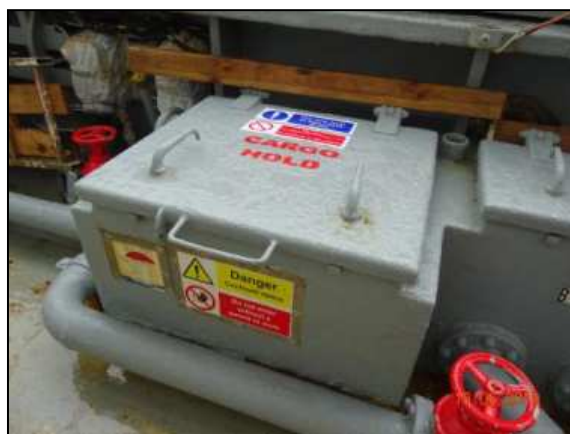
Figure 4: Cargo hold access hatch - aft

Although there was no evidence available, which indicated that the chief engineer was involved in the preparation of the risk assessment and/or the enclosed space entry permit, warning signs were posted on the cargo hold access cover (Figure 4). In addition, the able seafarer, who solely was
