SAFETY INVESTIGATION REPORT

REPORT NO.: 11/2020

MT ALYARMOUK

**Damage to equipment, leading to a fall from a height on deck,
in position 06° 20' N 079° 34' W
10 May 2019**

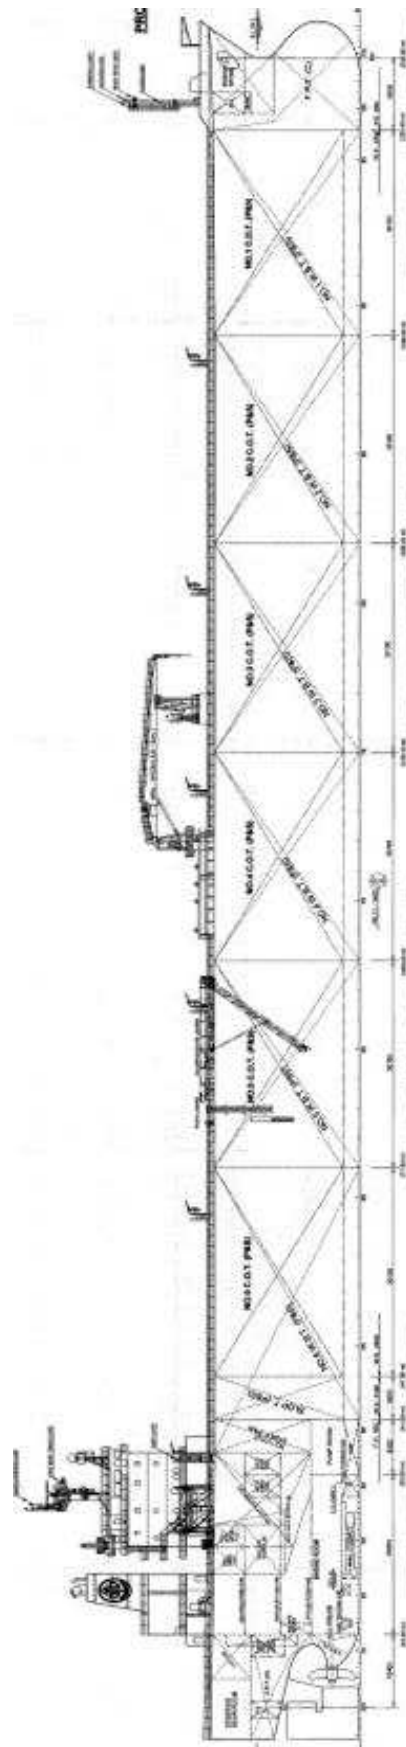
**Figure 1: General Arrangement Plan
MT *Alyarmouk* (Scale: 1:300)**

MT *Alyarmouk* (Figure 1) was a 61,342 gt oil tanker, built in the Republic of Korea in 2008. She was owned by Libyan Voyager Ltd. and managed by V. Ships U.K. Ltd. At the time of the accident, the vessel was classed with Class NK.

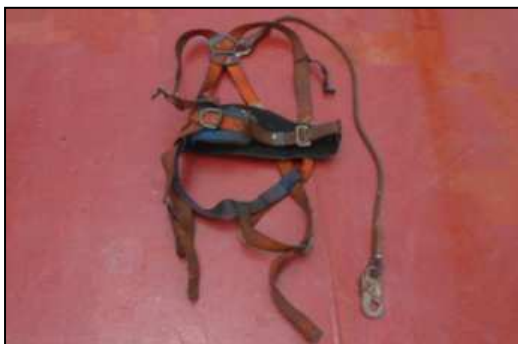
Figure 3: The safety harness

The safety harness was reportedly inspected for fraying, discolouration and damages, the buckles and their connections were inspected, and the lanyard was checked for fuzzy, worn, broken or cut fibres.

At the time of the accident, the injured seafarer was wearing the appropriate PPE required for the task *i.e.*, a hard hat with a chin-strap, overalls, safety gloves and safety shoes. In addition, as mentioned earlier, he had worn a safety harness, which was secured to rope 'B'.

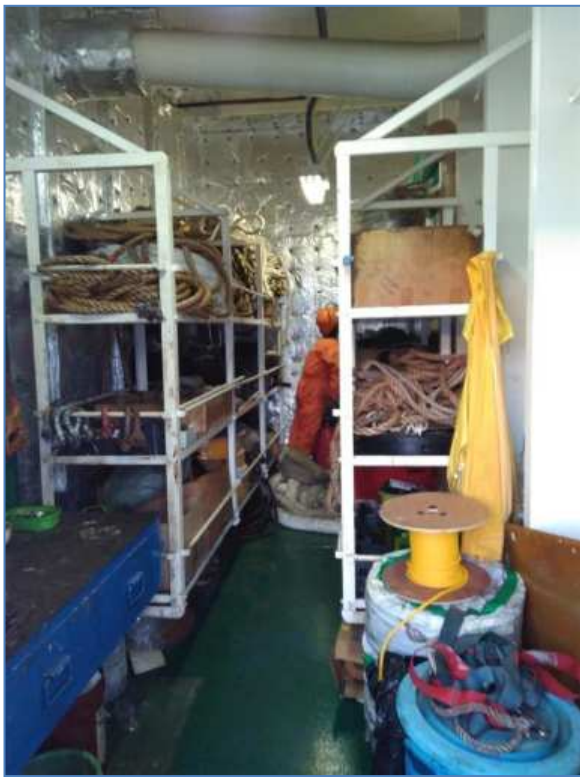
It was reported that the ropes in use at the time of this accident, were stored on racks in one of the vessel's stores (Figure 10).

Figure 10: Storage space of the ropes

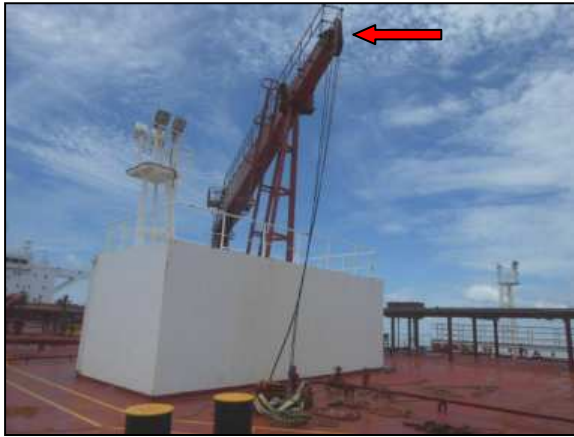
A twist in the runner wire of the crane, which was noticed earlier, was also planned to be rectified during the maintenance. The rectification of the twist required disconnection of the end of the wire which was secured to the head of the jib (marked with the red arrow in Figure 11) and would, therefore, require work to be carried out while being suspended from a height.

Figure 11: The hose handling crane

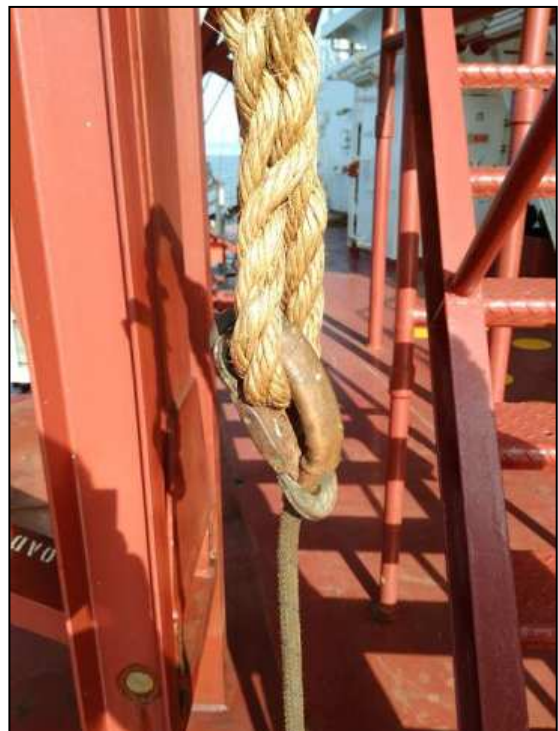
The equipment was rigged (Figure 6) following which, the bosun, who was the assigned team leader, conducted the final checks of the work area and of the PPE. At 1035, the bosun descended onto the bosun's chair, wearing a safety harness secured to rope 'B' (Figure 12). In order to enable access to the secured end of the crane's wire,

Figure 12: Simulation of safety harness secured to rope B during maintenance.

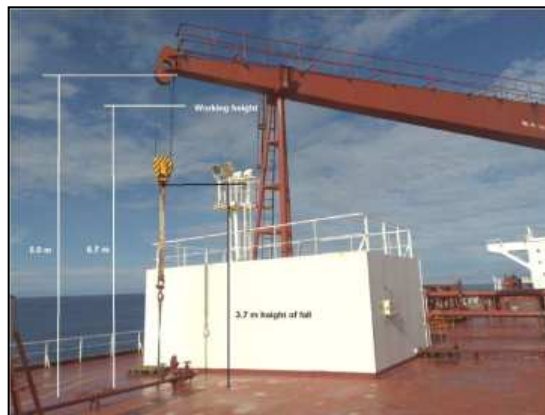
At around 1105, when the bosun's chair was lowered by about 3.0 m, rope 'A' parted from about 1.5 m above the point where it was connected to the chair. This resulted in the bosun's chair and the bosun, falling to the main deck (Figure 14) from a height estimated to be about 3.7 m (Figure 15), while the knot of the safety harness slid down along the length of rope 'B'.

Figure 15: Height from which the bosun fell

The comminuted fracture of the bosun's left heel was synonymous to a fall from a height³. In all probability, the bosun's left heel was his first point of contact with the main deck.
