Report on the investigation of
the fire on the main vehicle deck of

Commodore Clipper

while on passage to Portsmouth

16 June 2010

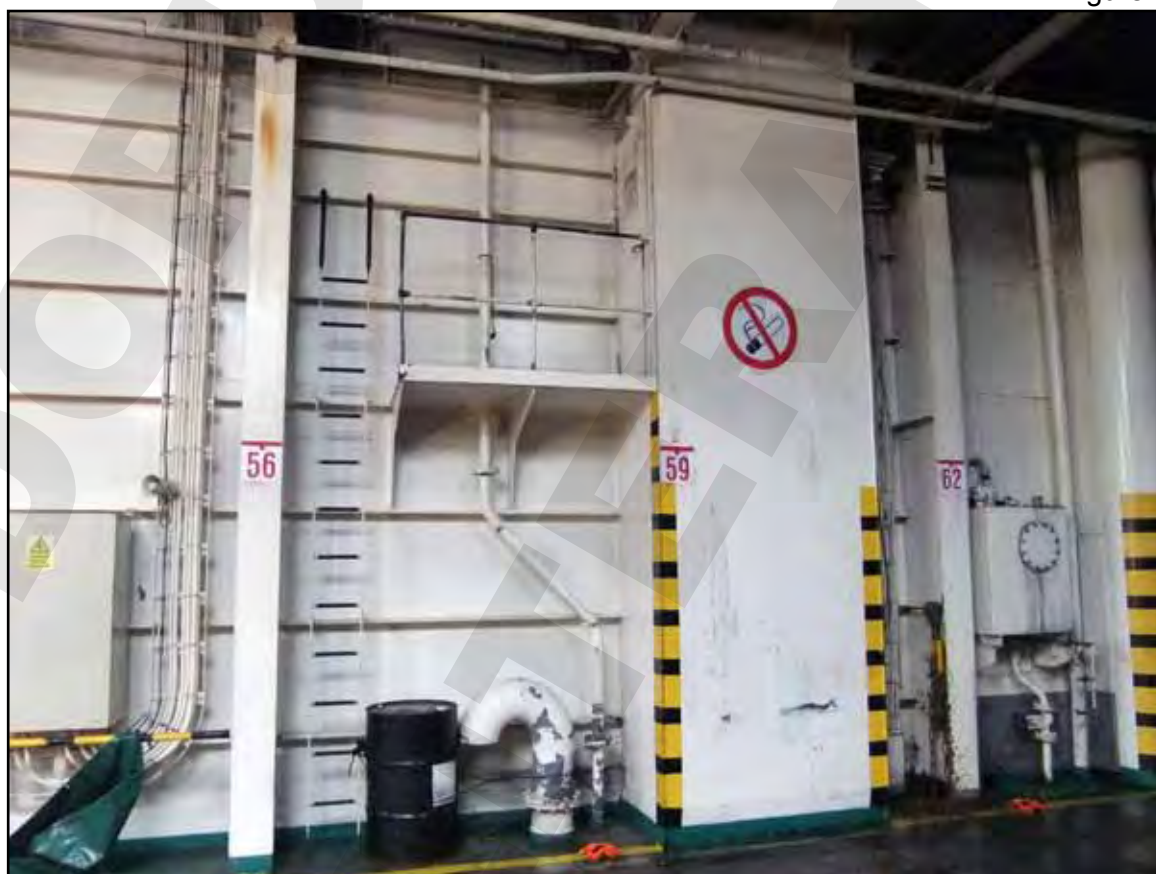
Figure 8

The chief officer and off-watch second officer dressed in firefighters' suits and BA, and began to re-enter⁵ the main vehicle deck at about 0640. They used an access trunk on the port side of the vessel that was slightly aft of the fire. The trunk led from the upper vehicle deck all the way down to the stabiliser room and had a door and small half landing at deck 4, slightly below the level of the roofs of the freight trailers (Figure 8).

Access platform at deck 4 above the main vehicle deck

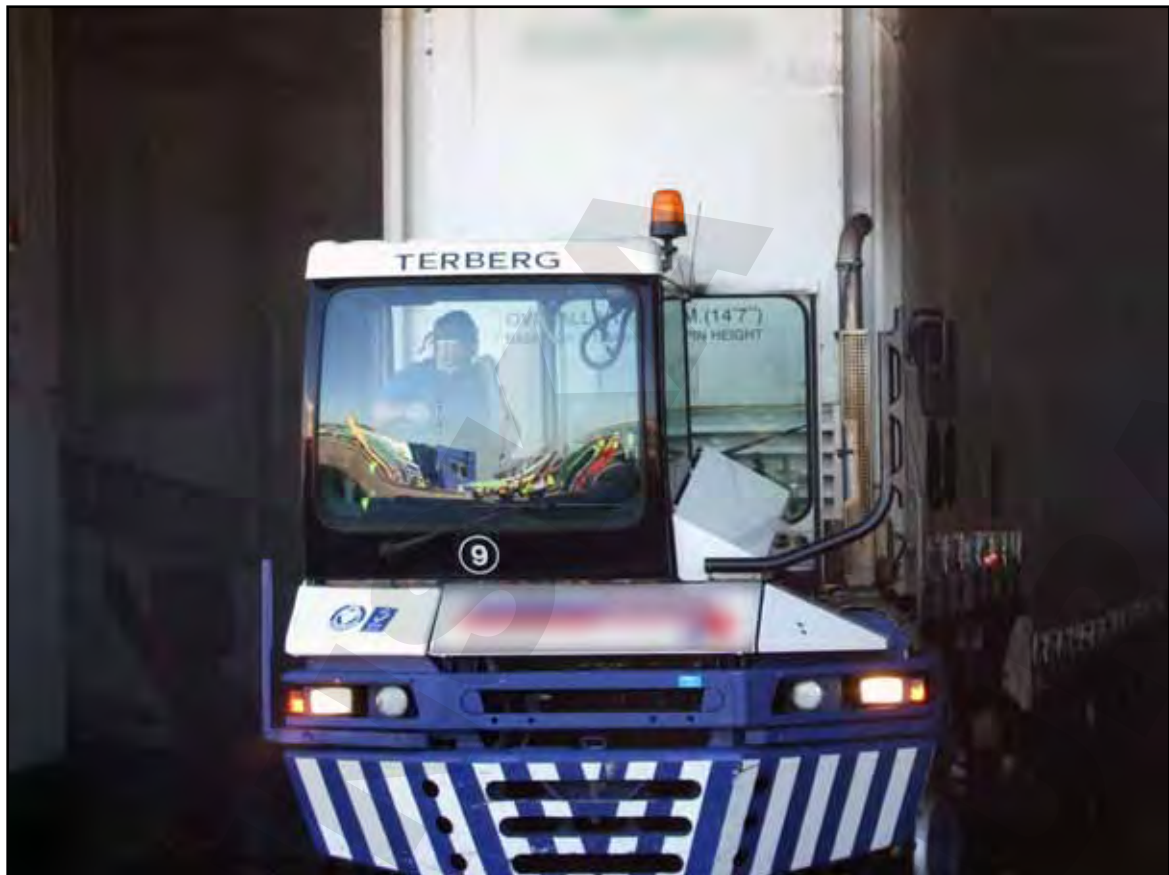
Visibility from the cab of the tugmaster was poor, and reduced to zero in the thickest smoke. Due to the limited space in the cab, the BA set had to be put to one side rather than worn conventionally, and the length of the hose between the cylinder and the facemask further limited the stevedore's movement. The stevedore used his knowledge of the vessel and the motion of the tugmaster as the tyres bumped over the lashing securing points in the deck to manoeuvre into the correct position and attach to each trailer.

The stevedore reported that he removed 11 trailers in this manner and used 7 BA cylinders. Each trailer took between 10 and 15 minutes to remove, compared with about 5-6 minutes in normal circumstances.

Stevedore wearing breathing apparatus in order to remove trailers from the smoke-filled vehicle deck

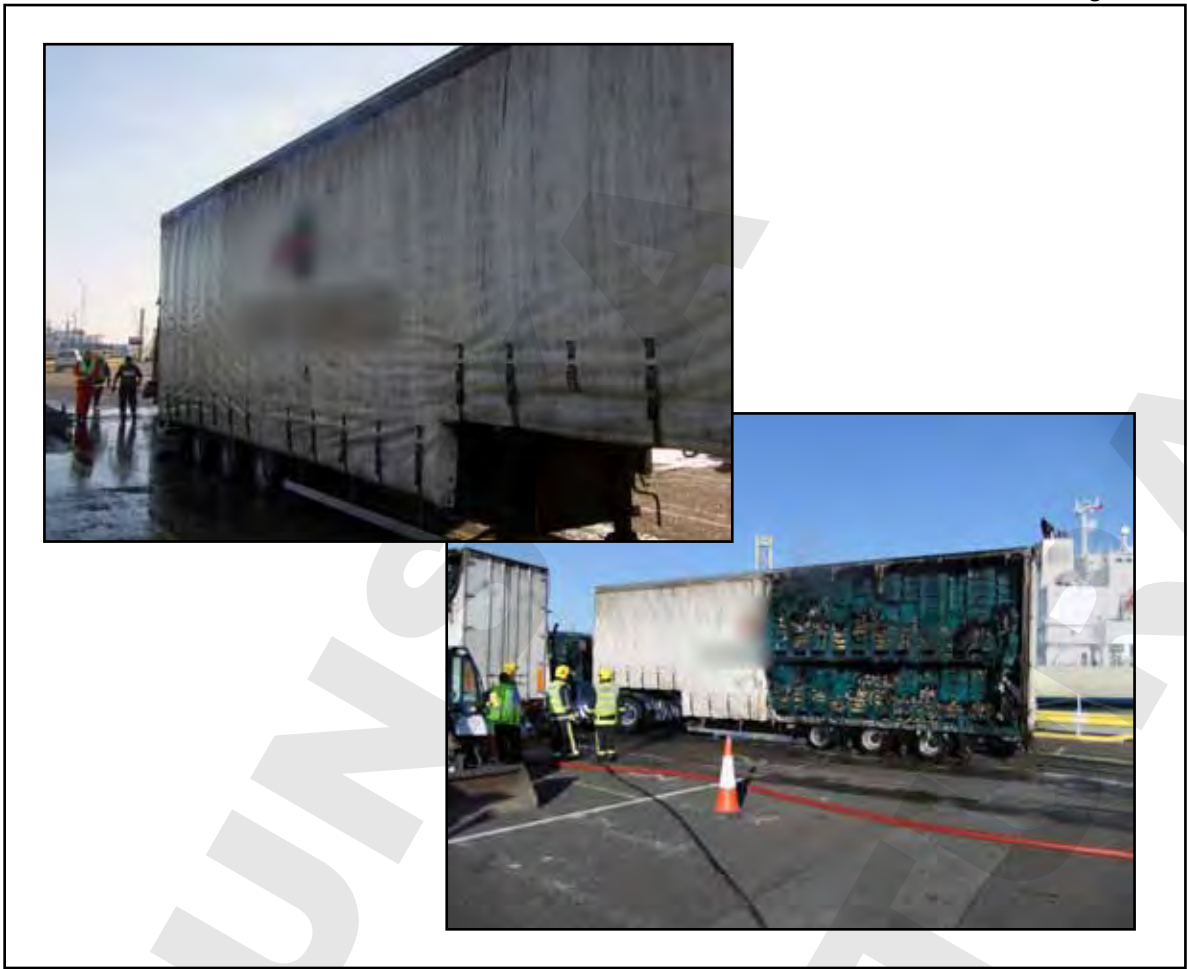
Figure 17

Trailer CRF439

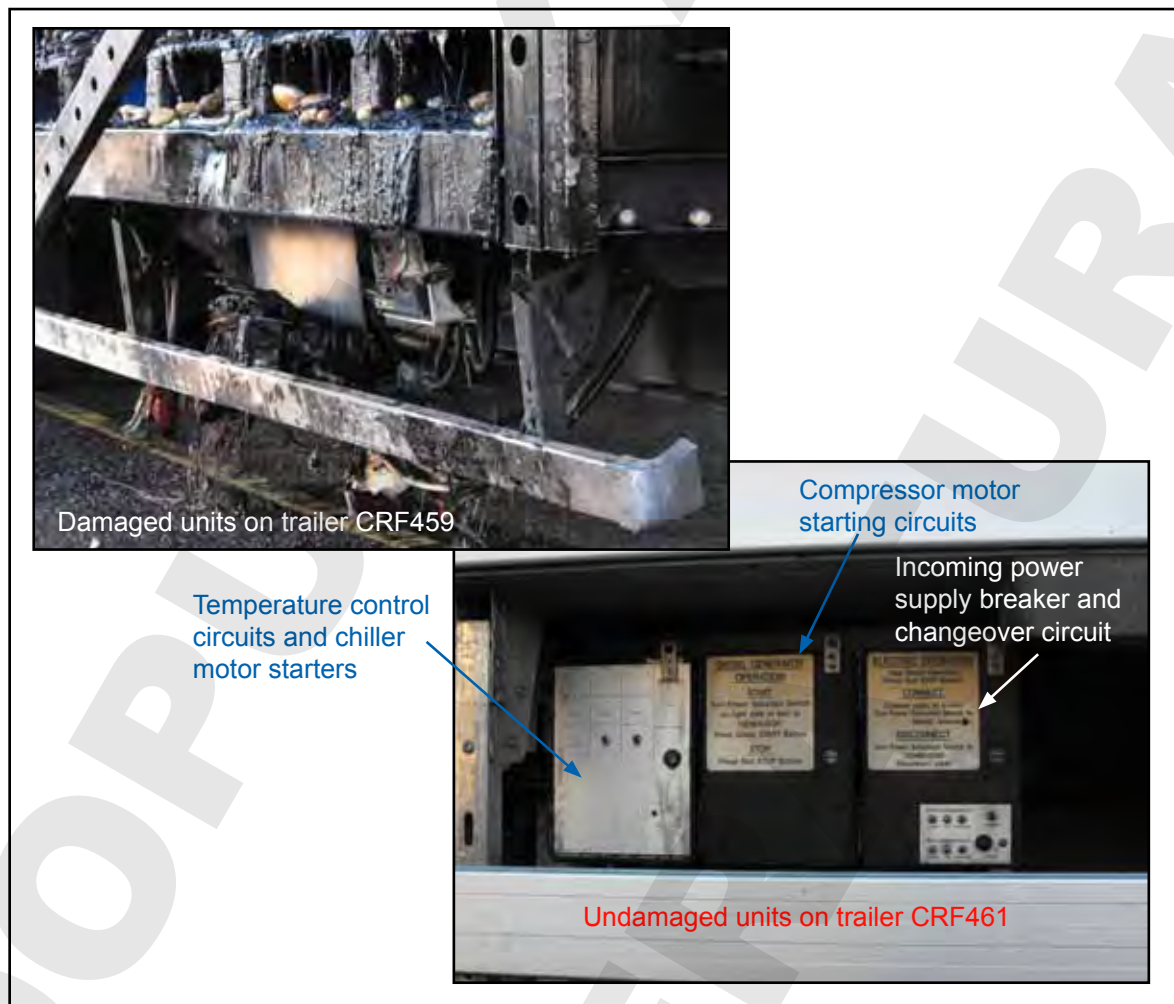
Figure 22

Three electrical control and power distribution cabinets, manufactured to meet IP67 ingress protection standards²⁰, were mounted on the right-hand side of the chassis beneath the load-bed of trailer CRF459 (**Figure 22**). The cabinet that was furthest forward housed the incoming power supply breaker, distribution circuit and a changeover switch that allowed the fridge unit to be powered by the trailer's own generator or an external supply. The changeover switch was found in the external power supply position. The next cabinet along, housed the compressor motor starting circuits. The third cabinet housed the control circuits and contactors for the chiller fan motors. A separate cabinet further forward contained a temperature data logging unit.

Electrical control and power distribution boxes

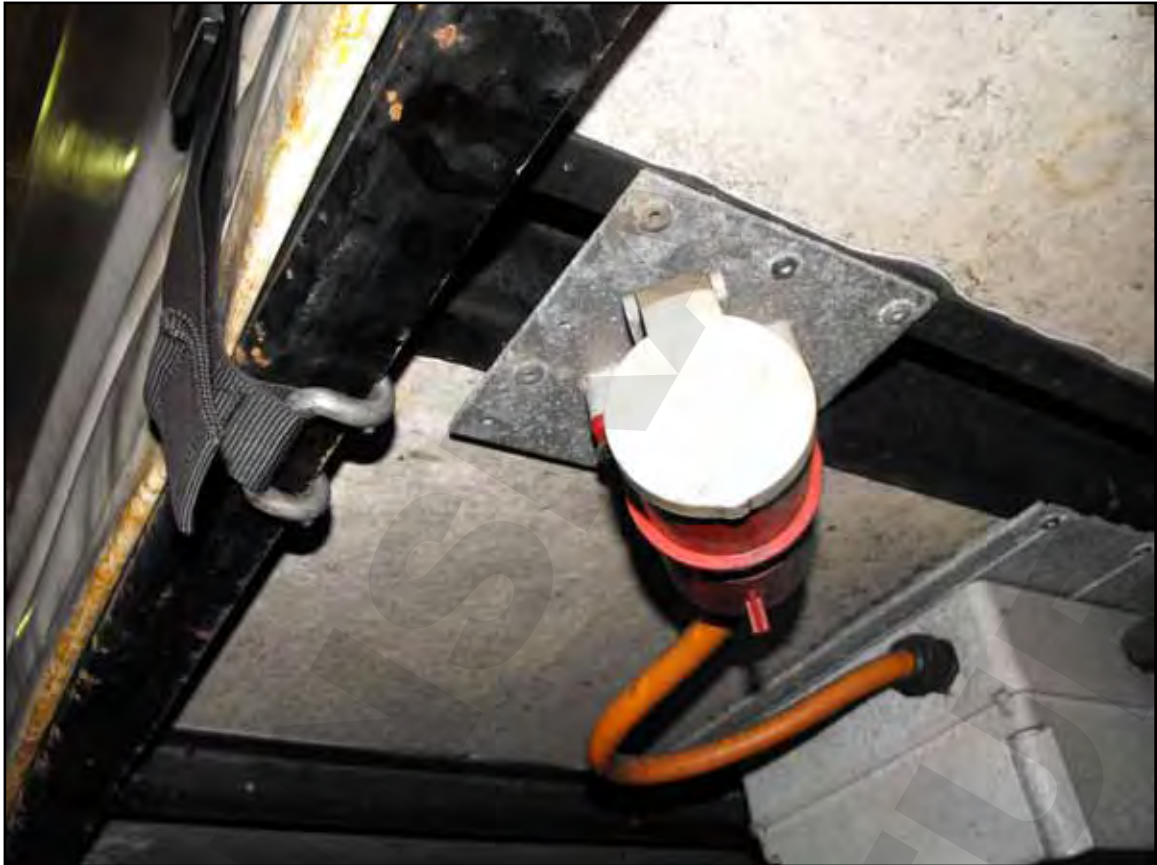
The socket for an external power supply was mounted to the underside of the load-bed to the rear of the three cabinets (**Figure 23**). The socket was connected to a phase changing device, which automatically sensed the phase rotation of the power supply and corrected it to suit the correct rotation of the compressor motor.

External power supply socket

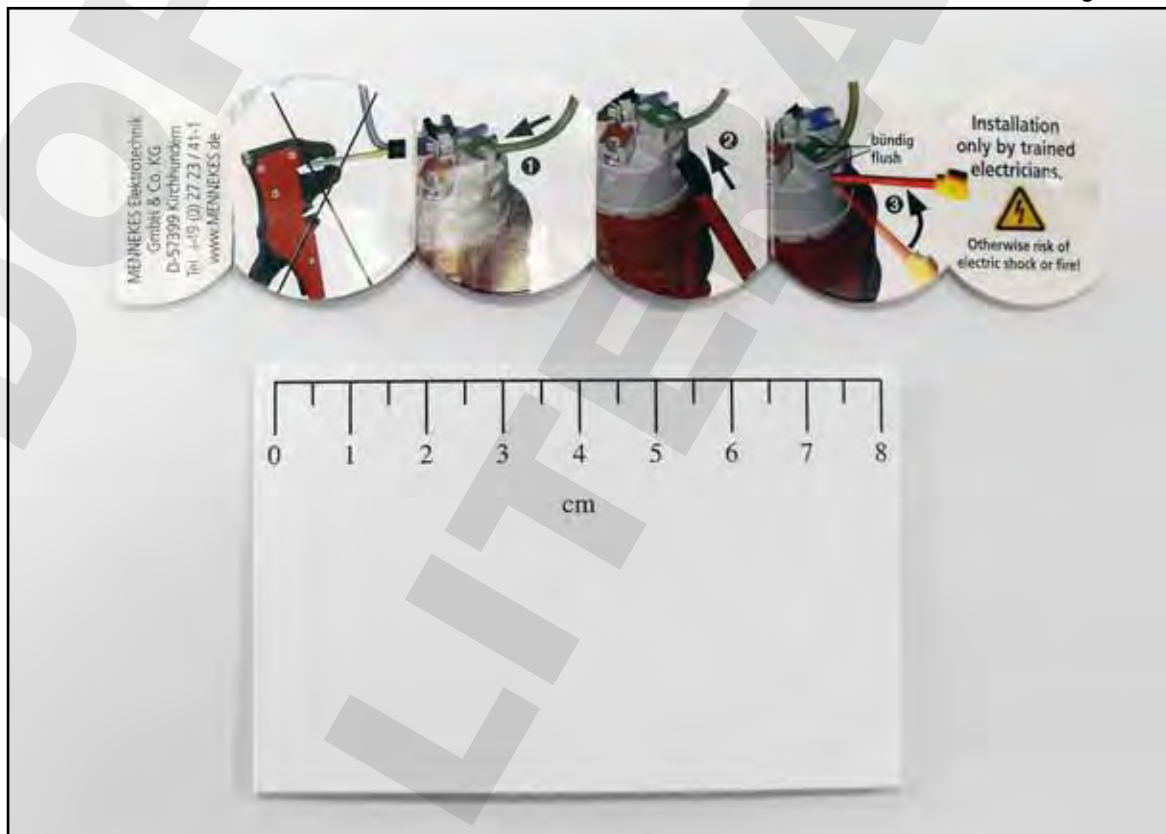
Figure 28

The StarTop plugs were suitable for up to 440V and 32A and were IP44 rated. The cable cores used on *Commodore Clipper* were the maximum size that the StarTop IDC terminals could accommodate. Each plug was supplied with a small instruction leaflet (**Figure 28**) that was secured to the terminals inside each plug assembly and indicated that insulation should not be removed from the conductors. Instead, each core of the cable should be inserted into the plug and the cap pushed down by hand or levered into place using a screwdriver. This forced the cable core into the IDC and cut the insulation, securing the conductor to the terminal. In practice, a considerable amount of force was required to achieve this successfully when using the maximum cable size.

StarTop plug instruction leaflet

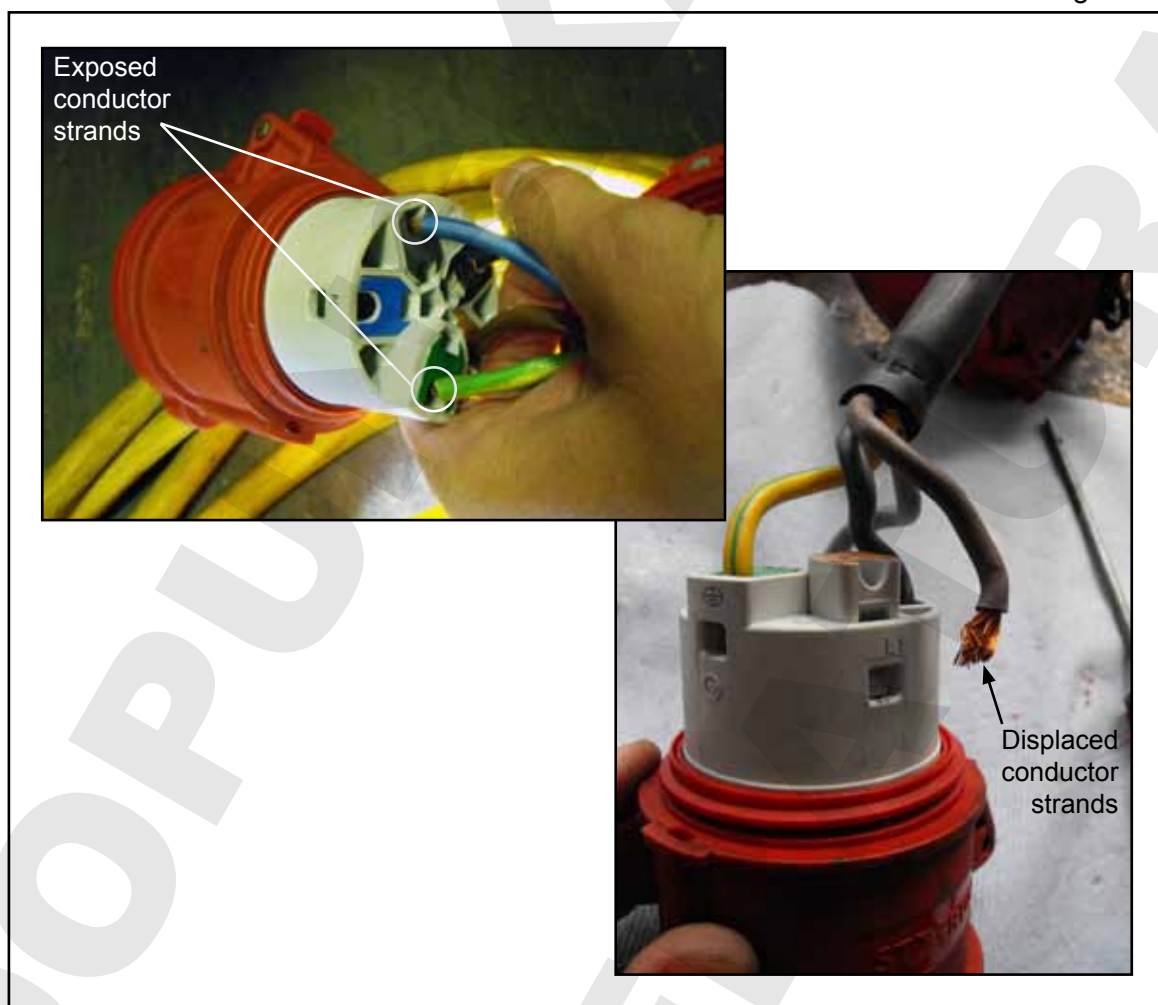
Figure 29

The three other examples of reefer cables found on board *Commodore Clipper*, that were fitted with StarTop plugs, were examined (**Figure 29**). In each case, the insulation had been removed from the ends of the cable cores before they had been inserted into the IDC. It is normal practice to remove insulation for a traditional screw terminal, but when using an IDC, the insulation is required to support the strands of the conductor and secure them in position. In the undamaged examples, the strands of the conductors were found to be displaced and at risk of not making adequate contact with the terminal. This would have been exacerbated if the cable gland became loose and the handling loads were transferred to the terminals.

Other StarTop plug connections assembled on board *Commodore Clipper*

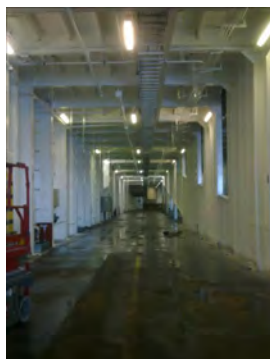
After fire

Repaired: Fire damage was repaired, as necessary, as detailed in the following report. Smoke affected zones were washed down with fresh water.

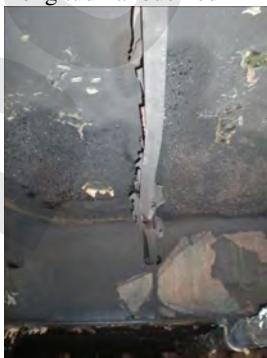
Longitudinal buckled

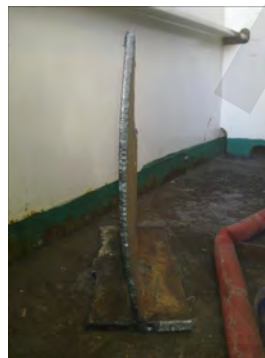
Section of cropped deep frame

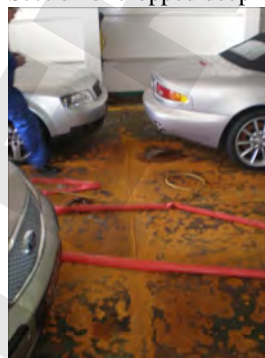
Upper Vehicle Deck buckled

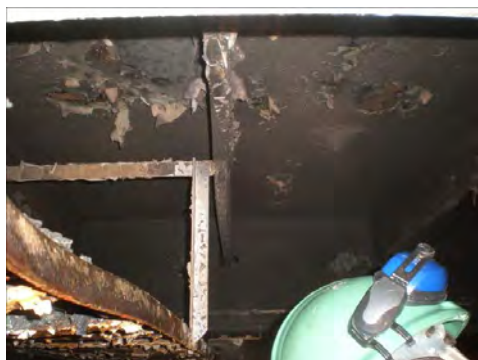
Longitudinal buckled

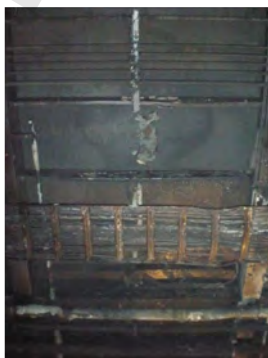
- Main Vehicle Deck (deck3), port side main cable tray buckled and cable insulation destroyed, between frames 74 and 77.
- Forward switchboard, both power supplies fire damaged.
- Reefer socket, fuse boxes and breaker cabinets water damaged.

Fire damaged cable tray

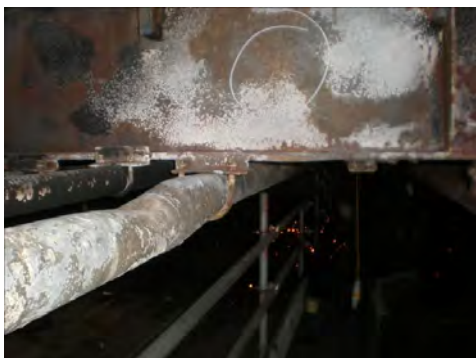
Main Vehicle Deck (deck3), port side drencher main (zone 4) buckled, between frames 74 and 77.

Buckled drencher main aft of frame 77

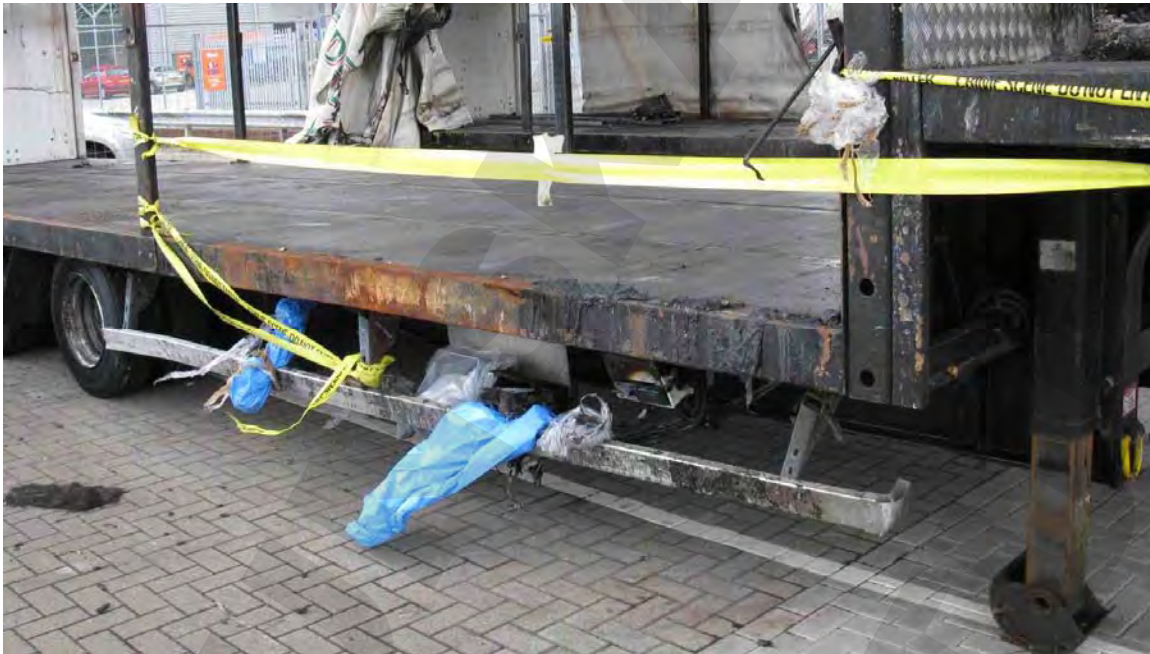
Figure 1 Location of electrical units

A general view of the location of the fire damage to the components under the bed of the trailer is shown in Fig. 1.

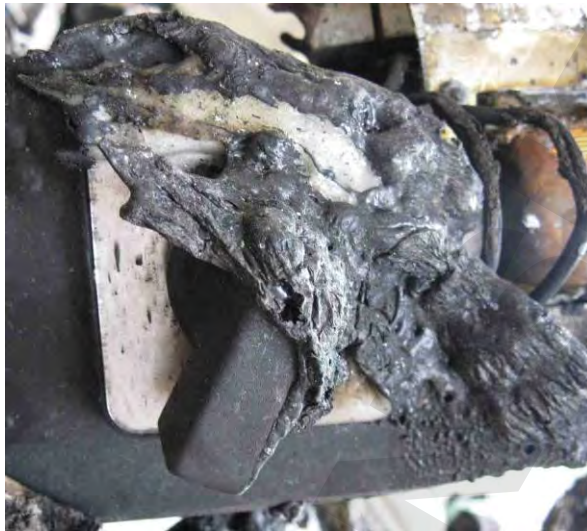
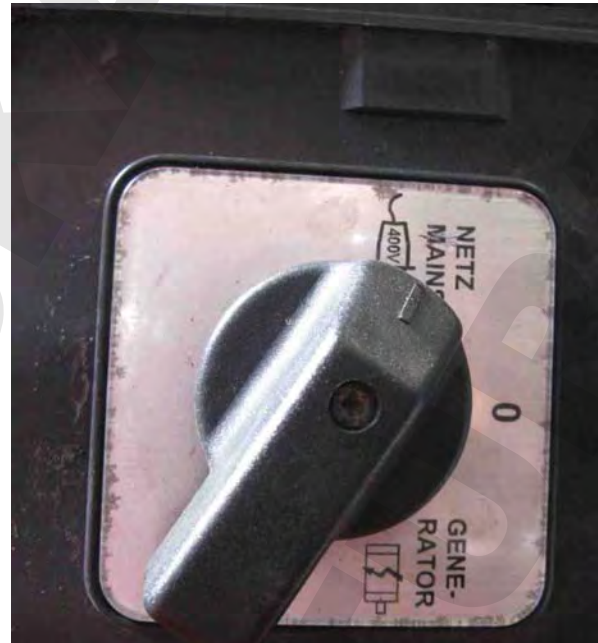
Figure 9 Changeover switches

The changeover switch on the side of the control unit was found to be in the correct position for taking a mains supply from the ship, Fig. 9

Fire damaged

Undamaged

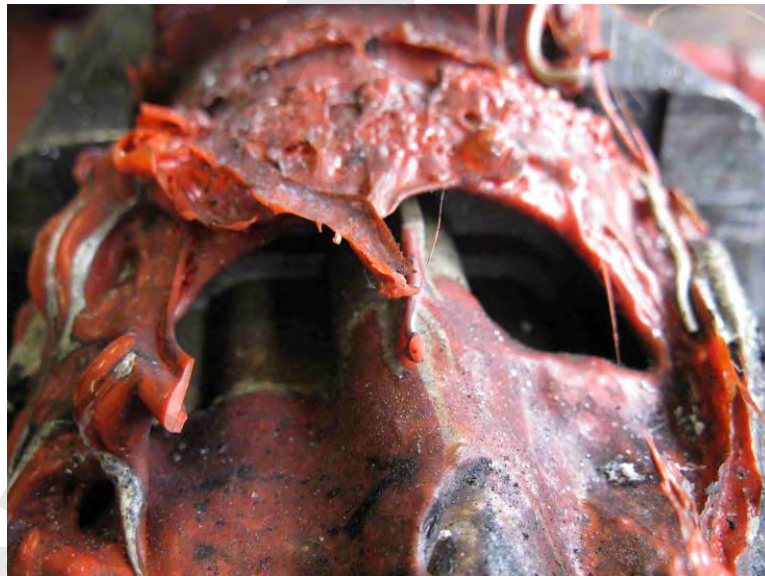
Figure 14 Terminals in fixed plug

The free socket at the trailer end of the cable from the ship's supply was a five-pin, 32 A, Mennekes 'Startop' socket. The trailer mounted plug and the socket were fused together by molten plastic. At the plug end the terminals were visible and did not show any evidence of arcing or severe overheating, Fig. 14. A large portion of the free socket had burned away, Fig. 15. The ends of one of the IDC connectors could be seen emerging from the charred plastic, Fig. 16.

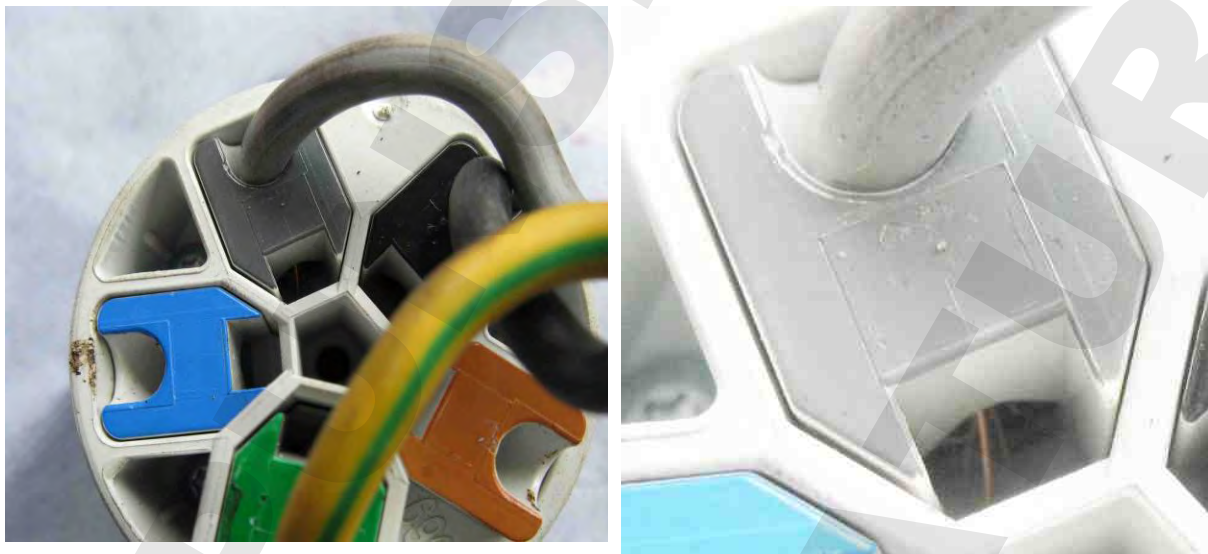
Figure 24 Conductor strands in connector

The other plugs and sockets recovered from the *Commodore Clipper* were examined. Most of these had screw terminals all of which were found to be tight with no evidence of overheating. One of the free sockets, recovered from the *Commodore Clipper*, was a 'Startup' socket with IDC terminals. On examination of this unit it was noted that the ends of some strands could be seen in the connector, Fig. 24. On dismantling the connector it was noted that the insulation appeared to have been stripped from the ends of the cable cores before the cable was inserted into the IDC, Fig. 25. Cobham remade one connection into the IDC without stripping the insulation, Fig. 26.

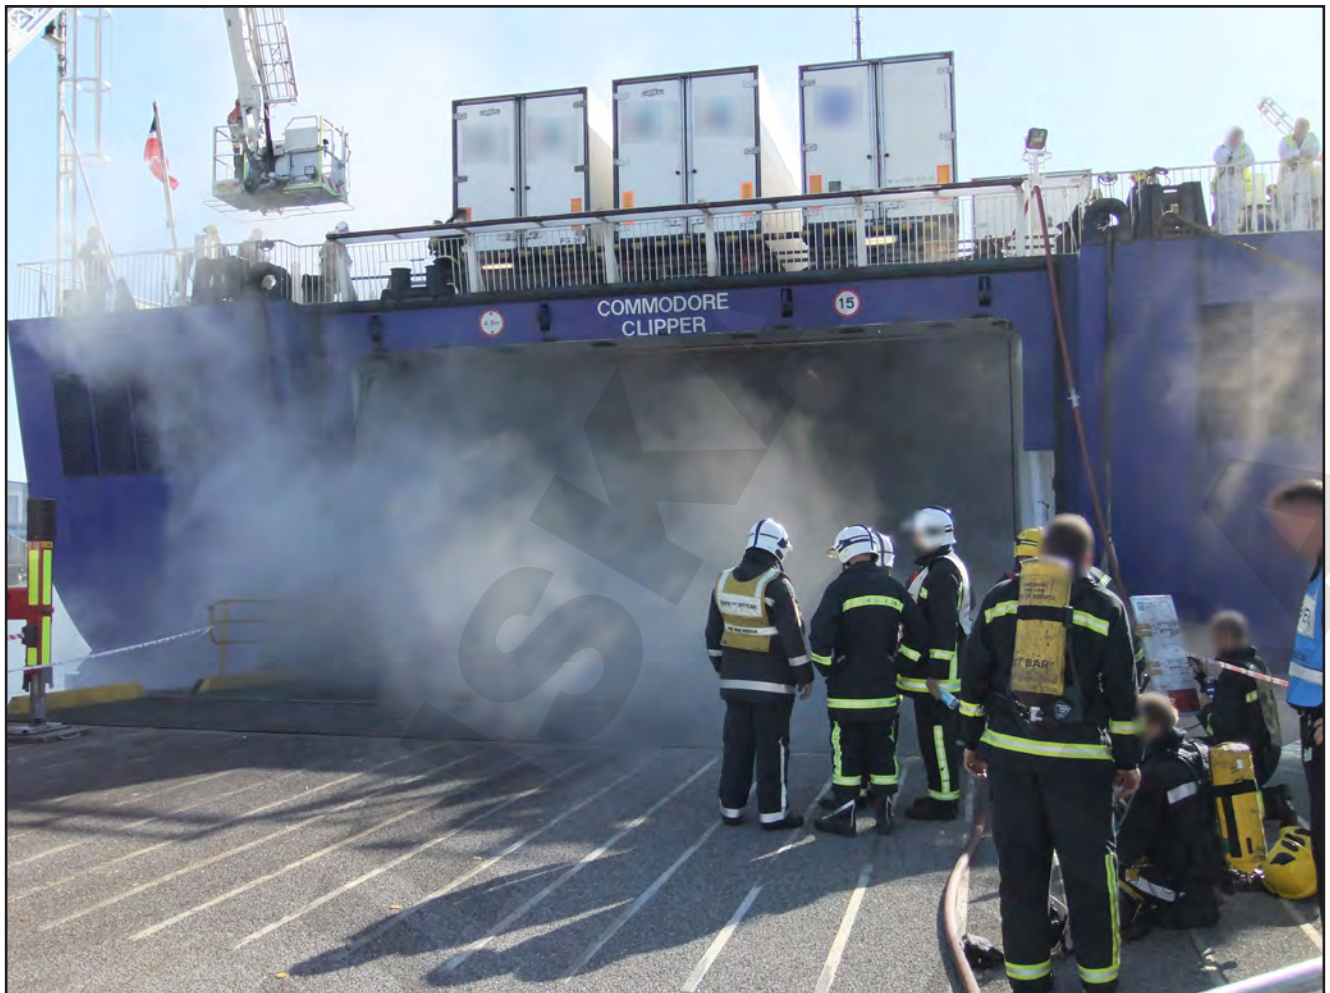
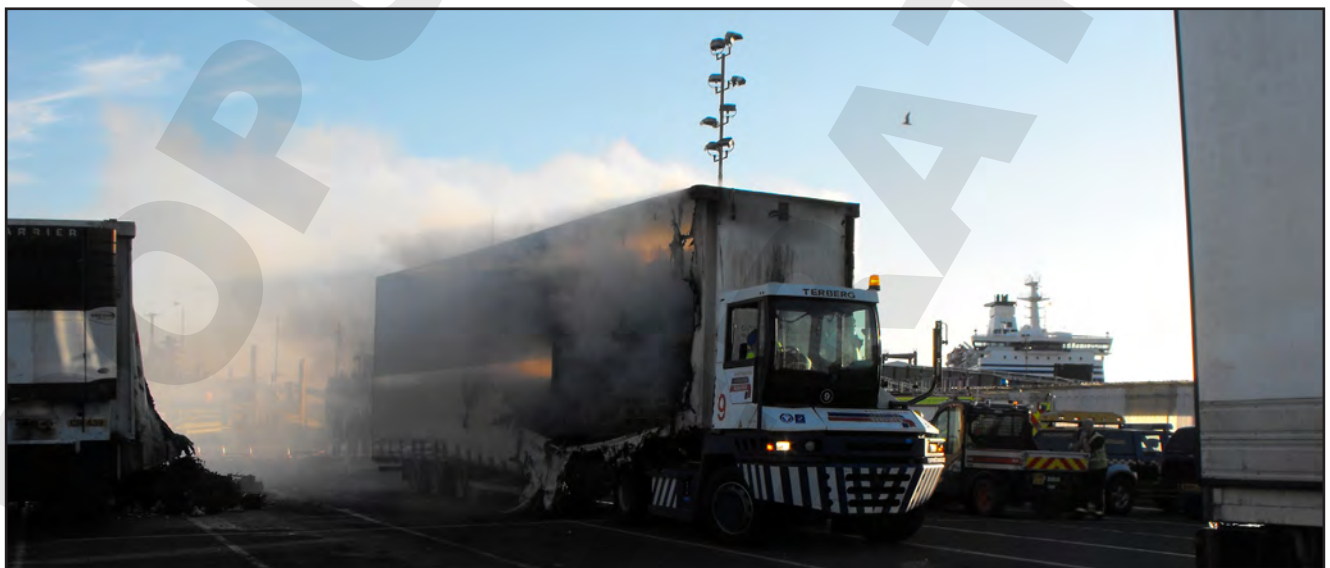
Unprotected cables and pipework running above the fire were soon damaged in the high temperatures that were generated by the burning curtain-side and cargo packaging materials. The vessel lost power to forward mooring deck winches and bow thrusters, control of the rudders was disrupted and the port rudder suddenly moved hard to starboard. Loose cargo partially blocked the deck drains and drencher water caused *Commodore Clipper* to list. Drenching was stopped while water drained to prevent further risk to the vessel's stability, but each time it was stopped, the fire grew in intensity.
