(wafer2,2,0,-1,-1,0,1) Characteristics

Summary

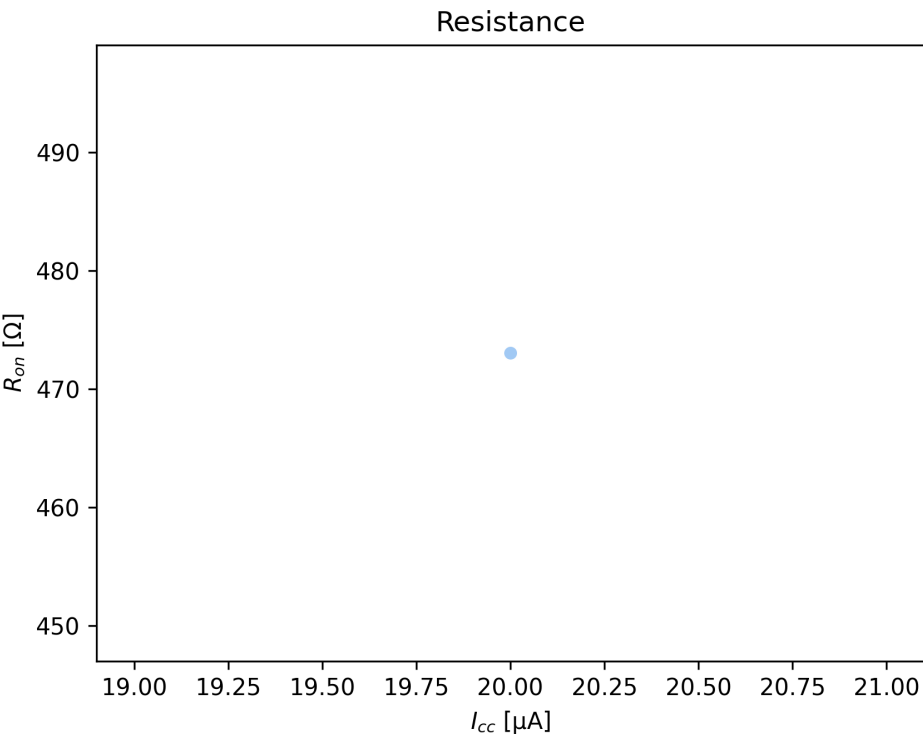
form

- **Time:** 04:01:03PM
- **Icc:** 20.0uA
- **Voltage Range:** 0V \rightarrow 5V
- **Target Ramp Rate:** 1V/s
- **True Ramp Rate:** 1.836 V/s*
- **Cycle:** 1
- **Error:** Set failed

Probe A on copper, B on platinum. Already set. Possibly due to minor layer short in wafer, around countour edge of bottom platinum layer.
