## Vehicle Data

Vehicle Type	PASSENGER VEHICLE	Registration Number	675513144
Manufacturer	MERCEDES-BENZ		
Model	C CLASS SEDAN	Paint Finish	C - COMMON
VIN	WDD2040082R088866	Fuel	DIESEL
Year Model	2009	Transmission	AUTOMATIC
Km Reading	238,574 KM	Doors	4
Cab / Body Type	SEDAN	Color	SILVER

## General Condition

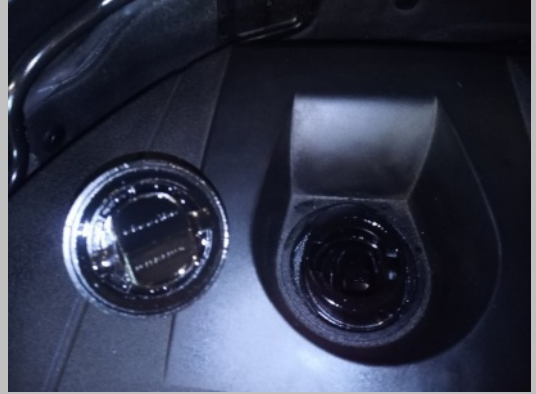
Oil cap

Components	Condition	Inspection Result
Engine-Oil	Very Good	The engine-oil level is normal with no visible signs of contamination.
Engine Cooling System	Very Good	The cooling system is without testable defects. The coolant level is normal.
Oil loss engine	Very Good	The engine is without visible oil leak.
Oil loss gearbox, drive shaft	Very Good	The gearbox and/or drive shafts are without visible oil loss.
Exhaust System	As Expected	The exhaust system shows signs of damages and/or rust, the functionality is not affected.
Gearshift, clutch, automatic transmissions (road test)	Very Good	During the road test no deficiencies were detected on gearshift, clutch, automatic transmissions.
Noise Levels Engine	Poor	During the road test atypical noises were detected. This may impact the performance of the vehicle and result in mechanical failure if not attended to.
Noise Levels Transmissions	Very Good	During the road test no atypical noises were detected.

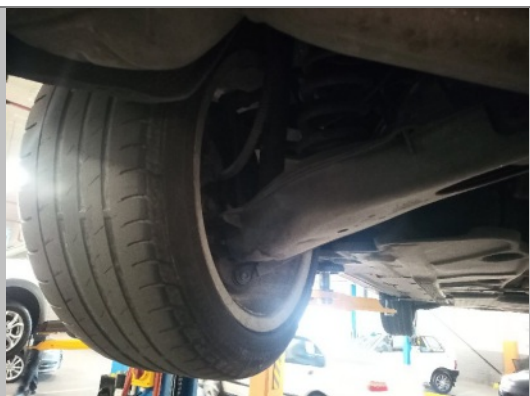
LR TYRE TREAD

Size	Load/Speed Index	Manufacture	Model	Type*	Production Date	Tread Depth (mm)
Front Left	225/45R17	91W	Continental	Contact	V	1514	1 mm
Front Right	225/45R17	91W	Continental	Contact	V	2914	0 mm
Rear Left	245/45R17	91W	Continental	Contact	V	3314	2 mm
Rear Right	245/40R17	91W	Continental	Contact	V	3314	2 mm
Spare	225/45R17	91W	Continental	Contact	V	0000	0 mm

Tyre tread depth minimum 1mm according to National Road Traffic Act 93 of 1996.
