Assignment

Client We Buy Cars

Vehicle Type	PASSENGER VEHICLE	Registration Number	987911674
Manufacturer	MERCEDES-BENZ		
Model	C CLASS SEDAN	Paint Finish	C - COMMON
VIN	WDD2040022R148261	Fuel	DIESEL
Year Model	2010	Transmission	AUTOMATIC
Km Reading	167,130 KM	Doors	4
Cab / Body Type	SEDAN	Color	WHITE

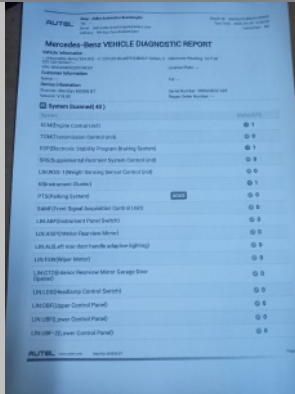
Diagnostic report

No	System	Code	Description	Status
1	KI	B210A84	POWER SUPPLY IN SYSTEM IS TOO LOW	STORED

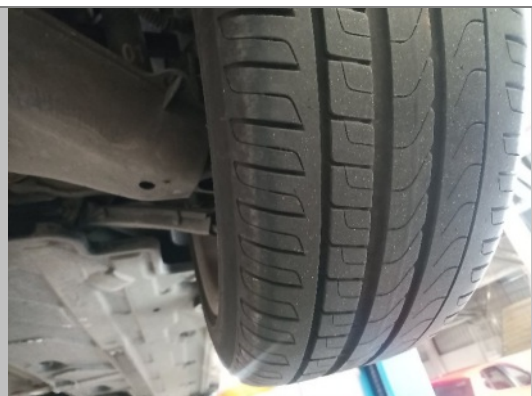
RR TYRE TREAD

Size	Load/Speed Index	Manufacture	Model	Type*	Production Date	Tread Depth (mm)
Front Left	225/45R17	91W	CONTINENTAL	SPORT	V	1417	0 mm
Front Right	225/45R17	91W	CONTINENTAL	SPORT	V	1417	0 mm
Rear Left	225/45R17	94W	MAXTREK	MAXIMUS	V	////	5 mm
Rear Right	225/45R17	91W	PIRELLI	CINTURATO	V	0920	5 mm
Spare	225/45R17	91W	PIRELLI	CINTURATO	V	////	5 mm
