NAKUJA PROJECT
DESIGN.MAKE.LAUNCH

N-3 Launch report

27th February 2024

Nakuja Project

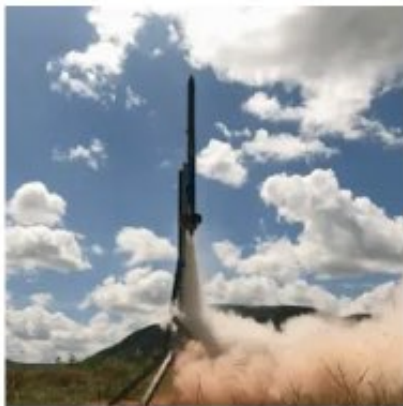
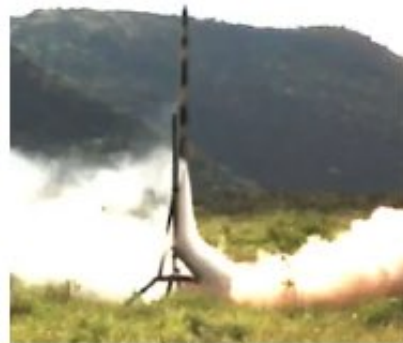
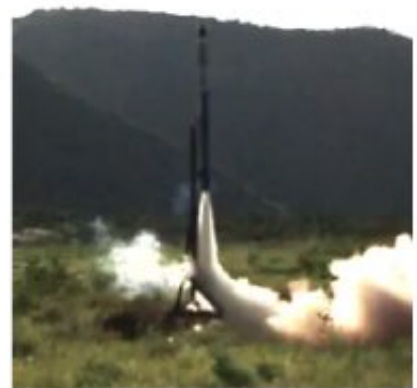
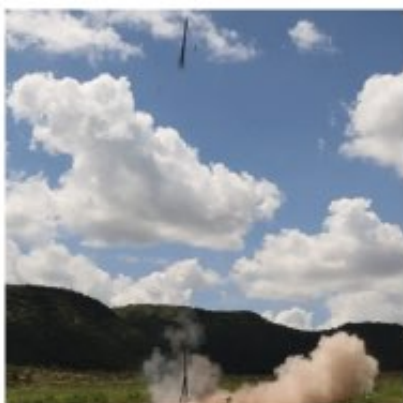
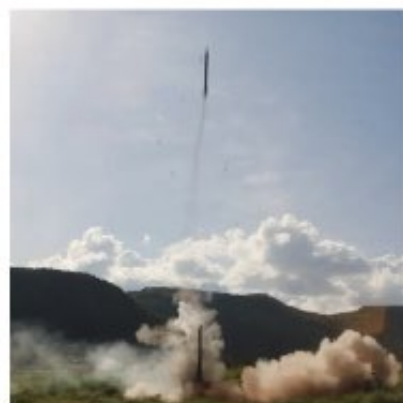
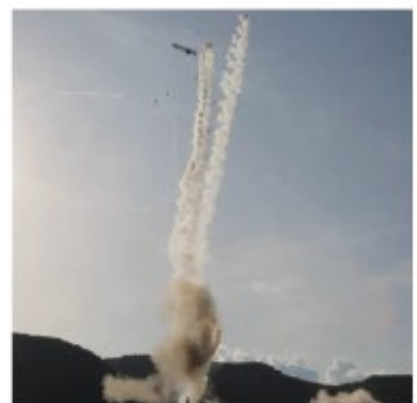
Figure 6. Rocket launch videos

The lesson to be learned to improve the quality of the shot is to point the camera at the launch pad to avoid the afternoon sun..

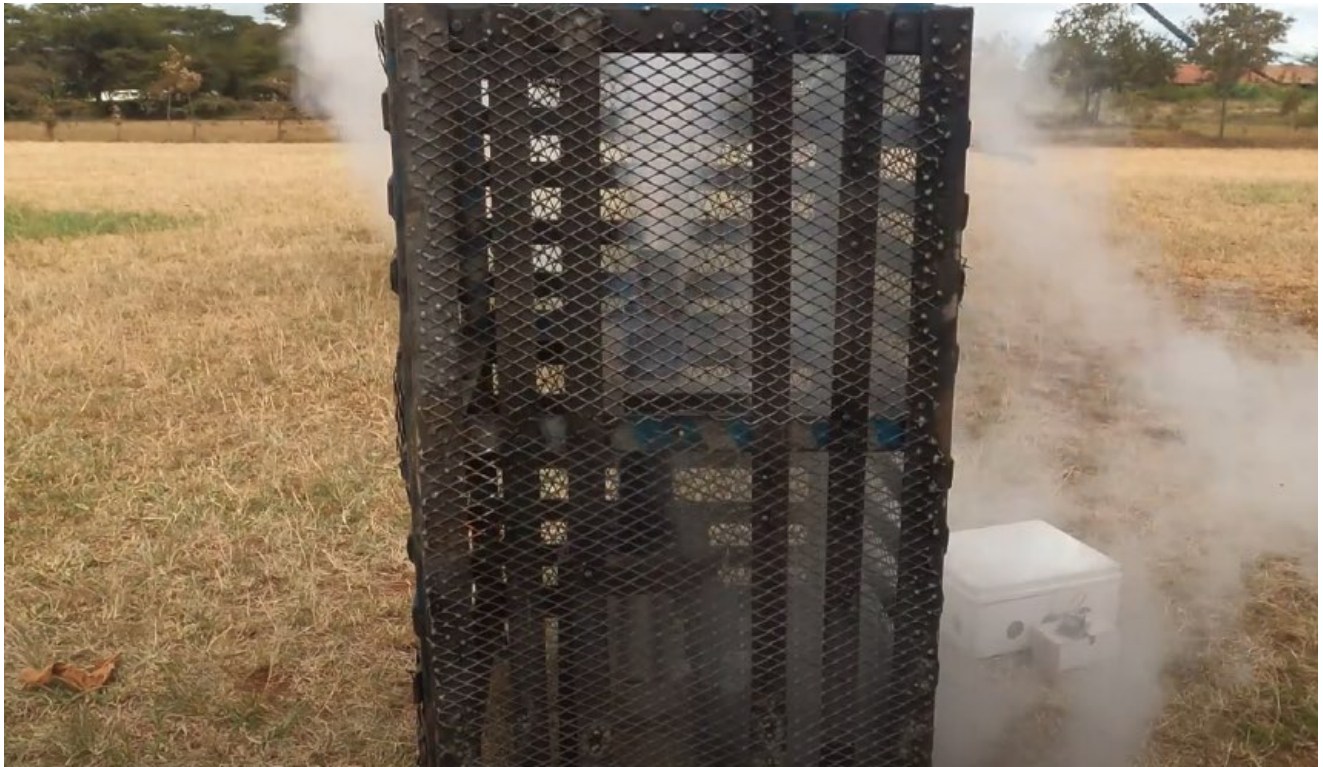
Figure 20. Static test of the improve solid rocket motor

The team conducted a static test to confirm the upgraded solid rocket motor, as shown in Figure 20. The thrust curve obtained in the test is shown in Figure 21.

Based on the findings, the team replaced the bolts with steel bolts and conducted a static test, where they successfully confirmed that the revised motor worked.
