Installation / Location	PS-3
Subject	Corrosion Monitoring Activities
Contract Number	LC241047A0
Assigned Axxess Representatives	Stuart Dunthorne
Date of Issue	18-07-2025

Activities Summary

Work activities were completed today, with Coupon and ER Probe locations being serviced on PS3-D Upper Deck and Main Decks. We also returned to PS3-B to install a new ER Probe at 1 location where there was a handrail obstruction. Further details as follows.

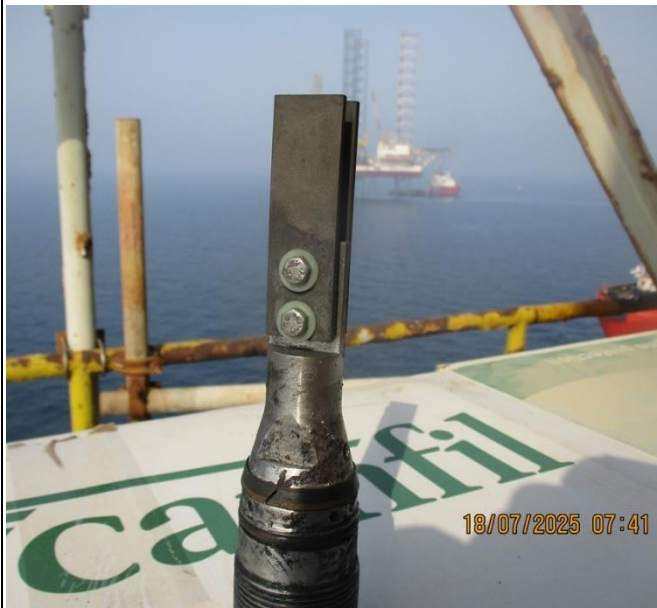
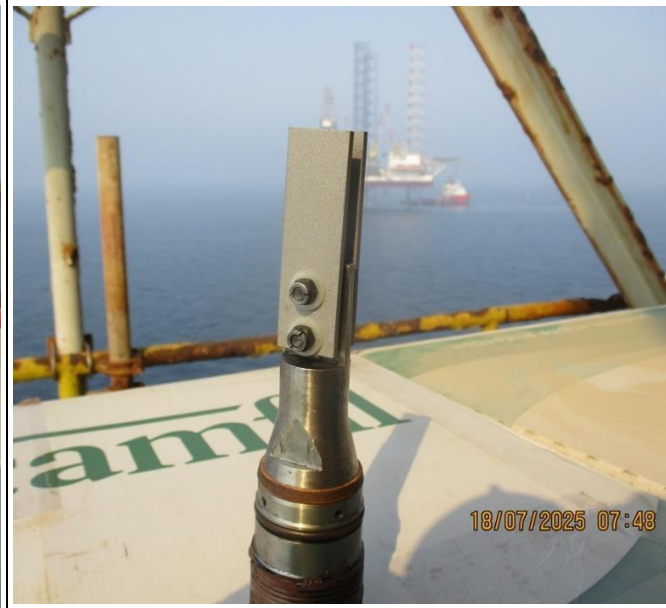
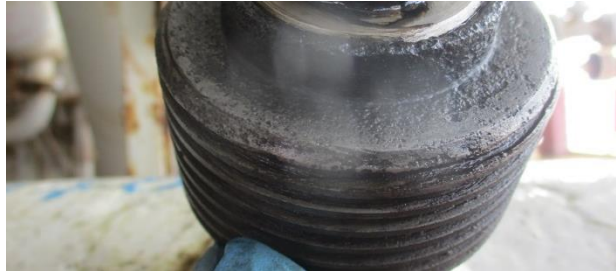
Tag No	Line No / Description	Pressure (psi)	A/F Orientation	Scope of Work	Retrieved Coupons ID / Holder Length	Coupon Appearance	Installed Coupons ID / Weight / Material / Date	Tool Used	Location Access	Remedial Actions
43-XCC-171	10-GP-430032 10" Vapor Gas Export to PS-1 (Right Hand Side A/F)	800psi	11 o Clock	Replace 3" Strip Coupons	MP983 & MP984 3.50" Holder	Dark in colour Minimal Corrosion Observed	NE622 – 36.7233 NE623 – 36.8286 C1018 18-07-2025	25"	Access OK	Repair Sealing Face
Access Fitting Photograph				Retrieved Coupons / Device Photograph			Installed Coupons / Device Photograph

Comments Although the location was serviced, the Access Fitting sealing face is in poor condition, with widespread pitting. This can become problematic during the retrieval process if a good seal between the Service Valve and sealing face is not maintained. It is recommended that the Access Fitting be replaced during shutdown, or the existing fitting be repaired/refaced during normal operations.

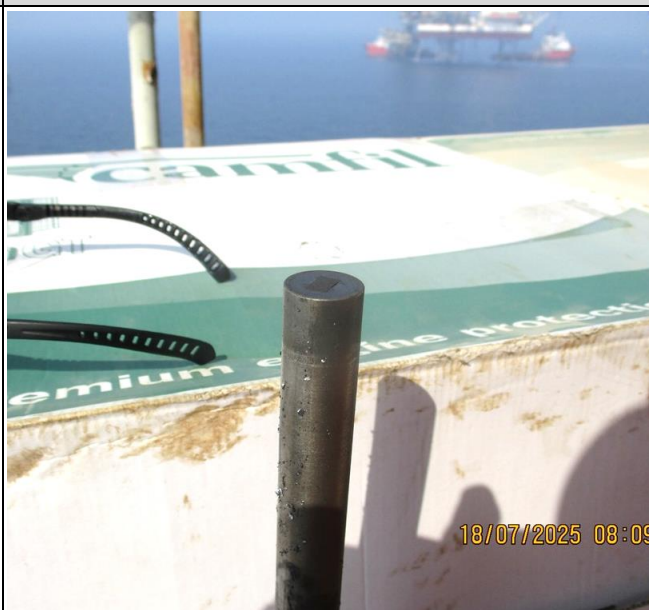
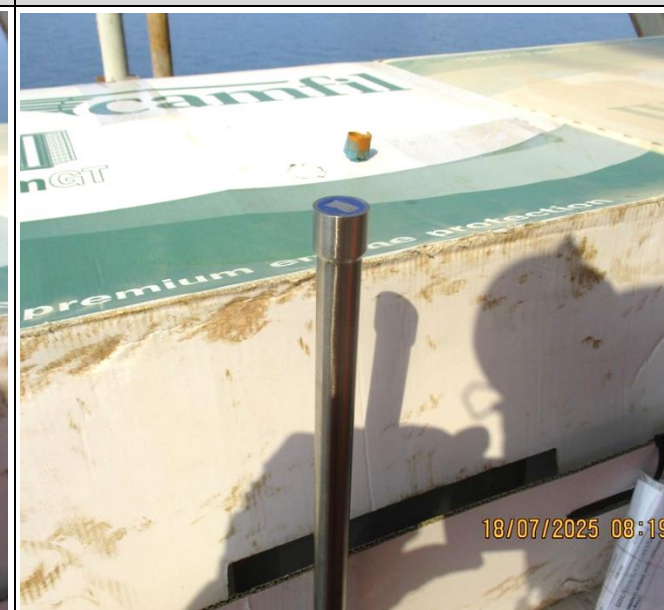
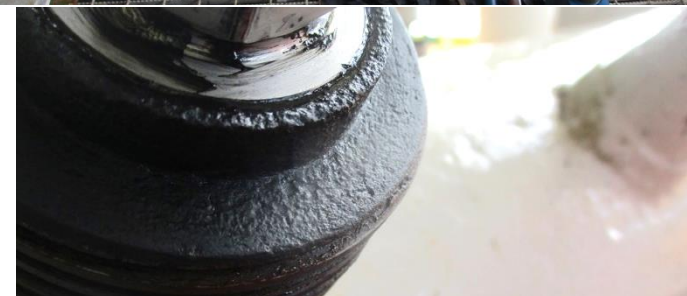
Tag No	Line No / Description	Pressure (psi)	A/F Orientation	Scope of Work	New Probe Size / Specification	Probe Readings	Date	Tool Used	Location Access	Remedial Actions
43-XCP-170	<u>10-GP-430032</u> 10" Vapor Gas Export to PS-1 (Middle A/F)	800psi	11 o Clock	Install New ER Probe	10.5" Flush Strip 4705-S8-K03005-10.50-0	Check – 814 Div – 69.3 M.Loss – 0.138 CR – N/A	18-07-2025	25"	Access OK	Repair Sealing Face

Although the location was serviced, the Access Fitting sealing face is in poor condition, with widespread pitting. This can become problematic during the retrieval process if a good seal between the Service Valve and sealing face is not maintained. It is recommended that the Access Fitting be replaced during shutdown, or the existing fitting be repaired/refaced during normal operations.

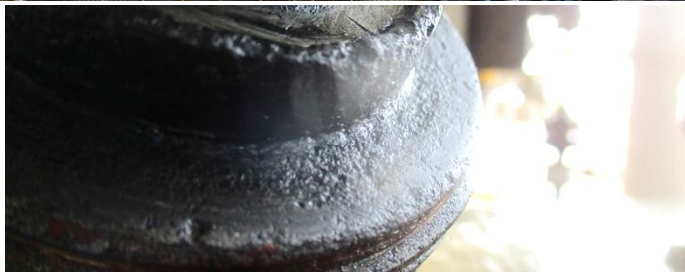
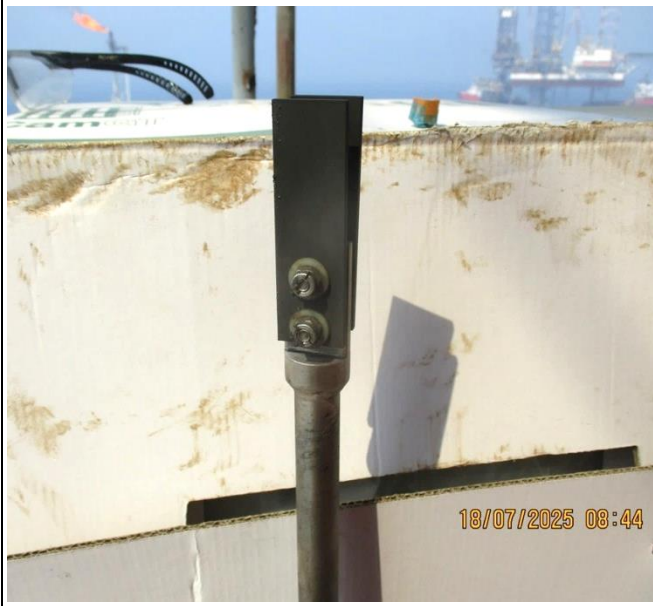
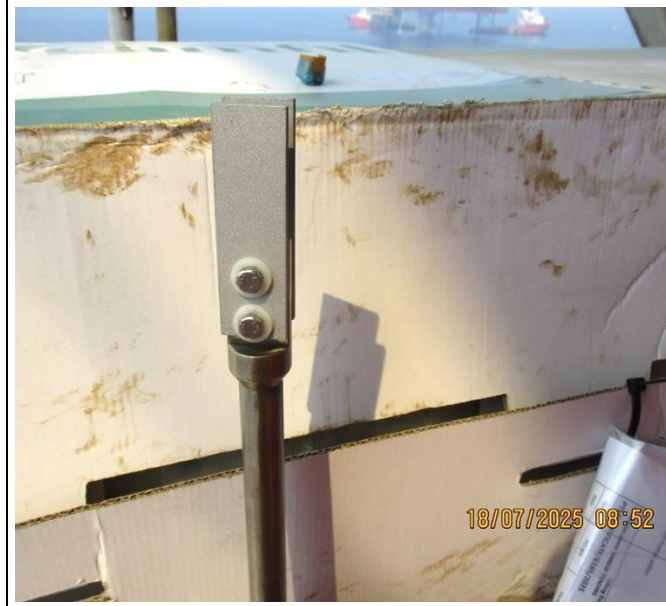
Tag No	Line No / Description	Pressure (psi)	A/F Orientation	Scope of Work	Retrieved Coupons ID / Holder Length	Coupon Appearance	Installed Coupons ID / Weight / Material / Date	Tool Used	Location Access	Remedial Actions
43-XCC-169	10-GP-430032 10" Vapor Gas Export to PS-1 (Left Hand Side A/F)	800psi	11 o Clock	Replace 3" Strip Coupons	MP981 & MP982 9.50" Holder	Dark in colour Minimal Corrosion Observed	NE624 – 37.0274 NE625 – 37.0795 C1018 18-07-2025	25"	Access OK	Repair Sealing Face
Access Fitting Photograph				Retrieved Coupons / Device Photograph			Installed Coupons / Device Photograph

Comments Although the location was serviced, the Access Fitting sealing face is in poor condition, with widespread pitting. This can become problematic during the retrieval process if a good seal between the Service Valve and sealing face is not maintained. It is recommended that the Access Fitting be replaced during shutdown, or the existing fitting be repaired/refaced during normal operations.

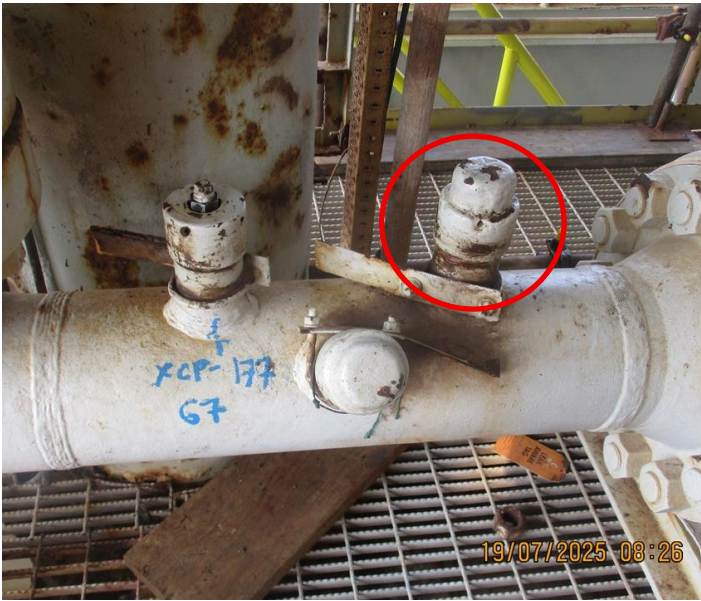
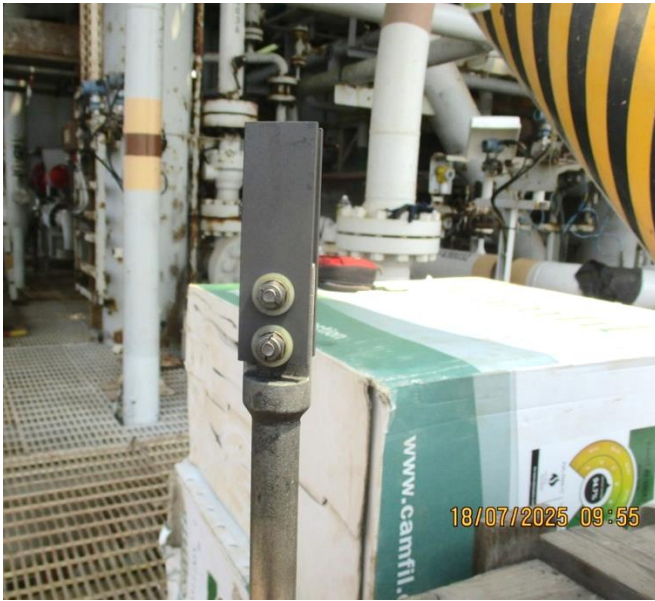
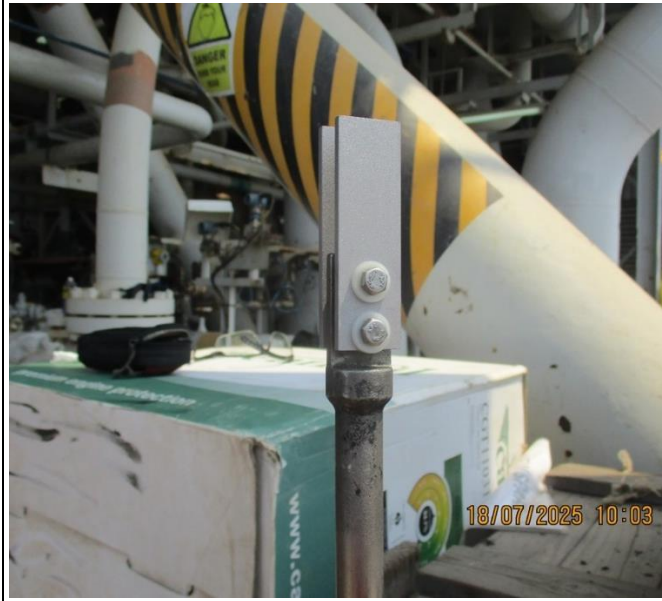
Tag No	Line No / Description	Pressure (psi)	A/F Orientation	Scope of Work	Retrieved Coupons ID / Holder Length	Coupon Appearance	Installed Coupons ID / Weight / Material / Date	Tool Used	Location Access	Remedial Actions
43-XCC-176	8-P-430070-9144 8" Liquid Export Line to PS-1 (Right Hand Side A/F)	300psi	11 o Clock	Replace 3" Strip Coupons	MQ007 & MQ008 7.00" Holder	Dark in colour Minimal Corrosion Observed	NE626 – 36.9555 NE627 – 36.6822 C1018 18-07-2025	25"	Access OK	None Required
Access Fitting Photograph				Retrieved Coupons / Device Photograph			Installed Coupons / Device Photograph

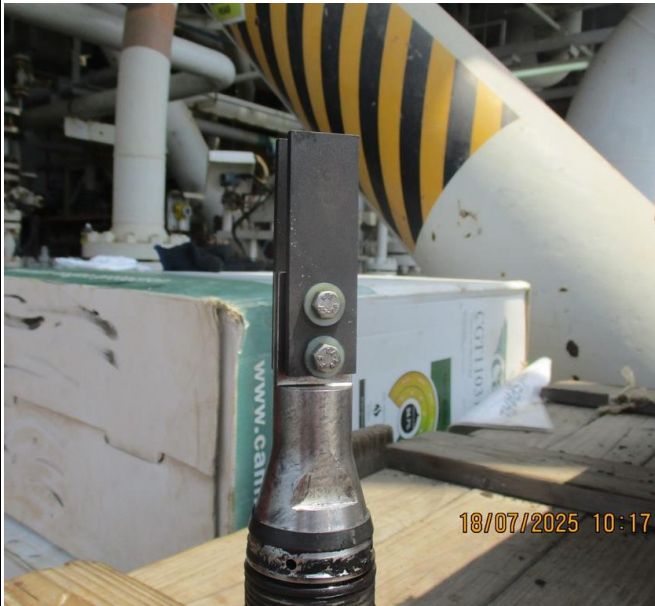
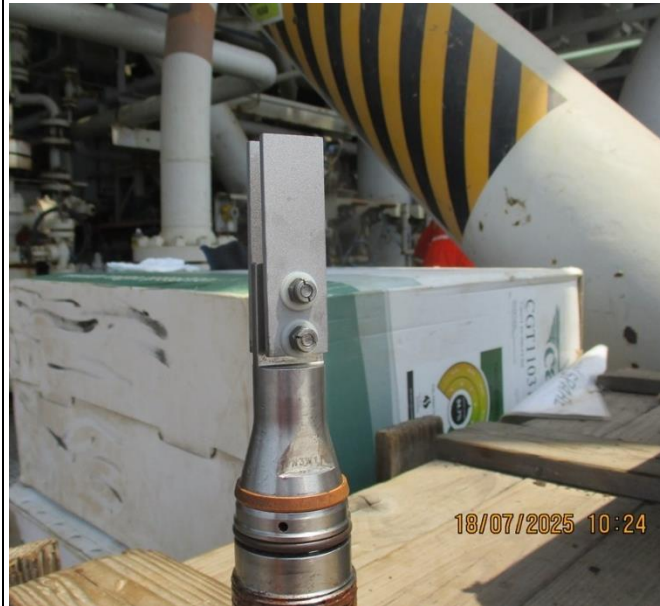
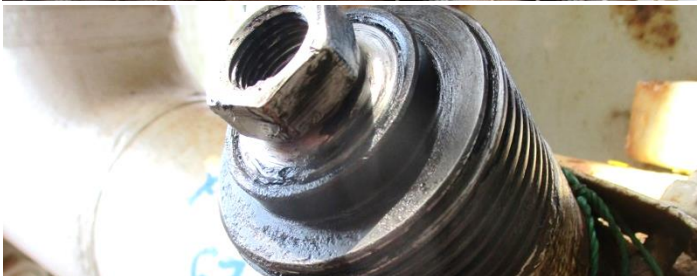
Tag No	Line No / Description	Pressure (psi)	A/F Orientation	Scope of Work	Retrieved Coupons ID / Holder Length	Coupon Appearance	Installed Coupons ID / Weight / Material / Date	Tool Used	Location Access	Remedial Actions
43-XCC-300	8-P-430070-9144 8" Liquid Export Line to PS-1 (Middle A/F)	300psi	11 o Clock	Replace 3" Strip Coupons	MQ009 & MQ010 3.00" Holder	Dark in colour Minimal Corrosion Observed	NE368 – 37.0628 NE369 – 36.9566 C1018 18-07-2025	25"	Access OK	Repair Sealing Face
Access Fitting Photograph				Retrieved Coupons / Device Photograph			Installed Coupons / Device Photograph

Comments Although the location was serviced, the Access Fitting sealing face is in poor condition, with widespread pitting. This can become problematic during the retrieval process if a good seal between the Service Valve and sealing face is not maintained. It is recommended that the Access Fitting be replaced during shutdown, or the existing fitting be repaired/refaced during normal operations.

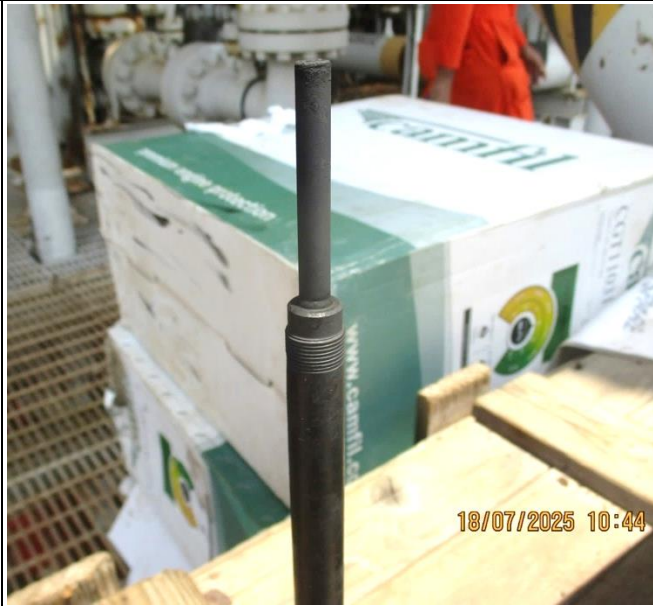
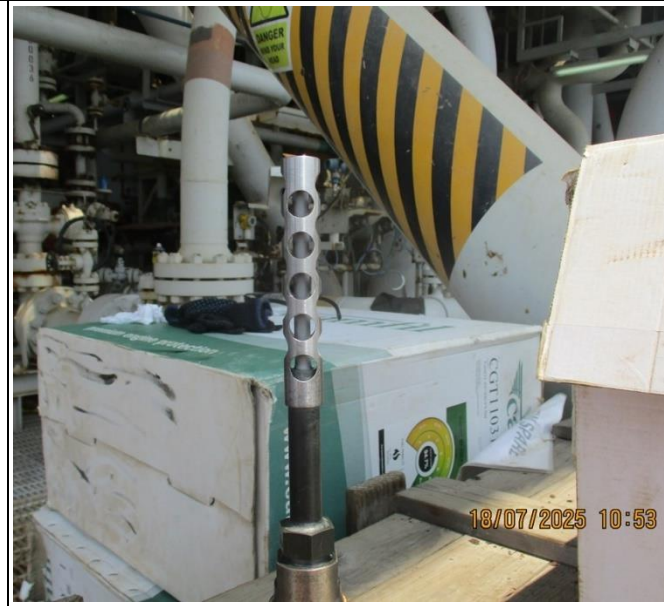
Tag No	Line No / Description	Pressure (psi)	A/F Orientation	Scope of Work	New Probe Size / Specification	Probe Readings	Date	Tool Used	Location Access	Remedial Actions
43-XCP-177	8-P-430070-9144 8" Liquid Export Line to PS-1 (Left Hand Side A/F)	300	12 o Clock	Install New ER Probe	7.00" Cylindrical 4500-T20-K03005- 7.00-1-0	Check – 783 Div – 48.8 M.Loss – 0.488 CR – N/A	18-07-2025	25"	Access OK	None Required
Access Fitting Picture				Removed Device		New Probe

18/07/2025 10:53				
Comments Exact specification of probe was not available, so slightly different specification was installed. Removed probe was 8.5" T10. The Checkmate handheld device was set up with the new specification of element. This location has also suffered pitting on the sealing face so it should be repaired as soon as possible.

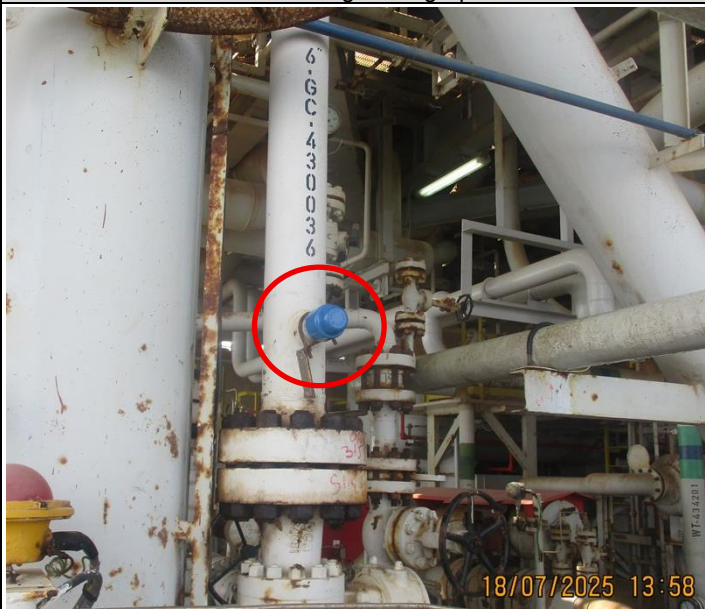
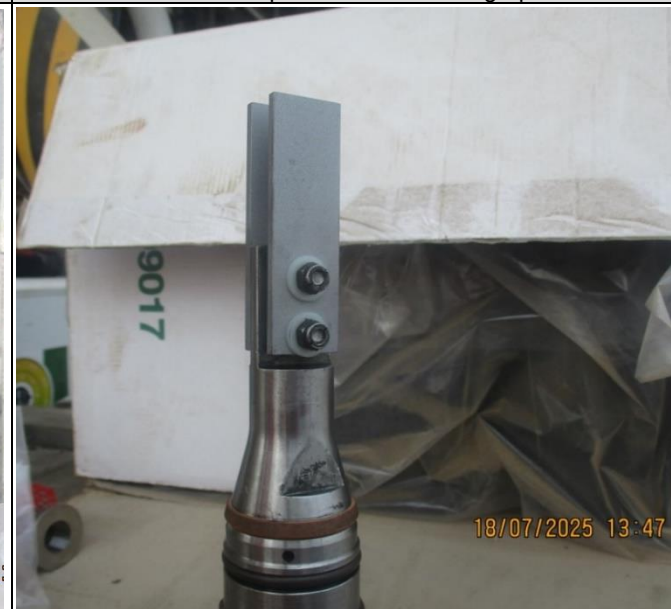
Tag No	Line No / Description	Pressure (psi)	A/F Orientation	Scope of Work	Retrieved Coupons ID / Holder Length	Coupon Appearance	Installed Coupons ID / Weight / Material / Date	Tool Used	Location Access	Remedial Actions
43-XCC-178	6-GC-430036 6" Liquid Line	300psi	9 o Clock	Replace 3" Strip Coupons	MP735 & MP736 3.00" Holder	Dark in colour Scoring marks from internal obstruction Coupon bent	NE370 – 36.9679 NE371 – 36.7598 C1018 18-07-2025	18" must be used	Access OK	Repair fitting internal obstruction
Access Fitting Photograph				Retrieved Coupons / Device Photograph			Installed Coupons / Device Photograph

Comments Although the coupons were successfully retrieved, resistance could be felt during operation of the tool, indicating that something was jamming/catching the installed coupons. Upon closer inspection of the retrieved coupons, mechanical damage could clearly be seen on the edges of the coupons. This would indicate an obstruction within the Access Fitting, most likely weld impingement from the fabrication process. It is recommended that this fabrication defect be repaired during the next available shutdown. This task could probably be completed with just basic hand tools

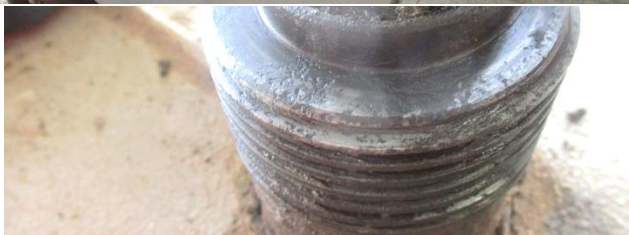
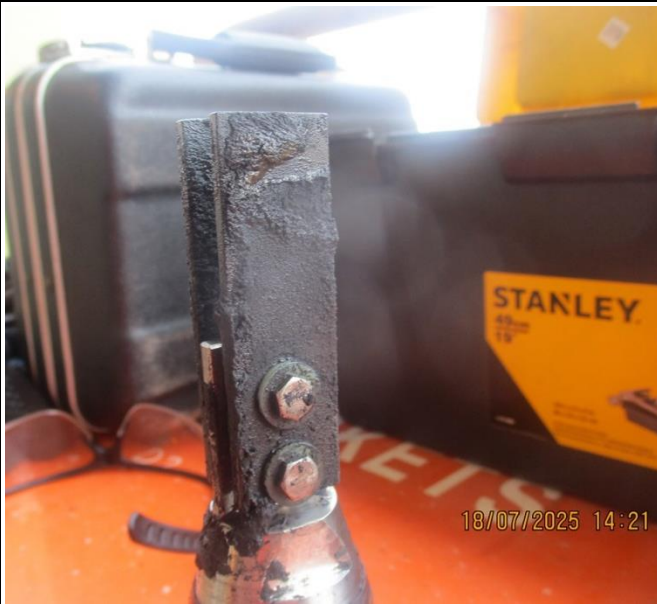
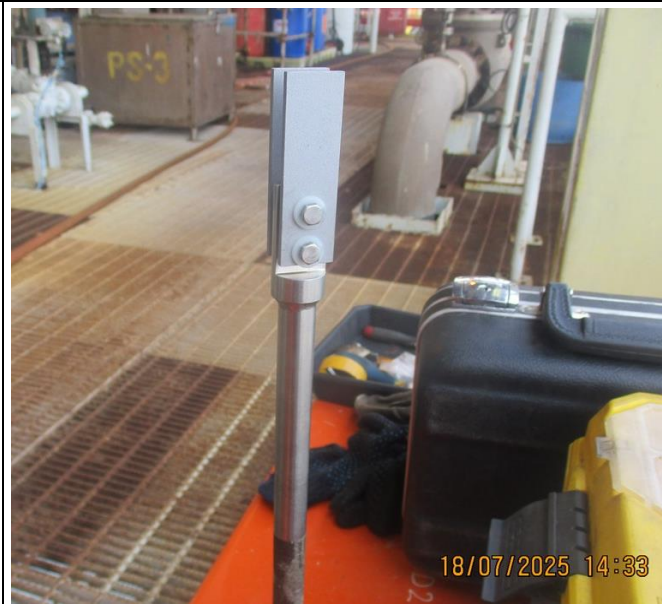
Tag No	Line No / Description	Pressure (psi)	A/F Orientation	Scope of Work	Retrieved Coupons ID / Holder Length	Coupon Appearance	Installed Coupons ID / Weight / Material / Date	Tool Used	Location Access	Remedial Actions
43-XCC-1037	24-GP-430009 24" Gas from V-5536 HP Separator to E-4303 2nd Stage Condenser	150psi	12 o Clock	Replace 3" Strip Coupons	MP985 & MP986 2.12" Holder removed 11.5" Holder installed	Dark in colour Thick wax like substance	NE372 – 36.9714 NE373 – 36.9204 C1018 18-07-2025	25"	Access OK Large scaffold required	None Required
Access Fitting Photograph				Retrieved Coupons / Device Photograph			Installed Coupons / Device Photograph

18/07/2025 14:33			
Comments This location has suffered some pitting on the sealing face so it should be repaired/refaced as soon as possible. The retrieved coupon holder was only 2.12" long so a longer 11.5" holder was installed. An even longer holder could potentially be installed, but this would mean moving up to the 37" Retrieval Tool. Using the 37" tool would however be much more difficult, as the tool would need to be moved up onto the high scaffolding tower.

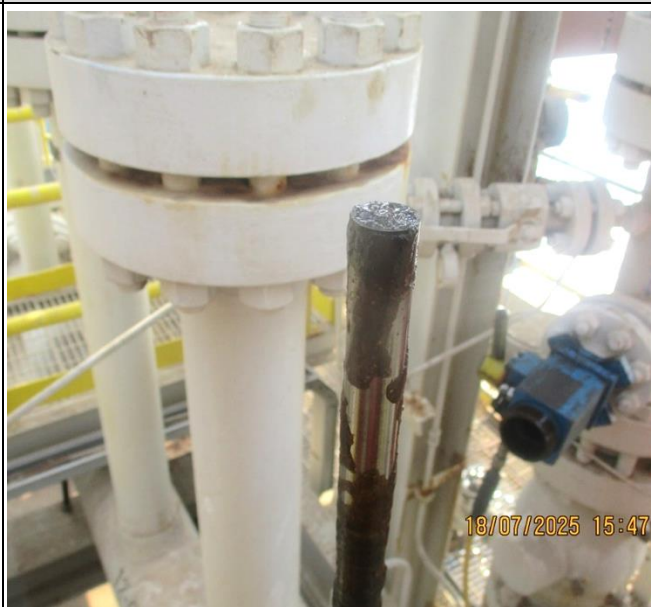
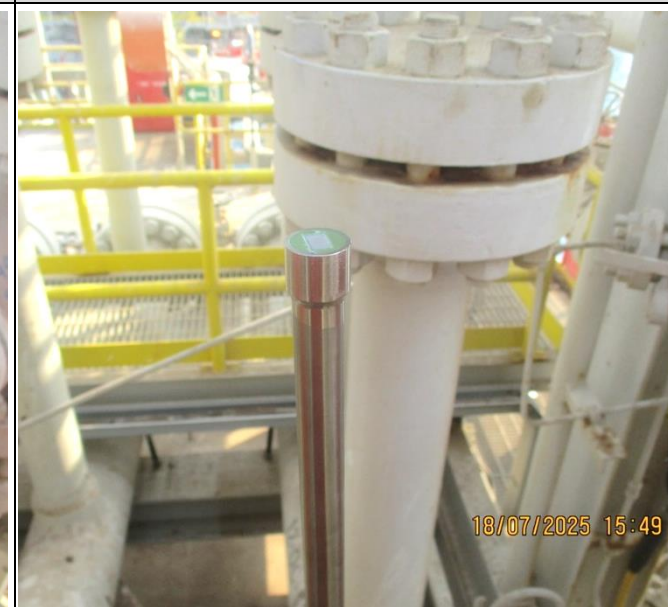
Tag No	Line No / Description	Pressure (psi)	A/F Orientation	Scope of Work	New Probe Size / Specification	Probe Readings	Date	Tool Used	Location Access	Remedial Actions
53-XCP-1169	6-OC-530044-15101 6" Oil from BH-3 WHJ to PS3-B Production Manifold	150psi	9 o Clock	Install New ER Probe	9.5" Flush Strip 4705-S8-K03005-9.75-0	Check – 795 Div – 14.9 M.Loss – 0.059 CR – N/A	18-07-2025	25"	Handrail must be removed	Modification to Handrail

The Access Fitting at this location is obstructed by a handrail. The handrail was successfully removed by the mechanical team, but it took quite some time and proved very challenging. It is recommended that a permanent modification be made to the handrail so future servicing is easier.

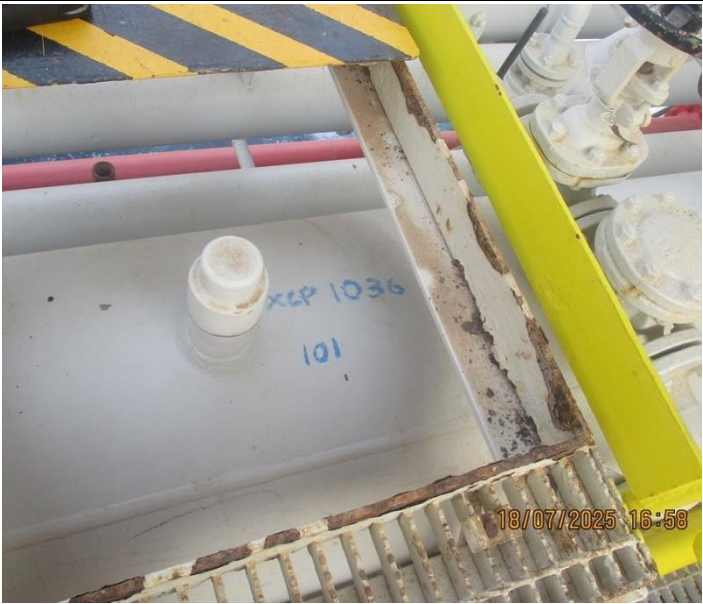
Tag No	Line No / Description	Pressure (psi)	A/F Orientation	Scope of Work	Work Performed	Probe Readings	Date	Tool Used	Location Access	Remedial Actions
43-XCP-1036	24-P-430015-1101 24" Gas Line from HP Gas Header to E4303 2 nd Stage Condenser	N/A	12 o Clock	External Service of Access Fitting	Cap removed, threads brushed and re-greased	Obtained Previously	18-07-2025	N/A	Access OK	None Required
Access Fitting Picture

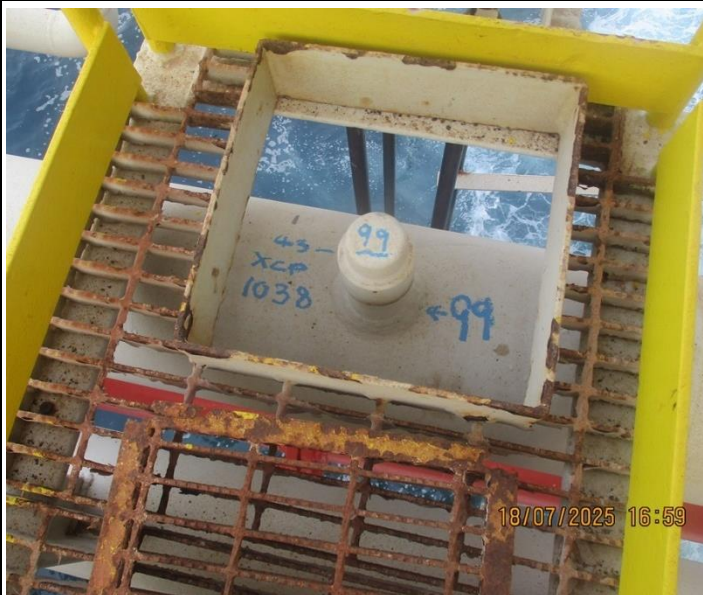
Tag No	Line No / Description	Pressure (psi)	A/F Orientation	Scope of Work	Work Performed	Probe Readings	Date	Tool Used	Location Access	Remedial Actions
43-XCP-1038	12-P-43010-1101 12" Gas Line from MP Gas Header to E4302 2 nd Stage Cooler	N/A	12 o Clock	External Service of Access Fitting	Cap removed, threads brushed and re-greased	Obtained Previously	18-07-2025	N/A	Access OK	None Required
Access Fitting Picture

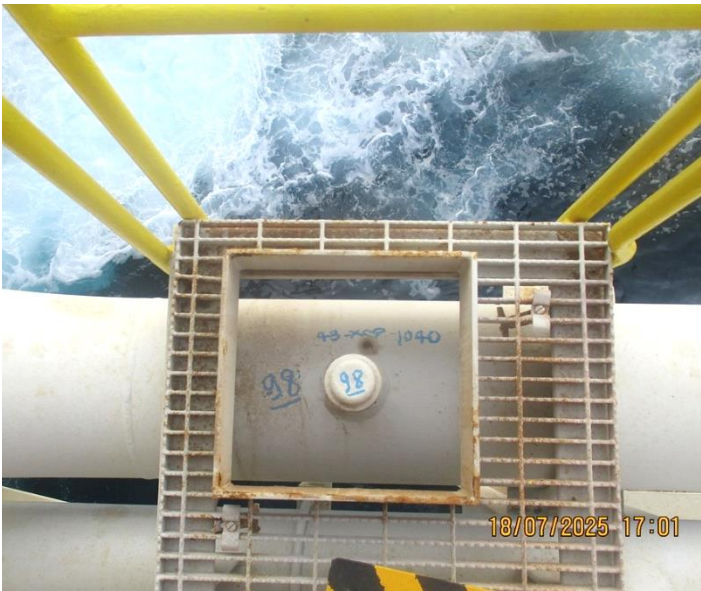
Tag No	Line No / Description	Pressure (psi)	A/F Orientation	Scope of Work	Work Performed	Probe Readings	Date	Tool Used	Location Access	Remedial Actions
43-XCP-1040	14-P-43001-1101 14" Gas Line from V5367 via LP Gas Header to V4301	N/A	12 o Clock	External Service of Access Fitting	Cap removed, threads brushed and re-greased	Obtained Previously	18-07-2025	N/A	Access OK	None Required
Access Fitting Picture
