2025 February Deployment and Emergency Recovery of unit_1024 1024-20250224

Summary

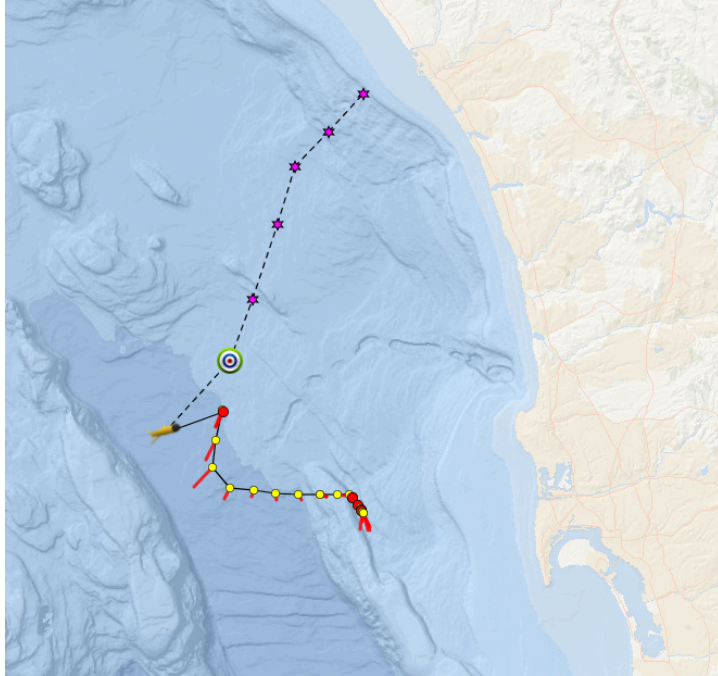
Figure 1. Path of “unit_1024.” unit_1024 was deployed 22 km west of Mission Bay, San Diego, CA on February 24, 2025. The glider flew a path west from the initial deployment location and was headed north toward Oceanside, CA, when it aborted its mission for a leak in the aft section. The glider drifted southwest overnight and was recovered on February 26, 2025 by the F/V *Outer Limits*. Yellow dots indicate where the glider surfaced throughout its deployment, red dots indicate points where the glider aborted its mission, and the bullseye represents the glider’s next waypoint.
