A note on the M_w 6.3 earthquake in Iceland on 29 May 2008 at 15:45 UTC

Abstract This preliminary study aims to investigate a M_w 6.3 earthquake that occurred in South Iceland on Thursday 29 May 2008 at 15:45 UTC. The epicentre was in the Olfus District between the towns of Selfoss and Hveragerdi. This study examines the data recorded and the damage observed immediately after the event. Horizontal accelerations of up to 80% g were recorded in the epicentral region and there is visual evidence that the vertical acceleration exceeded 1 g. The PGA data is compared to a ground motion estimation model developed for the South Iceland earthquakes in June 2000. In general the basic properties of this event are found to be similar to the characteristics of the South Iceland earthquakes in June 2000. The duration of strong-motion is short and the intensity attenuates rapidly with increasing distance. The earthquake action resisted by buildings in the near fault area is inspected through evaluation of elastic as well as inelastic response spectra. The vast majority of structures seemed to withstand the strong-motion fairly competently and without significant visual damage due firstly to the

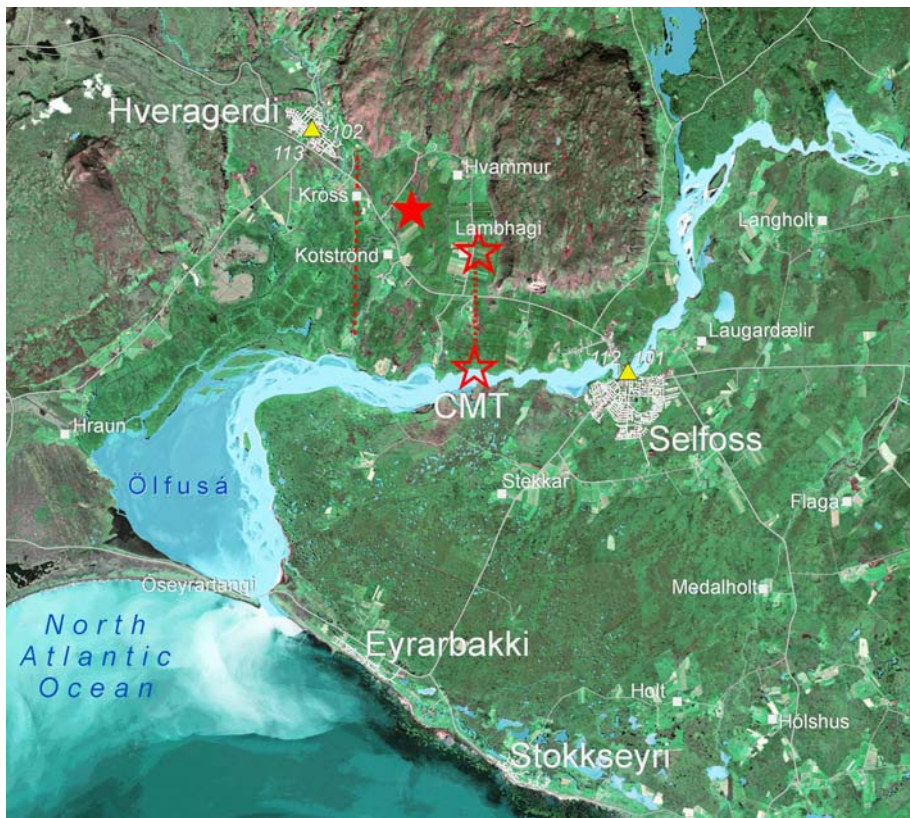
To substantiate the location of the initial rupture the inter-arrival time of the P-wave at six stations equipped with absolute GPS timing was used to estimate the epicentre applying the least squares technique. Due to the nature of the faulting described above, there was no clear distinction in the recorded time series between the P- and the S-waves. Using a P-wave velocity of 6.8 km/s (Fedorova et al. 2005) the initial epicentre was located at 63.97°N and 21.09°W. As seen in Fig. 2, this location is approximately inline with the location given by the CMT database.

In view of the above described scenario, as well as the lack of clear surface manifestation of a causative fault, we have chosen to use the macroseismic epicentre, 63.98°N and 21.13°W, as a reference for the distance measure applied and the distances reported in Table 1. This location is obtained by minimising the rms-error obtained as the difference between the recorded data and the model presented for the June 2000 earthquakes (Sigbjörnsson and Ólafsson 2004), applying the parameters listed in Fig. 3, and a variable epicentre. It is seen that this macroseismic epicentre falls in between the two causative faults (as indicated on Fig. 2).

Fig. 2 SPOT satellite image of the epicentral area of the 29 May 2008 earthquake showing the location of the macrosismic epicentre (solid red star) and the epicentre according to the Global Centroid Moment Tensor database (hollow red star labelled CMT). Our estimate of the location of the epicentre, based on strong-motion data, is indicated by the hollow star near to Lambhagi. Dashed red lines indicate proposed causative faults. Yellow triangles indicate locations of the Icelandic Strong-motion Network stations. Some of the towns and villages affected are shown. The location shown by the figure is indicated in Fig. 1 by the dashed red outline

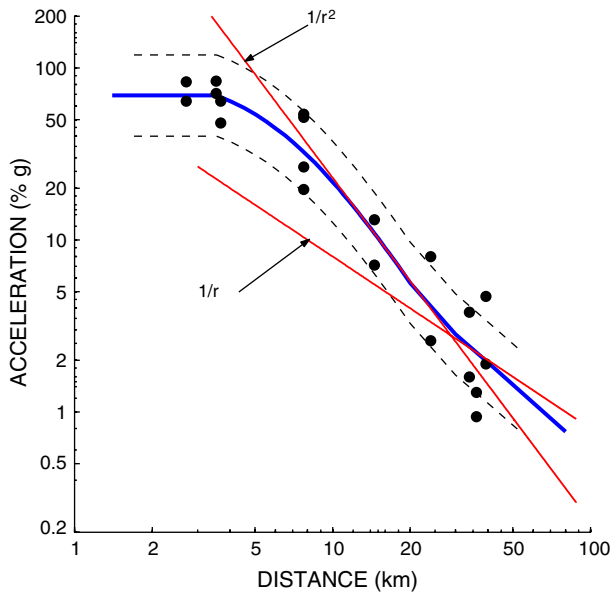
The PGA data available is plotted in Fig. 3 along with model estimates. The peak ground motion estimation equation represented by the blue curve in Fig. 3 consists of three main parts or zones. Firstly, the near-source zone denoted by the horizontal line for epicentral distances less than approximately 3.5 km. Secondly, the intermediate-source zone for epicentral distances in the range 3.5–25 km. This zone is characterised by rapid attenuation that is roughly proportional to $1/r^2$, *r* referring to the source distance. Thirdly, there is the far-source zone for epicentral distances above 25 km. In this zone the rate of attenuation decreases towards $1/r$ according to the model applied. It is worth noting that the standard deviation of the difference between the recorded values and the blue curve, (see Fig. 3), equals 0.236 (log-scale), furthermore that the mean difference is slightly below zero or −0.049.

Fig. 3 Horizontal peak ground acceleration (PGA) as a function of epicentral distance. Each dot denotes a recorded PGA single horizontal component and the solid blue curve indicates a ground estimation model suggested by Sigbjörnsson and Ólafsson (2004). The dashed lines are obtained as the blue curve \pm one standard deviation of the difference between the recorded values and the blue curve (standard deviation of the difference = 0.236 and mean difference = -0.049). The red lines indicate attenuation proportional to $1/r^2$ and $1/r$, respectively, where r refers to the source distance. The following data are assumed deriving the blue curve: moment magnitude, $M_w = 6.3$; shear wave velocity, $\beta = 3.5$ km/s; density of rock, $\rho = 2.9$ g/cm³; stress drop, $\Delta\sigma = 90$ bar; partitioning parameter, $C_p = 1/\sqrt{2}$; peak factor, $p = 2.94$; spectral decay in the near-field, $\kappa_o = 0.04$ s; duration used in near-field model, $T_o = 1.5 \cdot r/\beta$; characteristic dimension of the intermediate-field, $R_2 = 25$ km; depth parameter, $h = 6.3$ km; exponent describing attenuation in the intermediate-field, $n = 2$. The macroseismic epicentre, 63.98°N and 21.13°W, is obtained by minimising the rms error

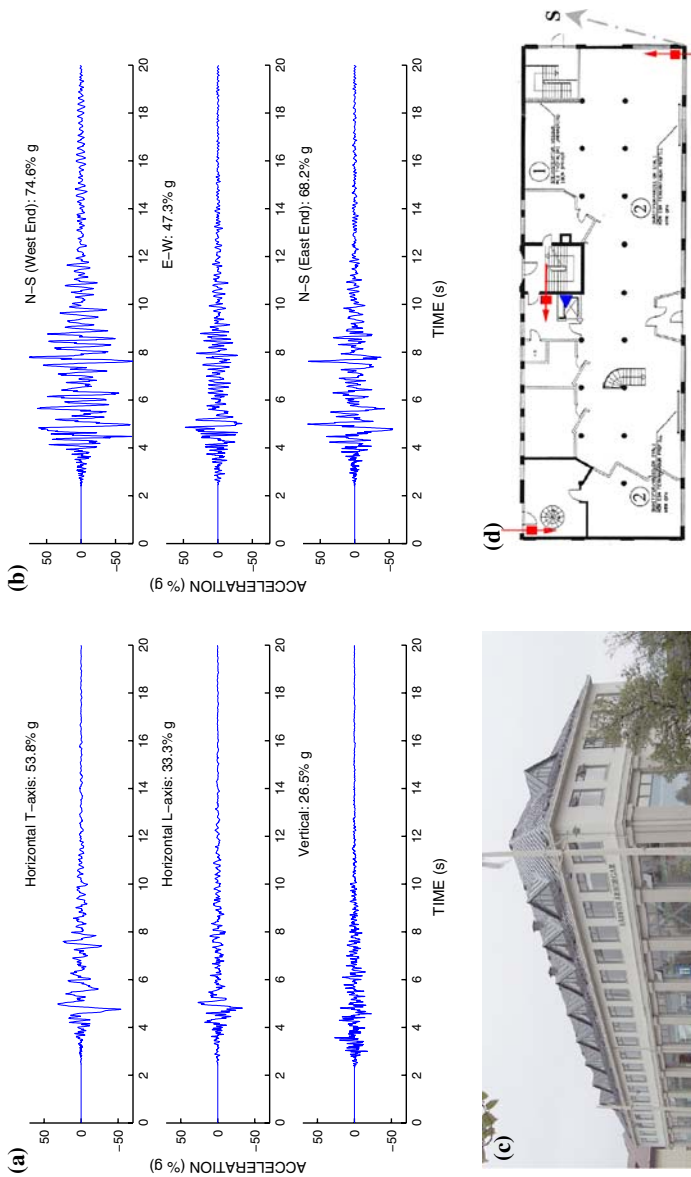
A detailed overview of the action that the buildings in the area had to resist can be obtained from ISESD. An example of recorded ground acceleration and structural response is given in Fig. 5, for a three-storey office building in the town of Selfoss. It is seen that the ground motion is not severely magnified by the structure as the peak acceleration level on the third floor is only about 1.4 times the PGA at base level for each horizontal direction. This corresponds to the dynamic characteristics of this building which has natural periods below 0.17 s, whereas the normalised response spectra (seismic coefficient) shown in Fig. 6 demonstrate that the horizontal earthquake action peaks at periods above 0.3 s. The fact that the low-rise buildings in the near-fault region did not pick up the peak earthquake action has been a contributing factor in limiting the potential damage caused by this event.

Fig. 5 Accelerations recorded in a three storey office building in the town of Selfoss: **(a)** ground acceleration components recorded in the basement; **(b)** horizontal acceleration recorded on the third floor, NS (West End) is the transversal component of the west end of the building, E-W is the longitudinal component and N-S (East End) is the transversal component of the east end of the building; **(c)** photo showing the north and west sides of the building; and **(d)** drawing showing the location of accelerometers. The red rectangles identify the locations of uni-axial accelerometers on the third floor while the arrows indicate the sensor directions. The blue triangle denotes a tri-axial accelerometer in the basement

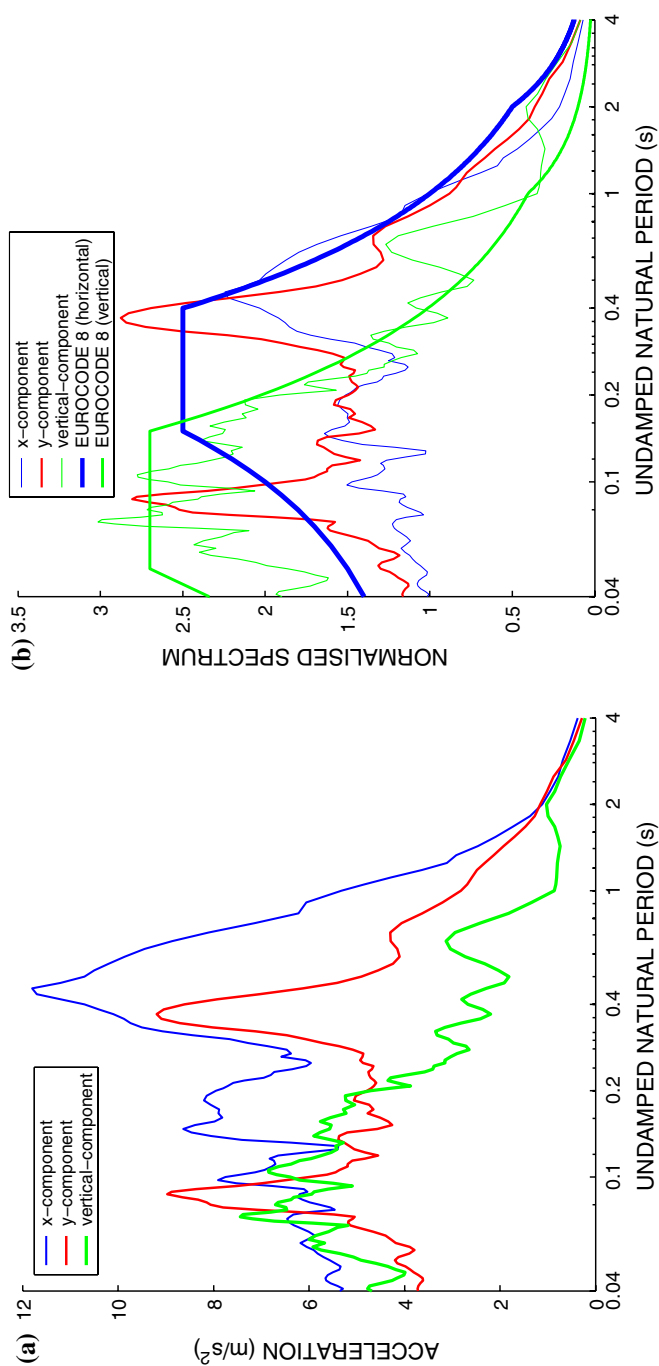
Fig. 6 Linear elastic earthquake response spectrum derived from ground acceleration components recorded in a three storey office building in the town of Selfoss: **(a)** Spectral acceleration for transverse (north–south) acceleration (blue line), longitudinal (east–west) acceleration (red line) and vertical acceleration (green line). **(b)** Normalised earthquake response spectrum (seismic coefficient) for transverse (north–south) ground acceleration (thin blue line), longitudinal (east–west) acceleration (red line) and vertical ground acceleration (thin green line). Eurocode 8 horizontal and vertical ground accelerations are indicated by the thick blue line and thick green line, respectively. Critical damping ratio is 5% in all cases

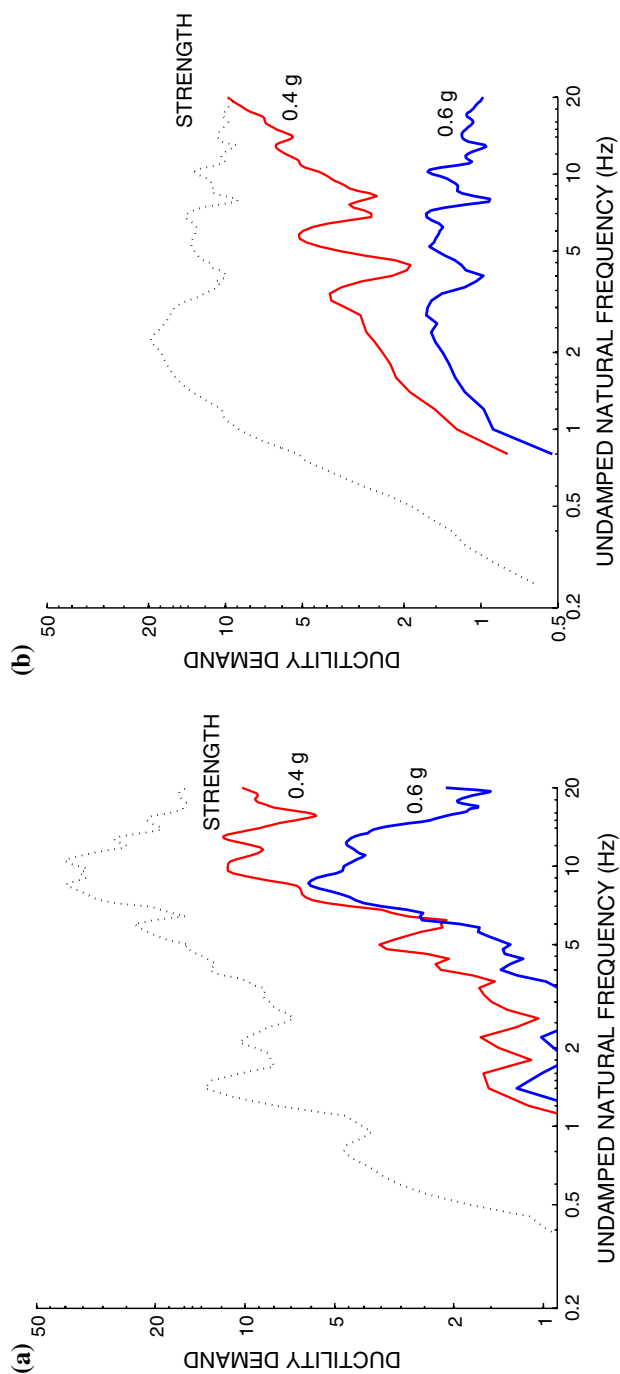
Fig. 7 Inelastic response spectra for constant strength, respectively, 0.4 g (blue curve) and 0.6 g (red curve). Solid curves indicate inelastic earthquake response spectra and dashed curve gives the linear elastic earthquake response spectra scaled by the yield displacement for a system with strength of 0.6 g. The critical damping ratio is 5% in all cases. (a) Hveragerði-Retirement House (Id. No. 113), (b) Selfoss-Town Hall (Id. No. 112)

requirements are, in general, rather weak and even non-existent for older buildings. Therefore, to assess the required strength demand, inelastic spectra has been calculated. The results are exemplified in Fig. 7 for two recording stations. Only horizontal action is considered. The figures show the ductility demand for a prescribed strength, corresponding to yield strength equal to 0.4 and 0.6 g. The dotted curves, indicating the linear displacement spectra for a 5% critical damping ratio, are inserted for comparison. They are obtained by dividing the linear displacements by a yield displacement equal to f_u/ω^2 , where f_u is the yield strength and ω is the undamped natural frequency in rad/s. The non-linear spectra show, in both cases, a tendency to well-known shifts in the characteristic spectral peaks. The shift is encountered for the weaker systems towards higher frequencies, relative to the characteristic peaks in the spectra for the stronger systems. These spectra indicate that low-rise buildings designed according to the minimum requirements of the seismic code, applied for the bulk of the buildings, are bound to suffer damage. These damages surface as cracks in the concrete and masonry partitions, yielding in reinforcements and significant deformations in timber elements.

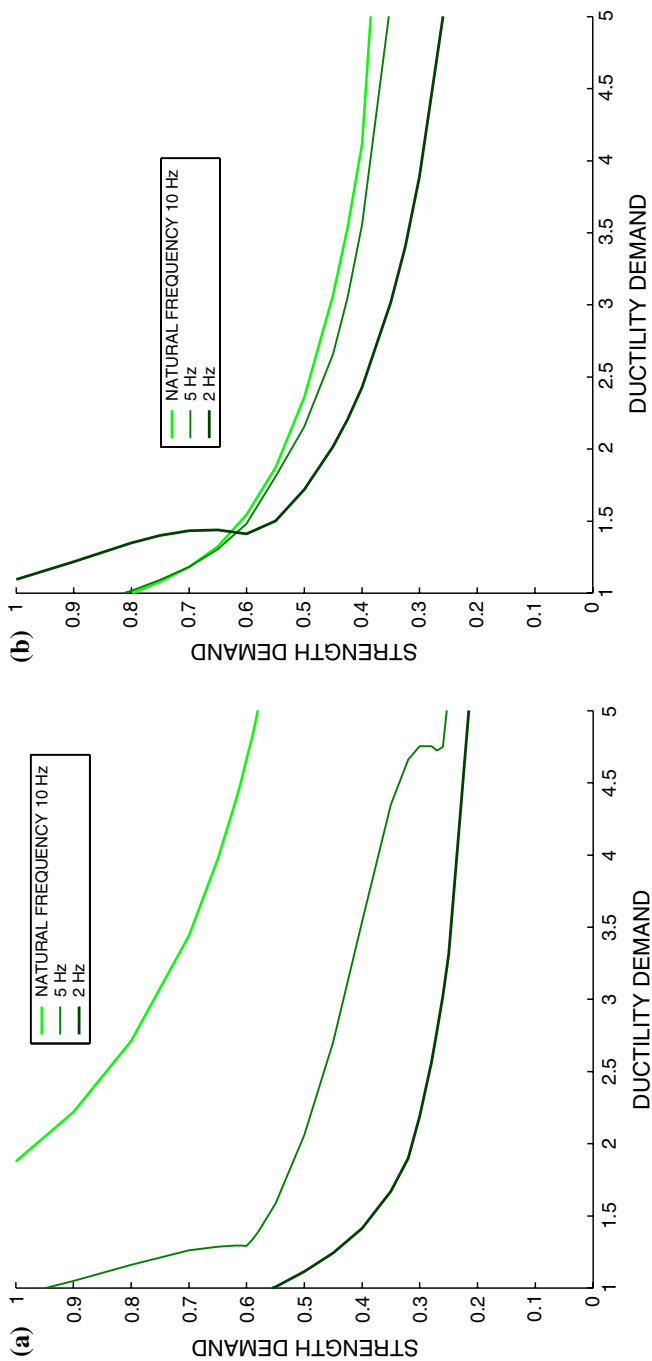
The strength demand as a function of the ductility demand is displayed in Fig. 8 for the above-mentioned recording stations. Only structures with an undamped natural frequency equal to 2, 5 and 10 Hz, respectively, are considered. On average we see that the strength demand decreases with increasing ductility demand. The figure displays, however, some characteristic differences also seen in Fig. 6. The curve for a structure with a 10 Hz natural frequency at Station 113 indicates considerably higher action than the corresponding curve for Station 112. This can be attributed to the spectral characteristics of the ground acceleration reflected in the higher dominating frequency at Station 113 than 112. It is also seen that for high-resistant low-rise structures, for example with an undamped natural period of about 10 Hz and strength equal to 1 g, the ductility demand is low, i.e. in the range of 1.5–2 (see Fig. 8).

Fig. 8 Strength ductility demand for three selected undamped natural frequencies, 2, 5 and 10 Hz. The critical damping ratio is 5% in all cases. (a) Hveragerði Retirement House (Id. No. 113), (b) Selfoss Town Hall (Id. No. 112)
