## Accident

<b>Aircraft Type and Registration:</b>	UAS Malloy Aeronautics T150	
<b>No &amp; Type of Engines:</b>	8 Electric motors	
<b>Year of Manufacture:</b>	2023 (Serial no: 120)	
<b>Date &amp; Time (UTC):</b>	27 June 2023 at 1443 hrs	
<b>Location:</b>	Field in South Scarle, Lincoln	
<b>Type of Flight:</b>	Training	
<b>Persons on Board:</b>	Crew - None	Passengers - None
<b>Injuries:</b>	Crew - N/A	Passengers - N/A
<b>Nature of Damage:</b>	Destroyed	
<b>Commander's Licence:</b>	General Visual line of sight Certificate (GVC)	
<b>Commander's Age:</b>	45 years	
<b>Commander's Flying Experience:</b>	150 hours (of which 2 were on type) Last 90 days - 5 hours Last 28 days - 5 hours	
<b>Information Source:</b>	AAIB Field Investigation

## Synopsis

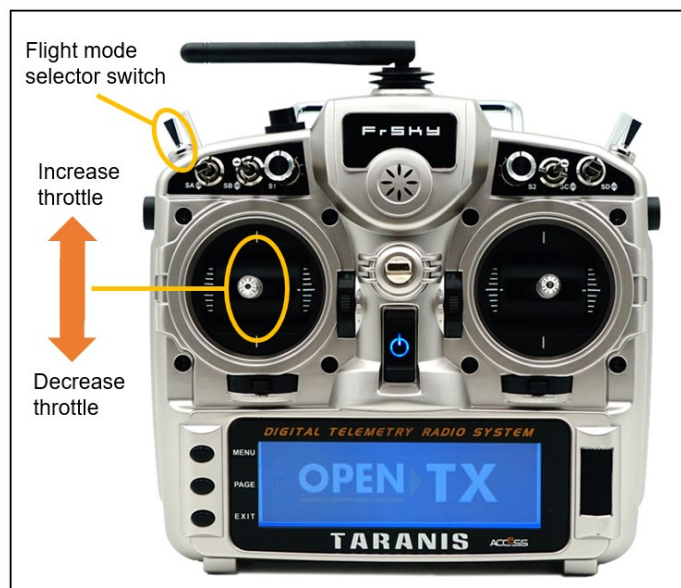
**Figure 4**

On the accident flight the RP operated the aircraft with a FrSky Taranis X9D plus transmitter (Figure 4) and was supported by a GCS operator. The transmitter operates on 2.4 GHz and has a variety of customisable switches and features. The left stick controlled the throttle and yaw with the right stick for pitch and roll. It is possible to adjust the length of the sticks to suit individual operators. The transmitter is fitted with a three-way toggle switch which enabled the RP to manually change between a selection of the pre-programmed flight modes. There are 20 different automated flight modes available within the aircraft firmware which can be combined with the automated mission flight profiles. On the accident flight the selectable flight modes were Altitude Hold (ALT HOLD), STAB and LOITER mode.

FrSky Taranis X9D plus transmitter

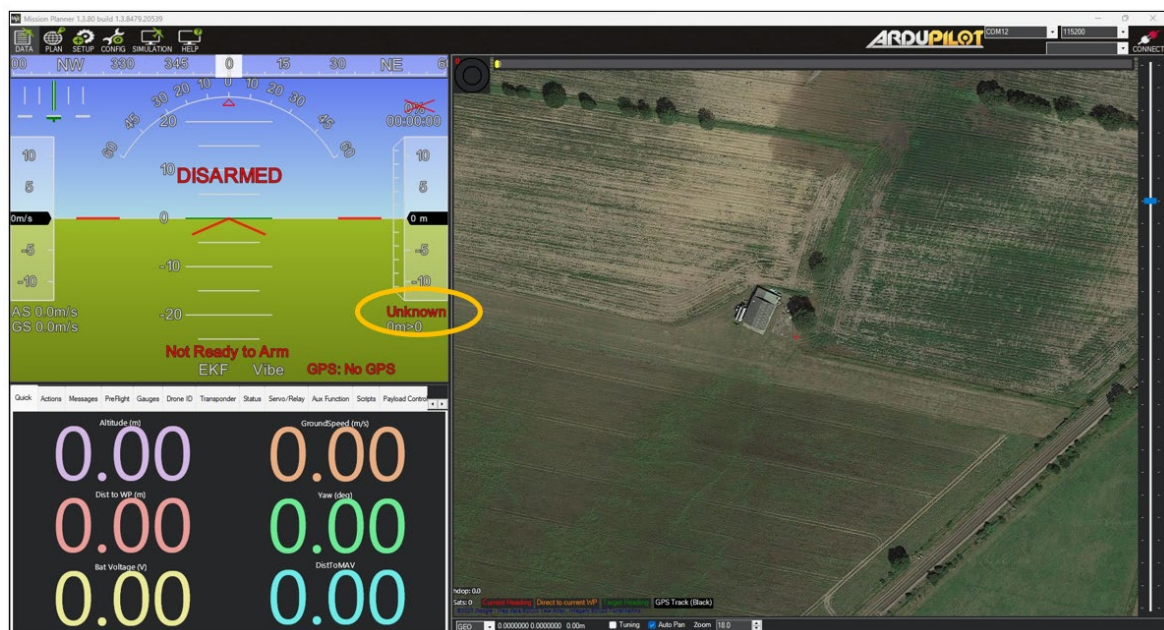
**Figure 5**

To assist the RP a GCS operator is employed to monitor the continuous data feed from the aircraft and provide warnings, information and updates via radio headsets. The GCS laptop uses the open source ARDU Pilot Mission Planner software and the user interface is shown in Figure 5.

ARDU Pilot Mission Planner interface

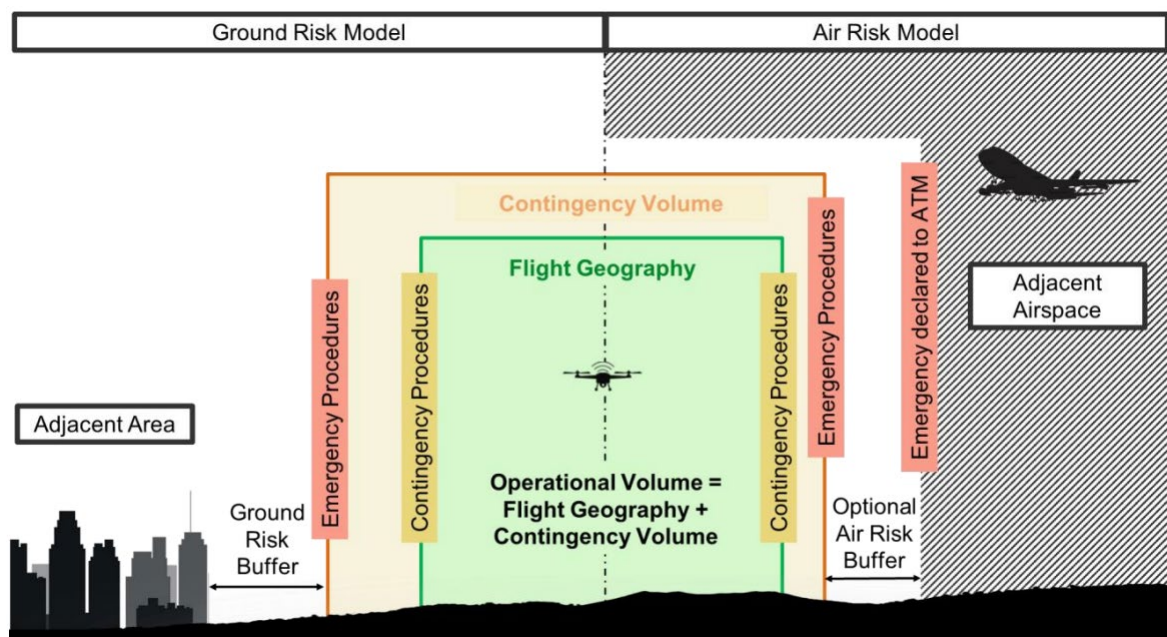
**Figure 6**

Volume 1 section 25.5 describes the software functionality of programming geofences and the interaction between the ADRU Pilot software and the Special Mission Computer. Figure 6 taken from the OSC, is the Safe Airspace Volume (SAV) diagram that RPs and mission commanders '*must understand*' during flight planning. The origin of the diagram is from the graphical representation of the Joint Authorities for Rulemaking of Unmanned Systems (JARUS) Specific Operations Risk Assessment (SORA) Semantic Model to ensure a common usage of terminology for risk assessments. There are no specific requirements or information on how to define a suitable size related to the flight purpose, nor any RP procedures in the event of a geofence breach despite the statement that a '*breach of the Operational volume will require emergency action*'. The operators understanding of the contingency volume is the maximum operating volume allowed under their OA which was 400 ft (120 m) above surface level and 500 m from the RP. The geofence on the accident flight was considered to be the flight geography volume.

SAV model / JARUS SORA Semantic Model
