# AURIX™ TC39x errata sheet

Marking/Step: (E)ES-BD, BD

10585AERRA

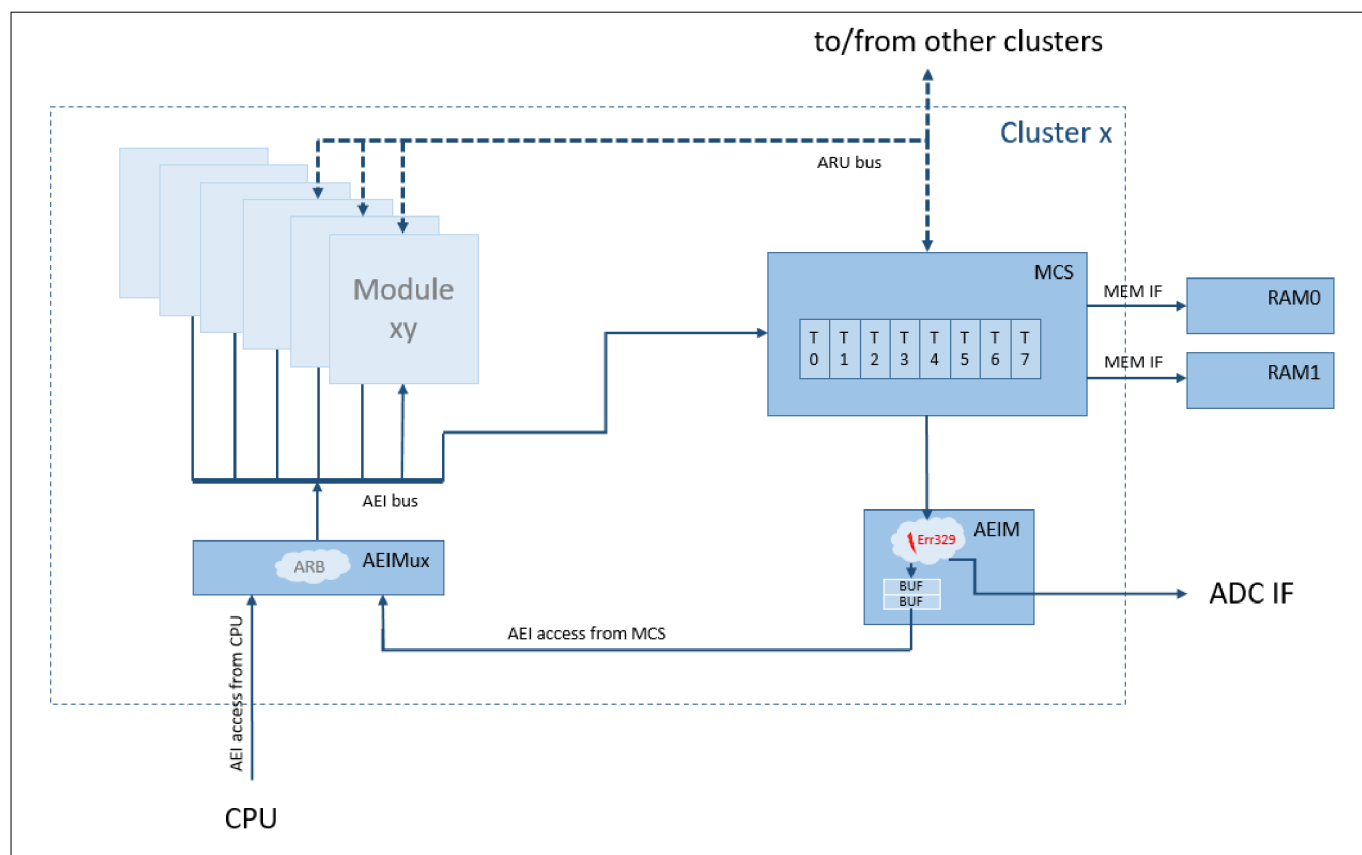
**Figure 5 Cluster-internal AEI network**

Problem GTM\_AI.329 is related to a potential incorrect handling of MCS access requests to the AEI bus at the AEIM entry stage in case that one AEIM buffer is already filled. If in such a case a new access request from MCS enters the AEIM logic during a very specific time window (related to progress on the AEI bus), the AEIM logic might signalize incorrect parameters back to MCS that could result in incorrect data, the loss of data or a repetitive execution of MCS accesses to AEI.
