EMERGING TECHNOLOGIES AGAINST FIRES AND EXPLOSIONS

FIRE IN A TANK STORAGE FACILITY CASE STUDY

**Training for the prevention of fires and explosions through the use of data analysis and simulation
Project TSP2021\100311**

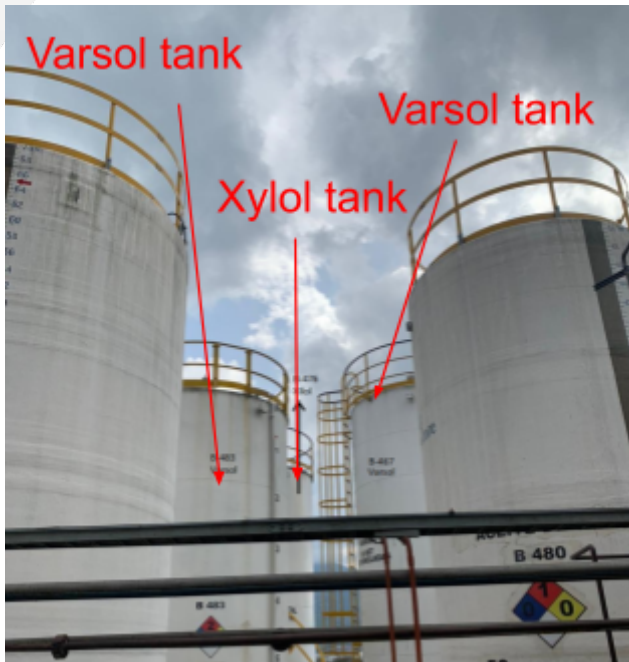
Figure 6. Xylol tank, located between the varsol tanks

In the area marked in red, a detail shown in [Figure 5](#), there are two tanks that contained varsol, and the other tank with xylol that exploded. In [Figure 6](#), the varsol and xylol tanks are shown before the explosion and fire. The size of these tanks vary between 3 - 4 m in diameter and 5 - 8 m in height, with capacities to contain between 70 - 80 m³ of flammable liquids.
