Mold Growth Cause and Origin Assessment and Mold Remediation Protocol

Blanck Residence
2212 Tuscany Way
Boynton Beach, FL 33435

AirSpec Project # ML18111215

Southern Oak Insurance Claim # 37997

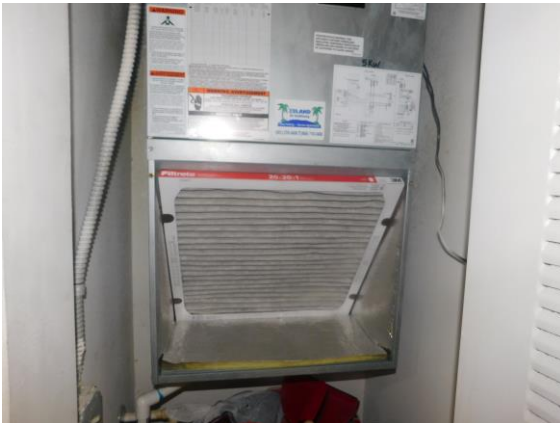
Left Picture: This picture shows the AHU. Right Picture: This picture shows seam tape deficiencies and holes in the supply ductwork and superficial mold growth on AHU closet drywall.

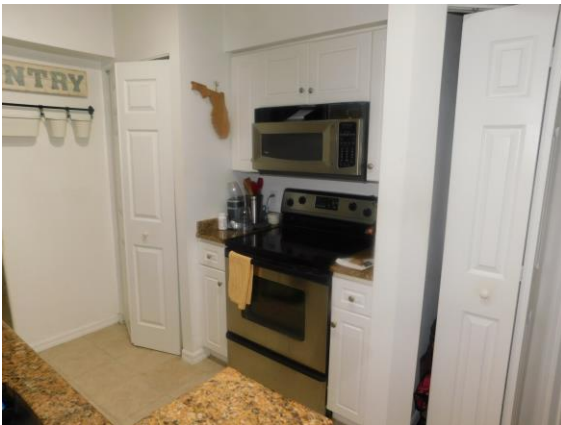
Left Picture: This picture shows the kitchen. Right Picture: This picture shows superficial mold growth on kitchen supply vent.

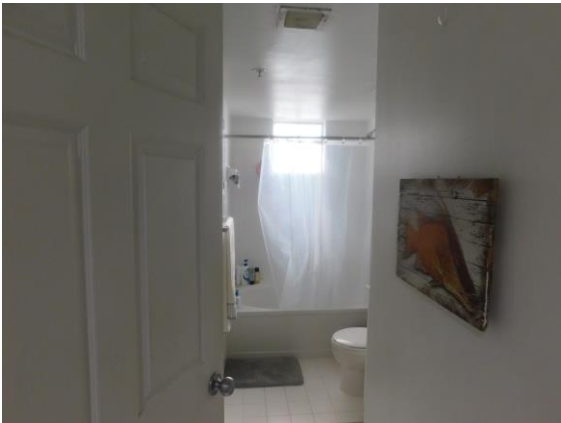
Left Picture: This picture shows the bathroom. Right Picture: This picture shows superficial mold growth and oxidation on the bathroom supply vent.

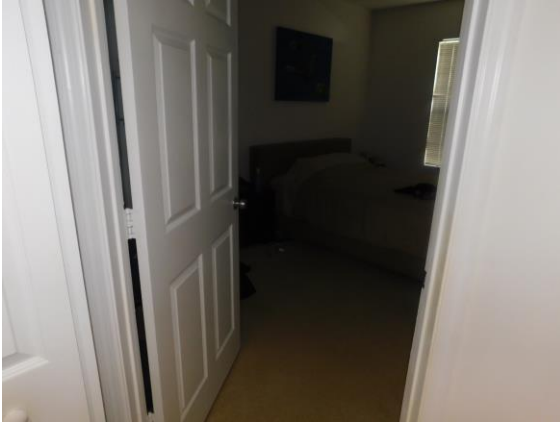
Left Picture: This picture shows the bedroom. Right Picture: This picture shows superficial mold growth and oxidation on bedroom supply vent.
