Job #14-358

API 653 INSPECTION

TANK #52

Location: Kerrobert Terminal

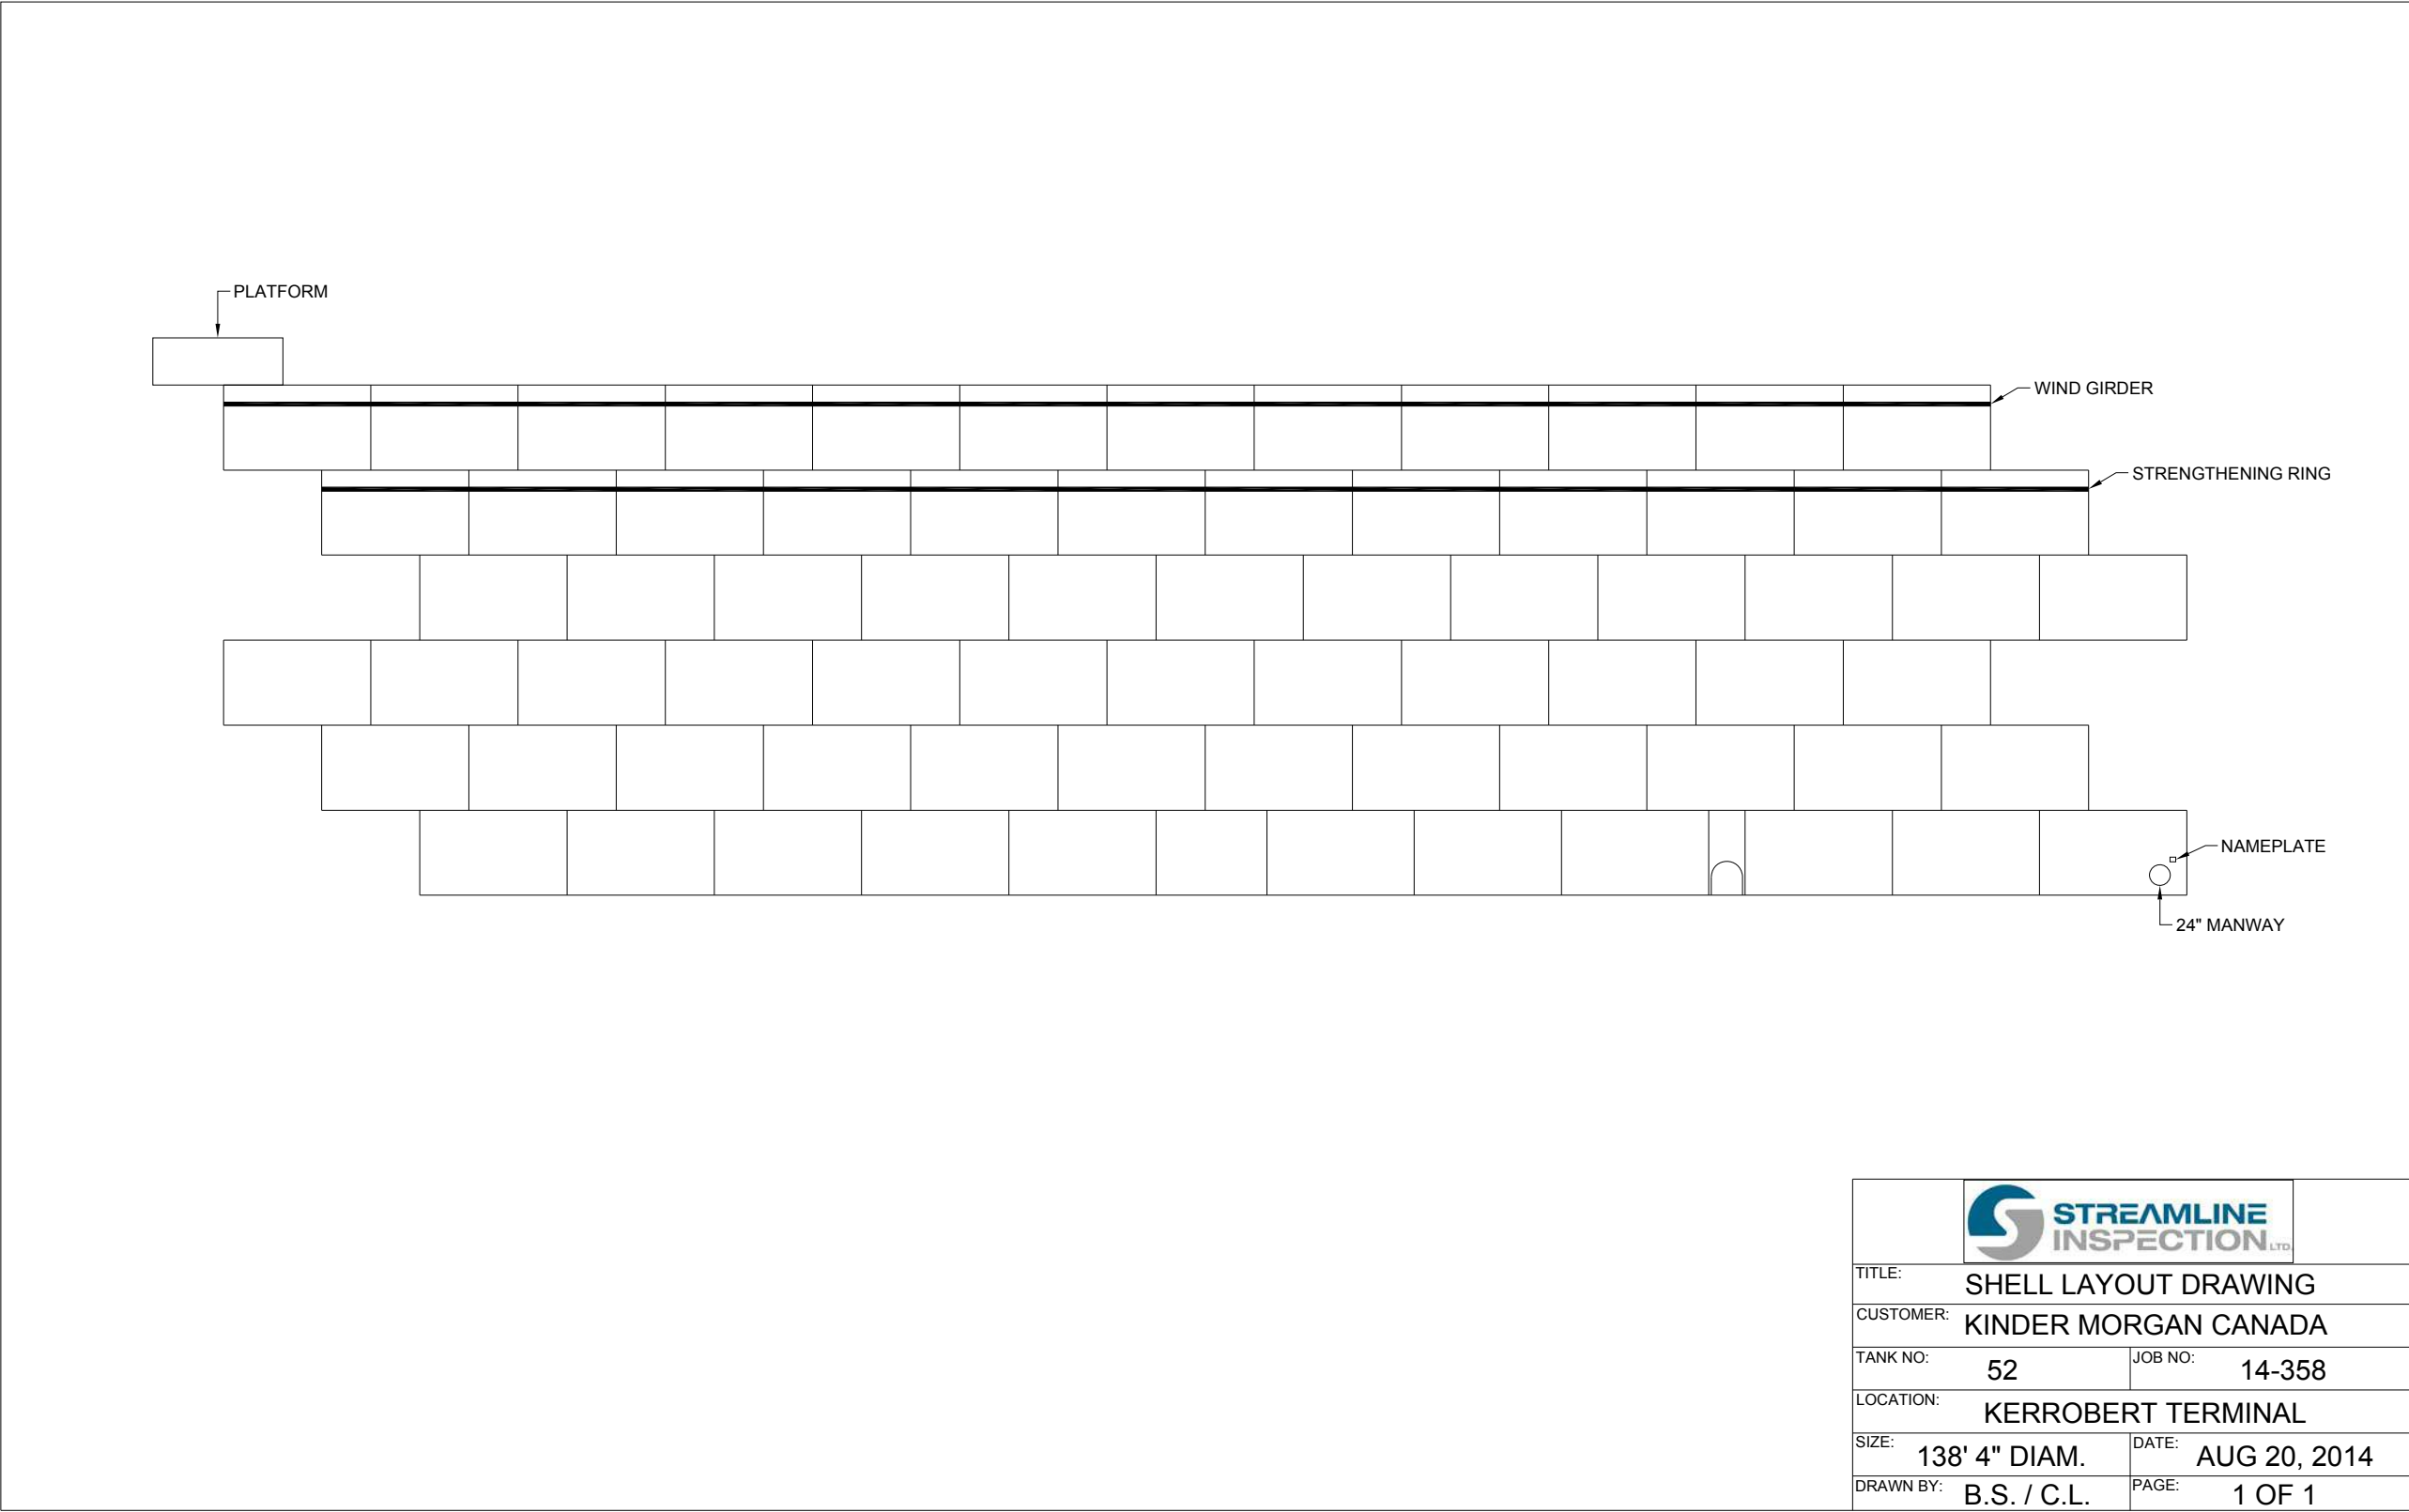
FIGURE 1 SHELL PLATE ROLLOUT

Minor deformations of the shell plate were noted.

No UT was performed on the 6th shell course due to a 5th course tensioning ring present at the period of inspection.

Internal shell plates were free of product where visible to inspector.

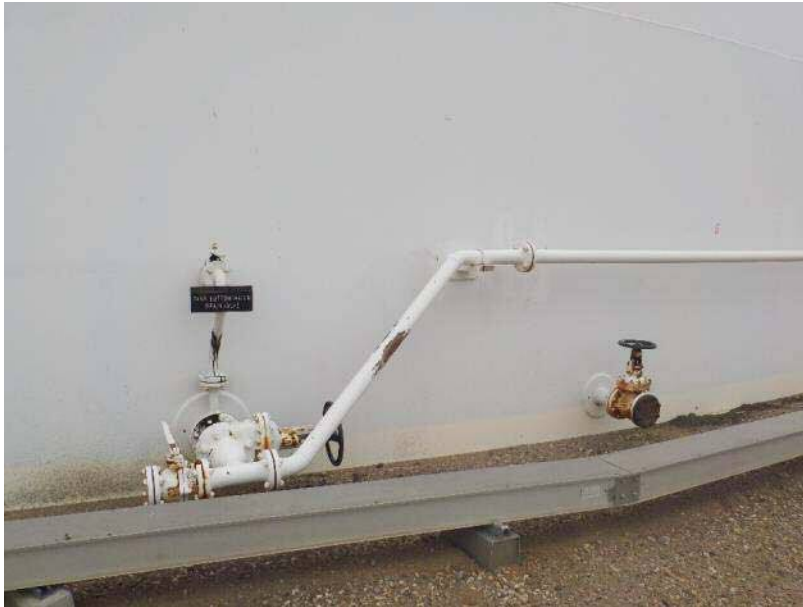
PHOTOGRAPH 6 EXTERNAL NOZZLES AND PIPING

AN external visual was performed on the nozzle necks during this outage, no weld defect or corrosion was observed.

UT was performed on external nozzle necks, no corrosion was identified as a result.

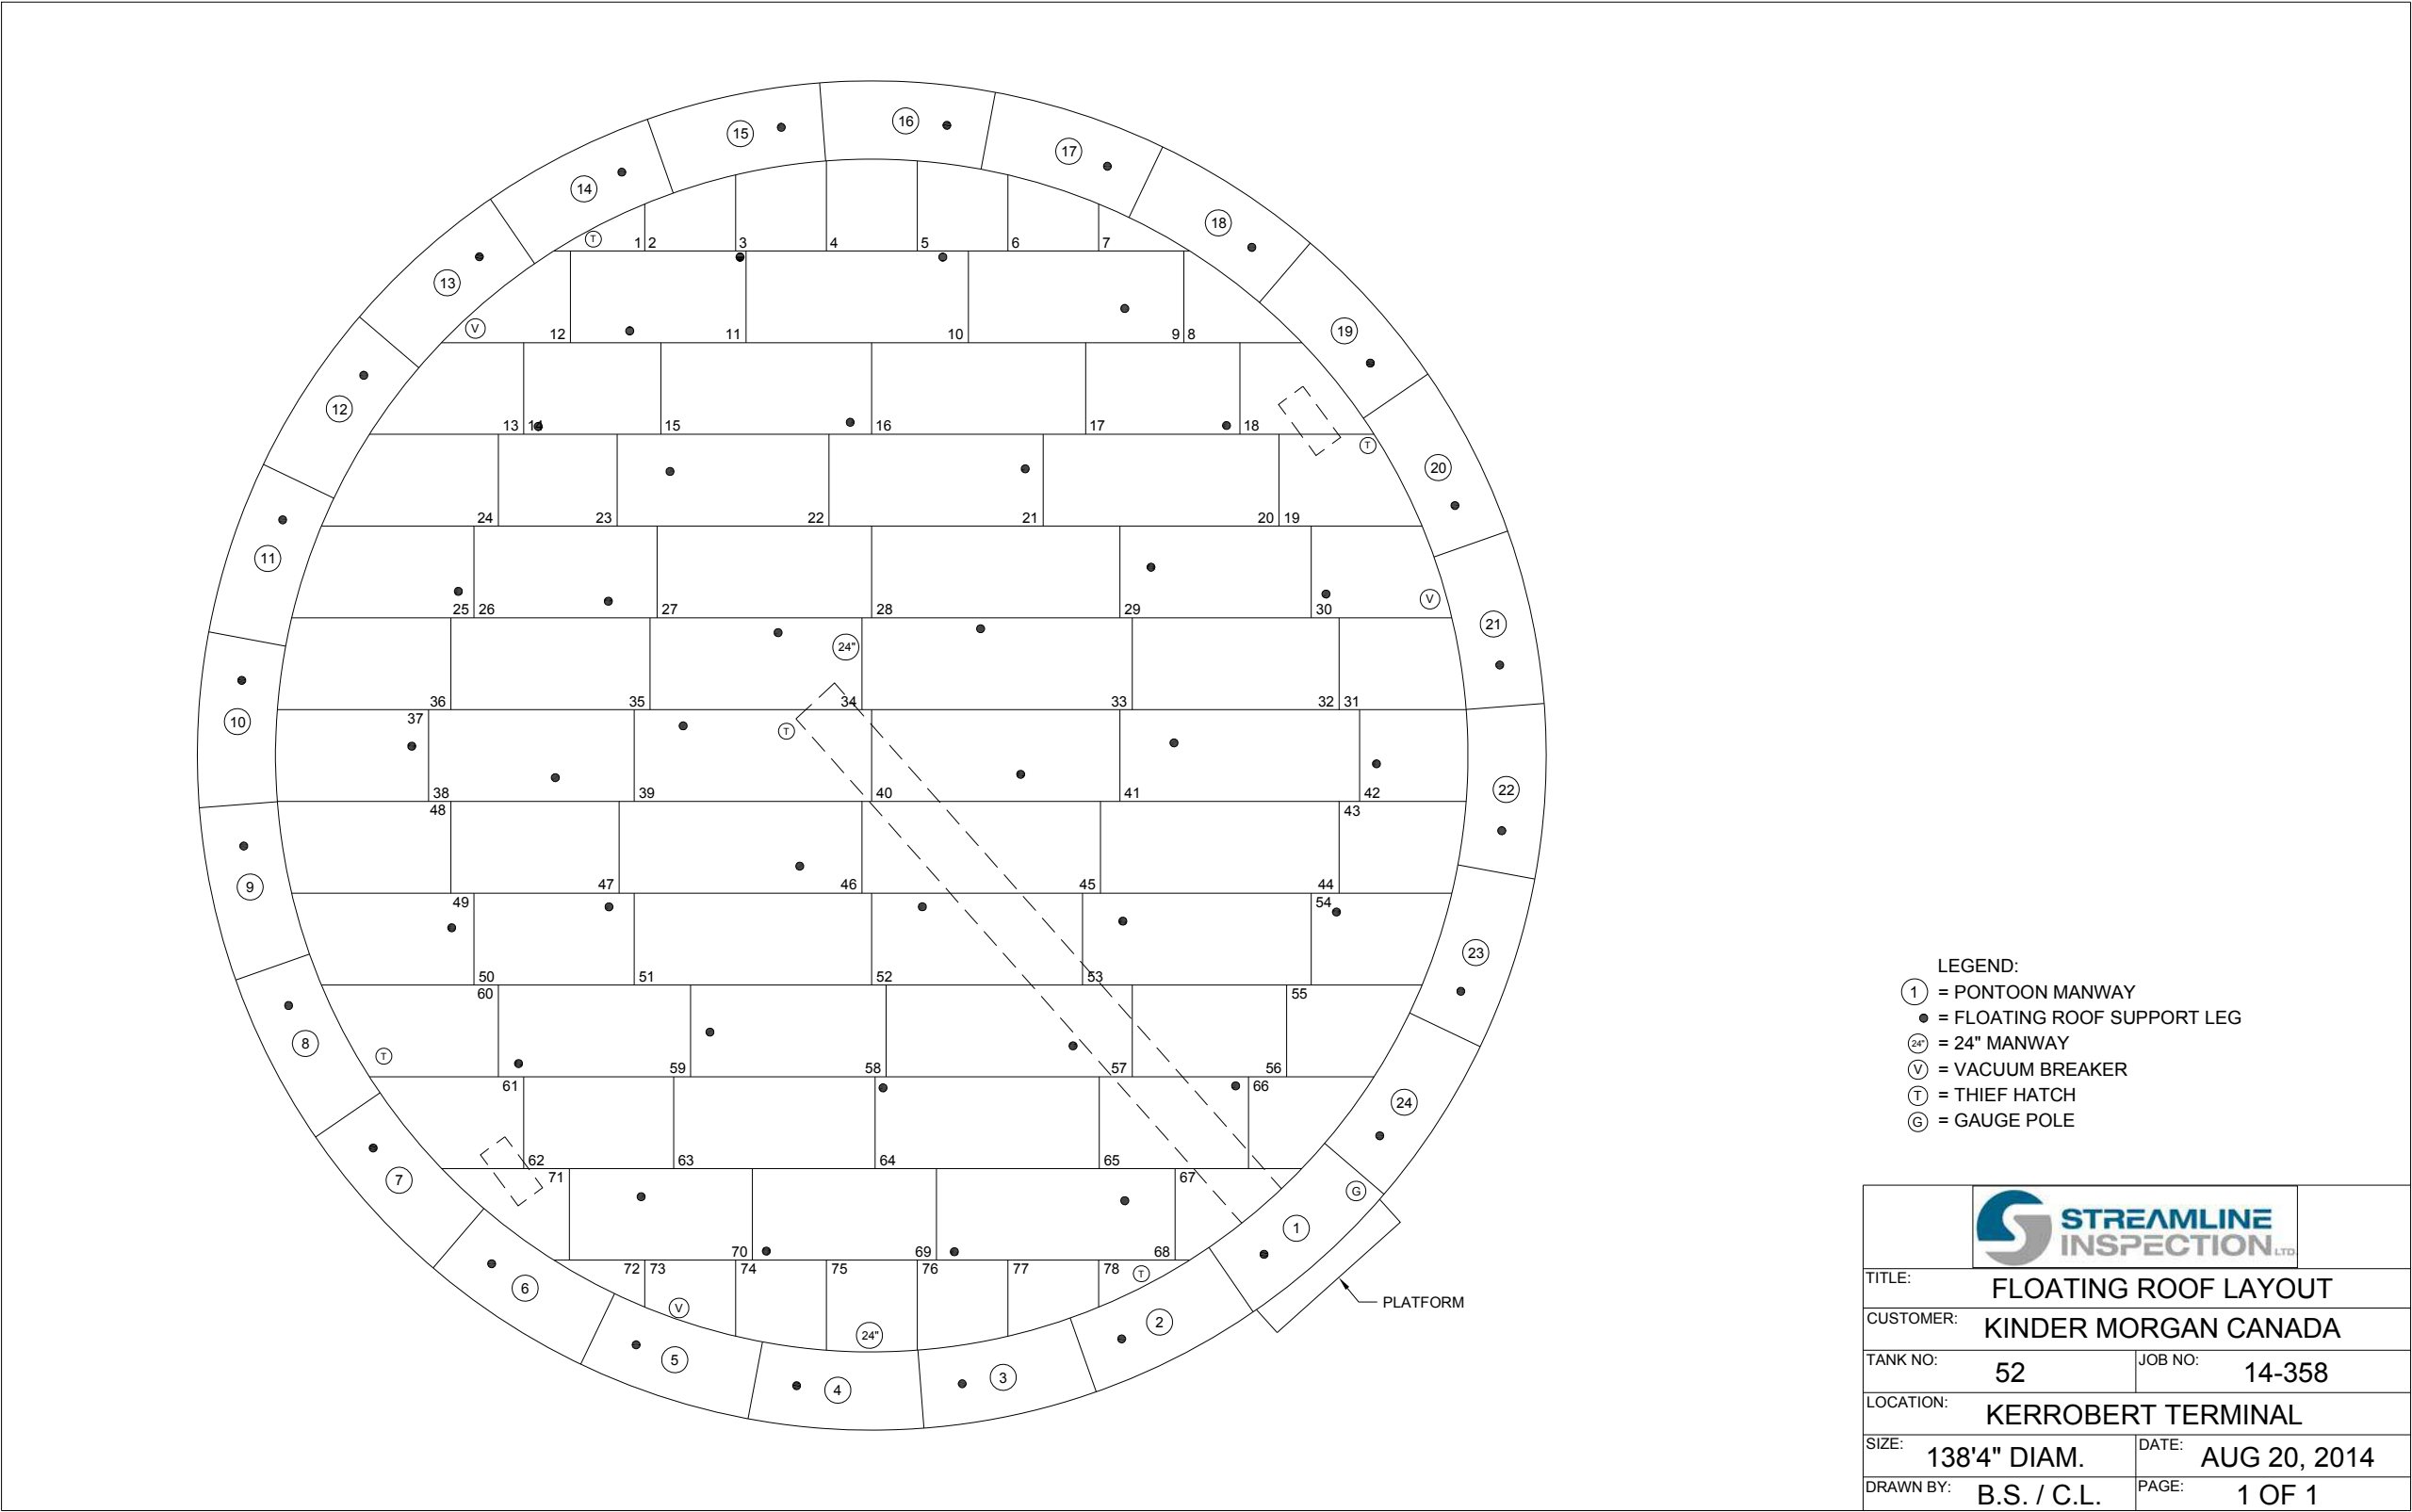
FIGURE 2 EXTERNAL FLOATING ROOF DRAWING

ARP shows zero corrosion, seal assembly is in good condition.

Gauge pole is soaked, seal assembly is in good condition.

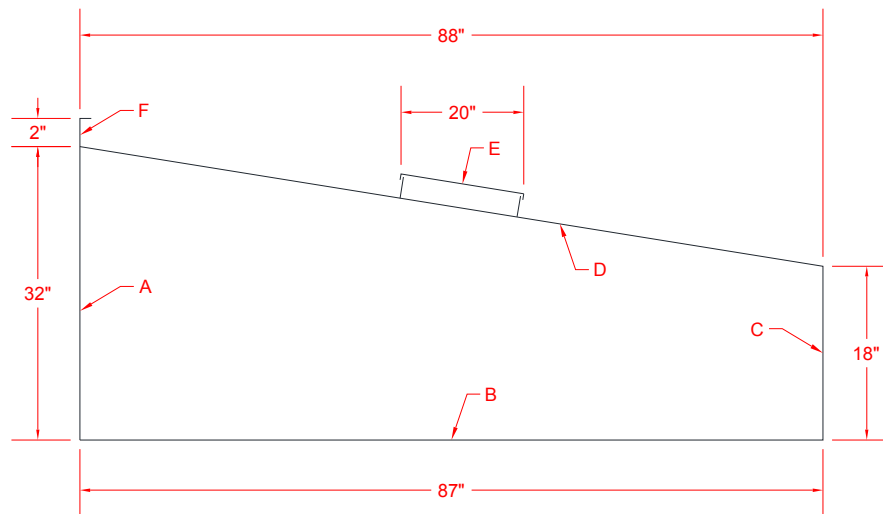
Random UT was performed on the outer pontoon side wall, nominal thickness of 0.212" recorded, several pontoons showed minor corrosion on the upper portions of the sidewall.
