MBS KINGMAN

Condition Monitoring Report

SEP - OCT 2023

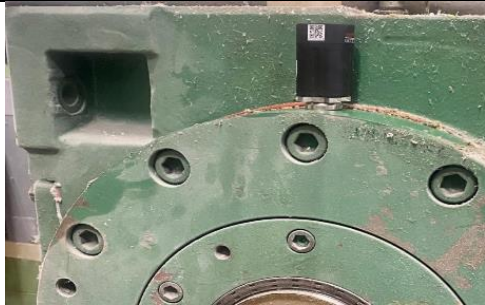
Highest Surface Temperature	38 °C

Remarks	<ul style="list-style-type: none"> • Overall condition of the machine/motor's condition is good as the vibration data are observed within ISO threshold limit. • To enable detailed analysis and fault alerts, machine parameters related to rpm, bearing, and gear are required.
---------	---

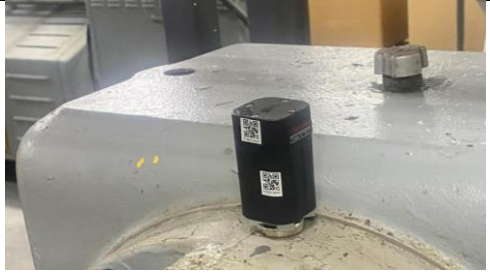
3.2 EXTRUDER DRIVE GEARBOX 1201:

Equipment Condition	Good

Duration	SEP - OCT 2023	
Highest Surface Temperature	51 °C

Remarks	<ul style="list-style-type: none"> • Overall condition of the machine/motor's condition is good as the vibration data are observed within ISO threshold limit. • To enable detailed analysis and fault alerts, machine parameters related to rpm, bearing, and gear are required.
---------	---

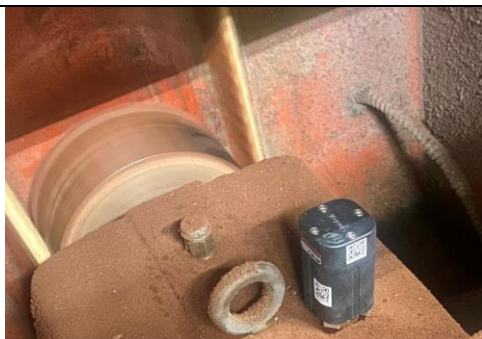
3.3 GODET 1 GEARBOX 1401:

Equipment Condition	Good

Duration	SEP - OCT 2023	
Highest Surface Temperature	49 °C

- Moving average trend requires attention as it's beyond the ISO threshold limit during the process.
- No clear trend is observed in the VRMS trend rate chart over the period

Remarks	<ul style="list-style-type: none"> • Overall condition of the machine/motor's condition is critical as the VRMS data are observed in the Critical range as per the ISO threshold limits. • To enable detailed analysis and fault alerts, machine parameters related to rpm, bearing, and gear are required.
---------	---

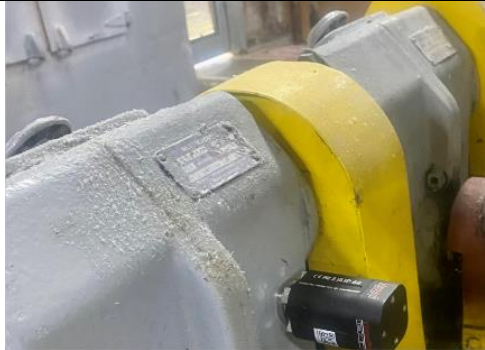
3.4 GEAR PUMP DRIVE GEARBOX 1202:

Equipment Condition	Good

Duration	SEP - OCT 2023	
Highest Surface Temperature	54 °C

- Moving average trend appears to be normal and within ISO threshold limit during the process.
- No clear trend is observed in the VRMS trend rate chart over the period
