City Of South Pasadena  
Tree Removal Request

1040 Orange Grove Ave  
South Pasadena, Ca 91030

**Oct 21<sup>st</sup>**

***Subject: Diseased and Defective Canary Island Palm Removal Request***

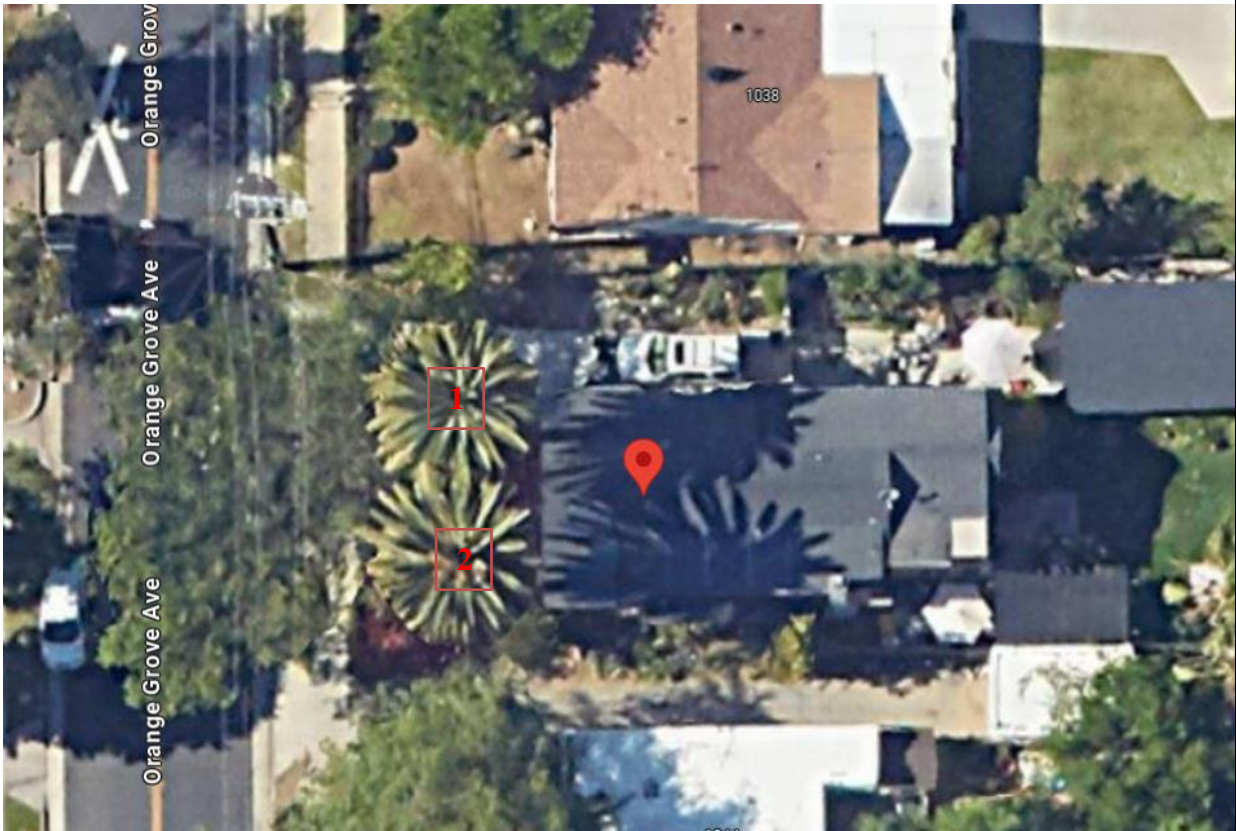
Google Satellite View with trees marked

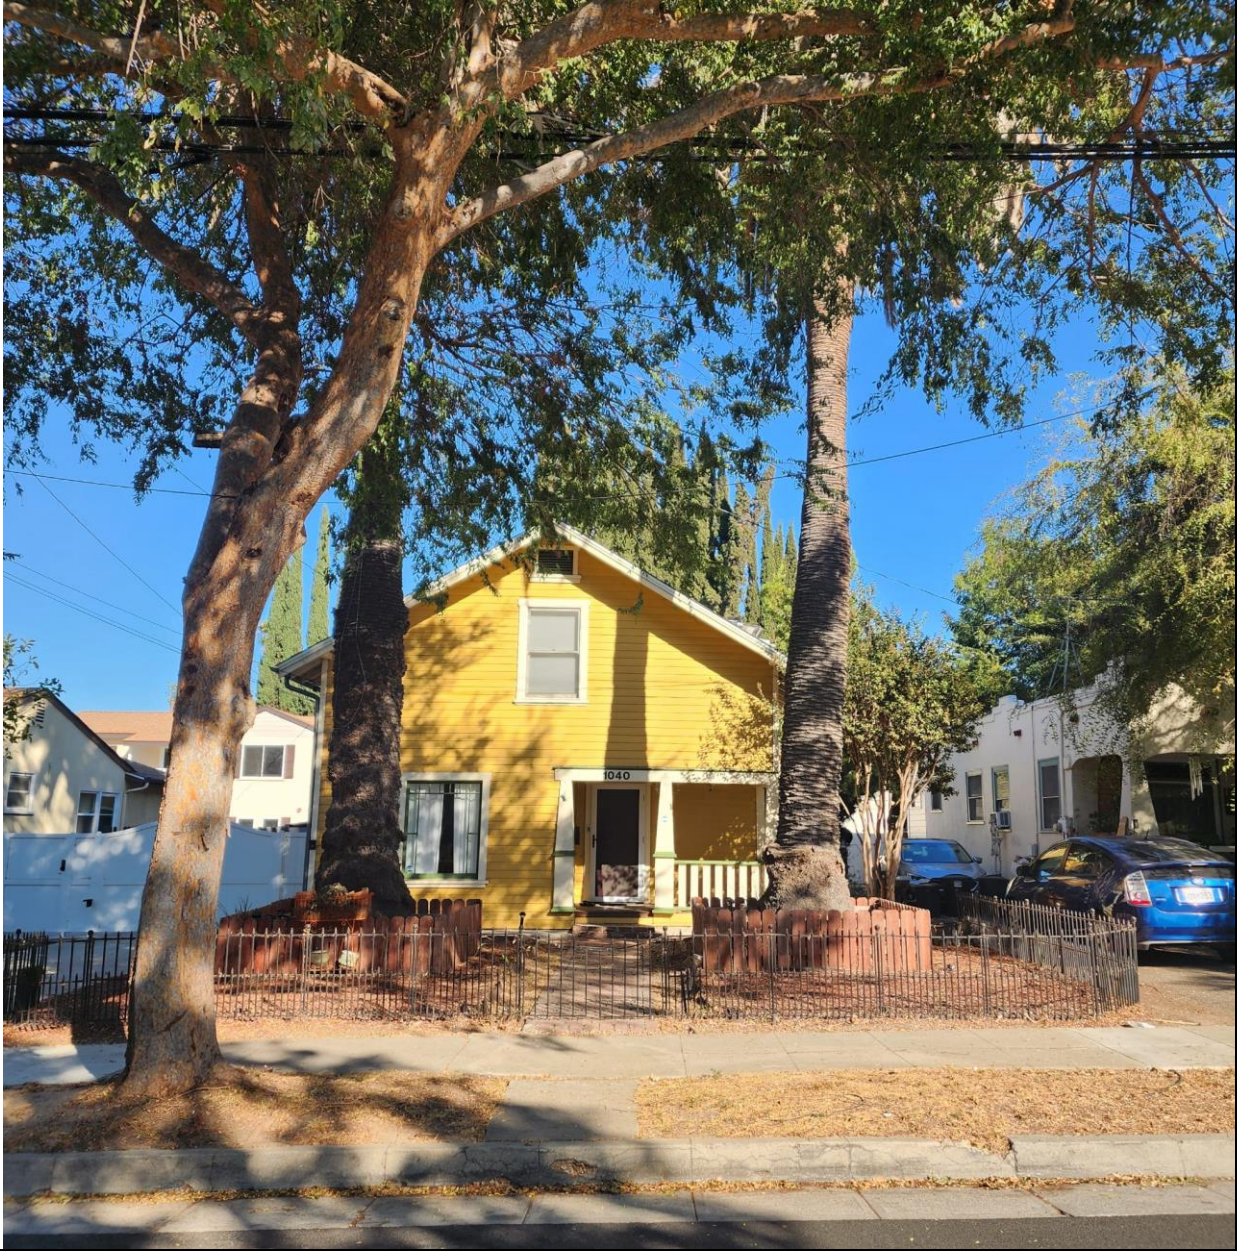
Site Photo Taken Oct 8th

The 2 Palm trees are planted too close together. The crowding has created a lean in their growth. Although the lean is slight, the two trunks are leaning away from each other. This species of Palm is very top heavy and not well adapted to resist leaning.

The two palms have built up planters around their base. The planters are full of soil and mulch. Trees do not do well when their natural grades are disturbed. The addition of soil above the original grade is a formula for decay and rot. Upon doing some manual digging at the base of the tree, I discovered areas that has apparently rotten roots and sunken trunk tissue with white fungal mycelia growing on it. This is generally an indicator that a fungal disease has begun digesting the structural tissue of the tree and weakening the trunk.

The last concerning condition that I noticed is that while the base of the Palm trees have a diameter of 30" and 36", over-pruning of these trees in the past have led to dangerous and irreversible taper in the trunks to about 18" (approx.) near the middle. From this narrow point upwards, the palm trunks widen again. Allowing these trees to continue getting taller and heavier above this 'pinch' point is unsafe.

The current recommendation is to remove and stump grind the subject trees and demolish the above ground planters in order to remove the trees completely. Remove as much of the ground up stump shavings and soil in order to remove as much of the diseased soil as possible. Import fill soil to cover the stump locations.
