PROJECT REPORT STAGE-1

**IMPROVEMENT IN QUALITY PPM IN REJECTION AND REWORK
FOR CUP-MACHINING OPERATIONS ON GILDEMEISTER (AS-48).**

➤ Project Sponsored by- CUMMINS India limited, Kothrud.

- **Gildemeister (AS-48)** is a cam operated- **Multi-spindle** automat machine.
- The machine was procured in **1971** by **Cummins India Limited., Kothrud**
- The machine is used for performing machining operations for diesel-generator-injector **cup**(nozzle).

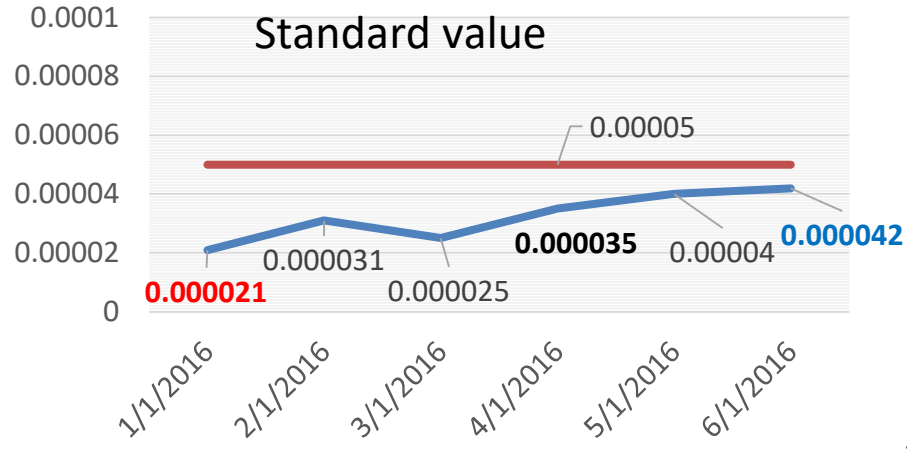
PARAMETER	SPECIFICATIONS	1 st SEPTEMBER	2 st SEPTEMBER	3 st SEPTEMBER	4 th SEPTEMBER	5 th SEPTEMBER	6 th SEPTEMBER
CONE ROUNDNESS	0.00005	0.000021	0.000031	0.000025	0.000035	0.00004	0.000042
CONE STRAIGHTNE SS	0.0001	0.000052	0.000045	0.000065	0.000061	0.00007	0.00008
INNER-SEAL FLATNESS	0.00003	0.000016	0.000011	0.000012	0.000013	0.000023	0.000028
OUTER-SEAL FLATNESS	0.00007	0.000012	0.000041	0.000038	0.000031	0.00005	0.000062
CUP FACE ROUGHNESS	10	5.12	5.45	6.19	3.97	4.5	7
CONE ANGLE	45	44.96	45.75	44	45.83	44.9	43.5
