Property Inspection Report

17860 Windflower Way, #1801, Dallas, TX 75252

Date of Inspection: 3/13/2019 Time: 11:00 am

Inspector: Clint Carpenter

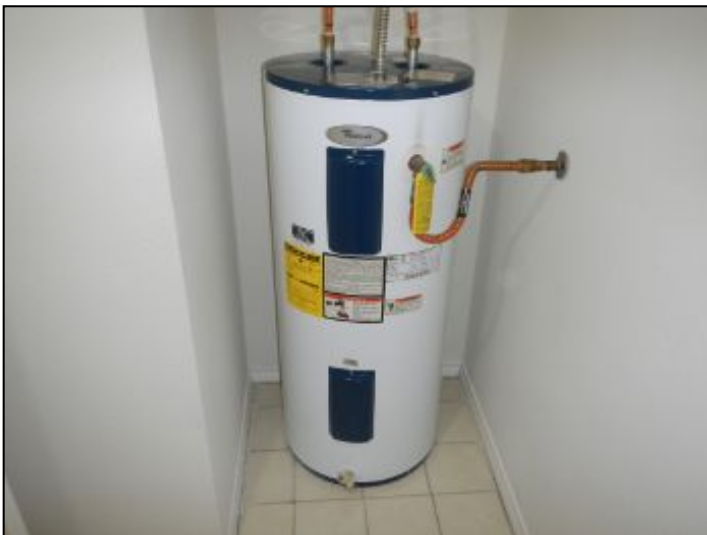
Whirlpool E2F40RD045V Serial #: 0636117580
Mfg. 09/2006

C.1. Drip pan is missing from under the water heater. I recommend having a drip pan installed to prevent any water damage.

C.2. There is no water heater **expansion tank** installed to allow for thermal expansion of water in the plumbing pipes. The house may have been built before the requirement for expansion tanks was set in place. Although it may not be required, I recommend the installation of an expansion tank by a qualified technician or plumbing contractor.

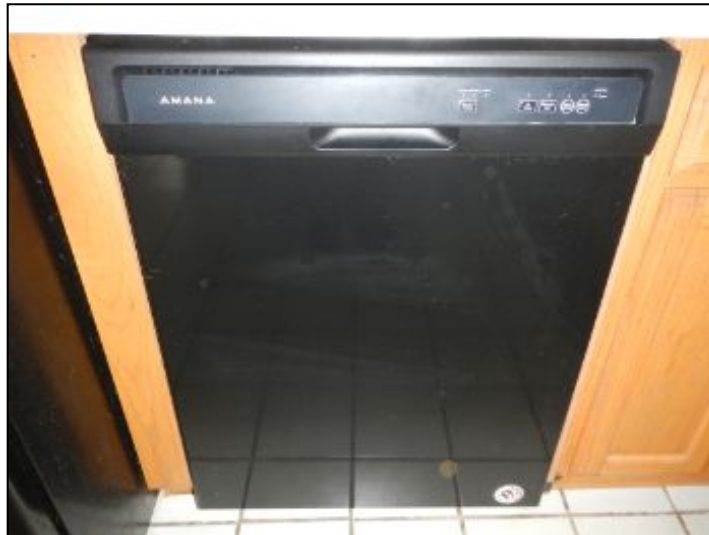
Amana ADB1300AFB0 Serial #: F64511159

A.2. Lack of a proper **air gap** noted at the dishwasher drain lines. In the event of a sewer backup this device prevents sewer matter from entering into dishwasher. I recommend having a qualified plumber install an air gap to prevent possible contamination.

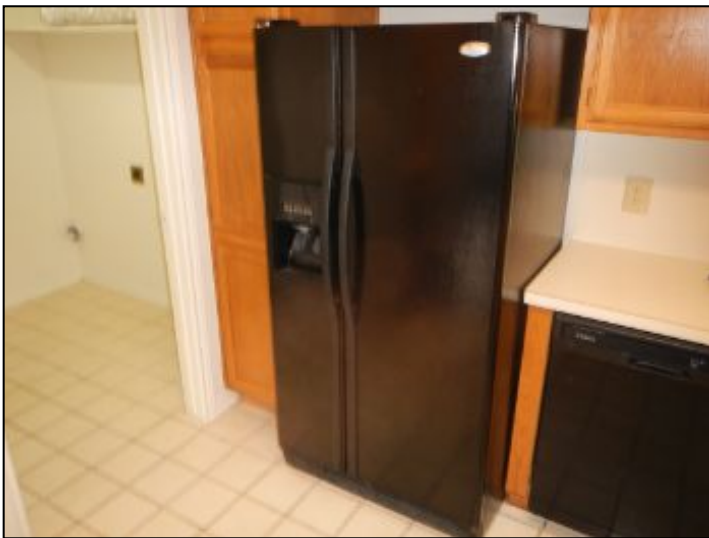
Whirlpool ED2VHEXVB00 Serial #:
HRW1408316

I.2. I was unable to retrieve any ice from the ice dispenser. It appears to be inoperable.

I.3. One of the pull-out drawers was cracked.
