# Installation of the new electronics for the Helix array 2 (Malargue December 2016)

## Abstract

We present here a first report on the installation of the helix antennas with the new electronics. We show also onsite measurements. 6

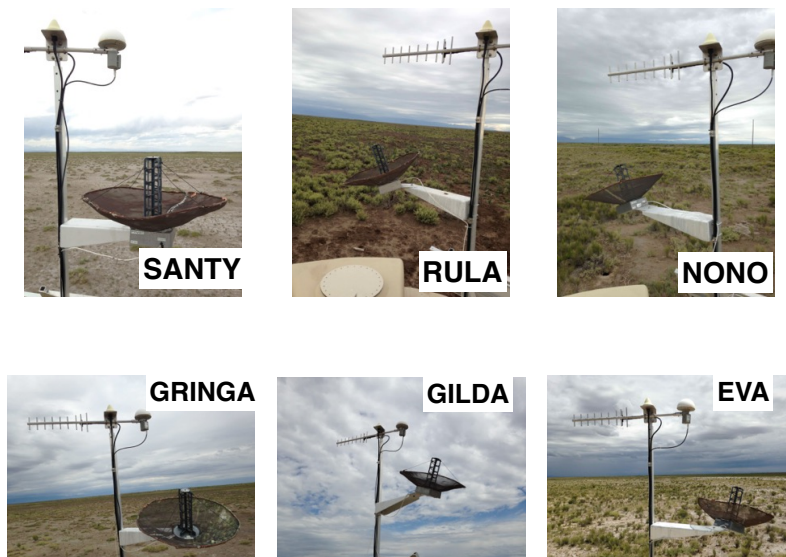
no particular issue during the installations and we spent approximately 30 minutes per tank. The pictures of the antennas once installed can be found on the Figure 3.

Figure 3 Picture of all the antennas (except Jorge)

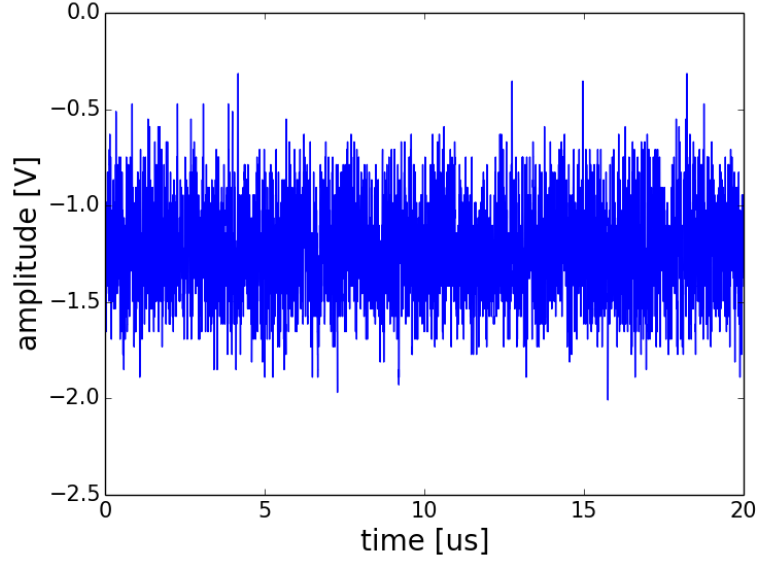
We also recorded waveform with the Picoscope. An example of a  $20\mu s$  long waveform recorded on Rula is shown in the Figure 7.

Figure 7 example of a trace recorded on Santy tank
