Helix detector status: May 2016

This note presents the status of the helix detectors. At the end of May 2016 they were all removed from the field and tested in the assembly building lab. We present the status in terms of mechanics and electronics.

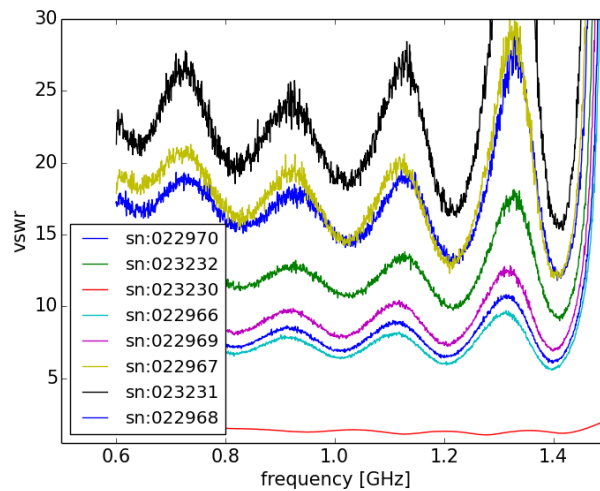
Figure 4 LNA VSWR

The characteristics of the LNA were also measured: the VSWR and the gain are shown 30 in the figure 4 and 5.

On the figure 5 it is clear that only one LNA is still working, the sn023230, that is the one that was installed on Nono. It has the expected gain (50dB) and a low VSWR. All of the 32

other ones are broken and almost all have the same characteristics.

So the LNA is the main failure of the system. The LNAs broke for an unknown reason. 34

Possible sources of failure are:

- a power surge at the LNA input (for instance an electro static discharge or an over 36
voltage due to a thunderstorm)
- the humid/water environment (for instance if the LNA was flooded inside the box) 38
