The Loma Prieta Earthquake: Implications of Structural Damage

S. A. Mahin

University of California, Berkeley, California

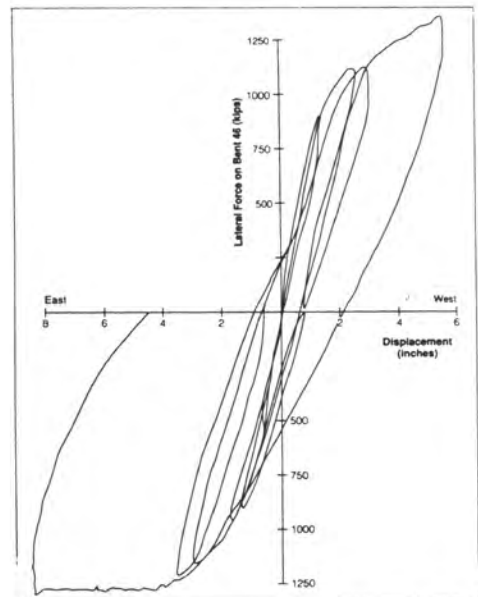
Fig. 27 Hysteretic Plots for Retrofit Viaduct
