# Post Flight Review

#2036  
INHARO

# Failure Analysis

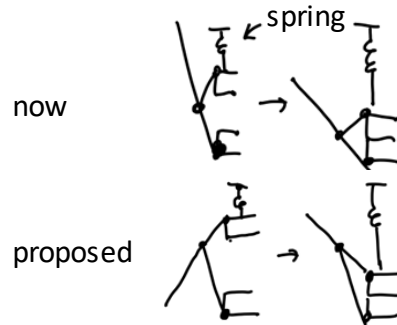
- Early deployment of parachute
- Parachute teared

- Parachute fastened with rubber band
- High-g during ascent caused parachute deployment

- Add a container to secure the parachute properly
- Reinforce the hole on parachute using some grommets
