**Report of the Chief Inspector of Marine Accidents
into the grounding and subsequent salvage of the tanker**

SEA EMPRESS

at Milford Haven

between 15 and 21 February 1996

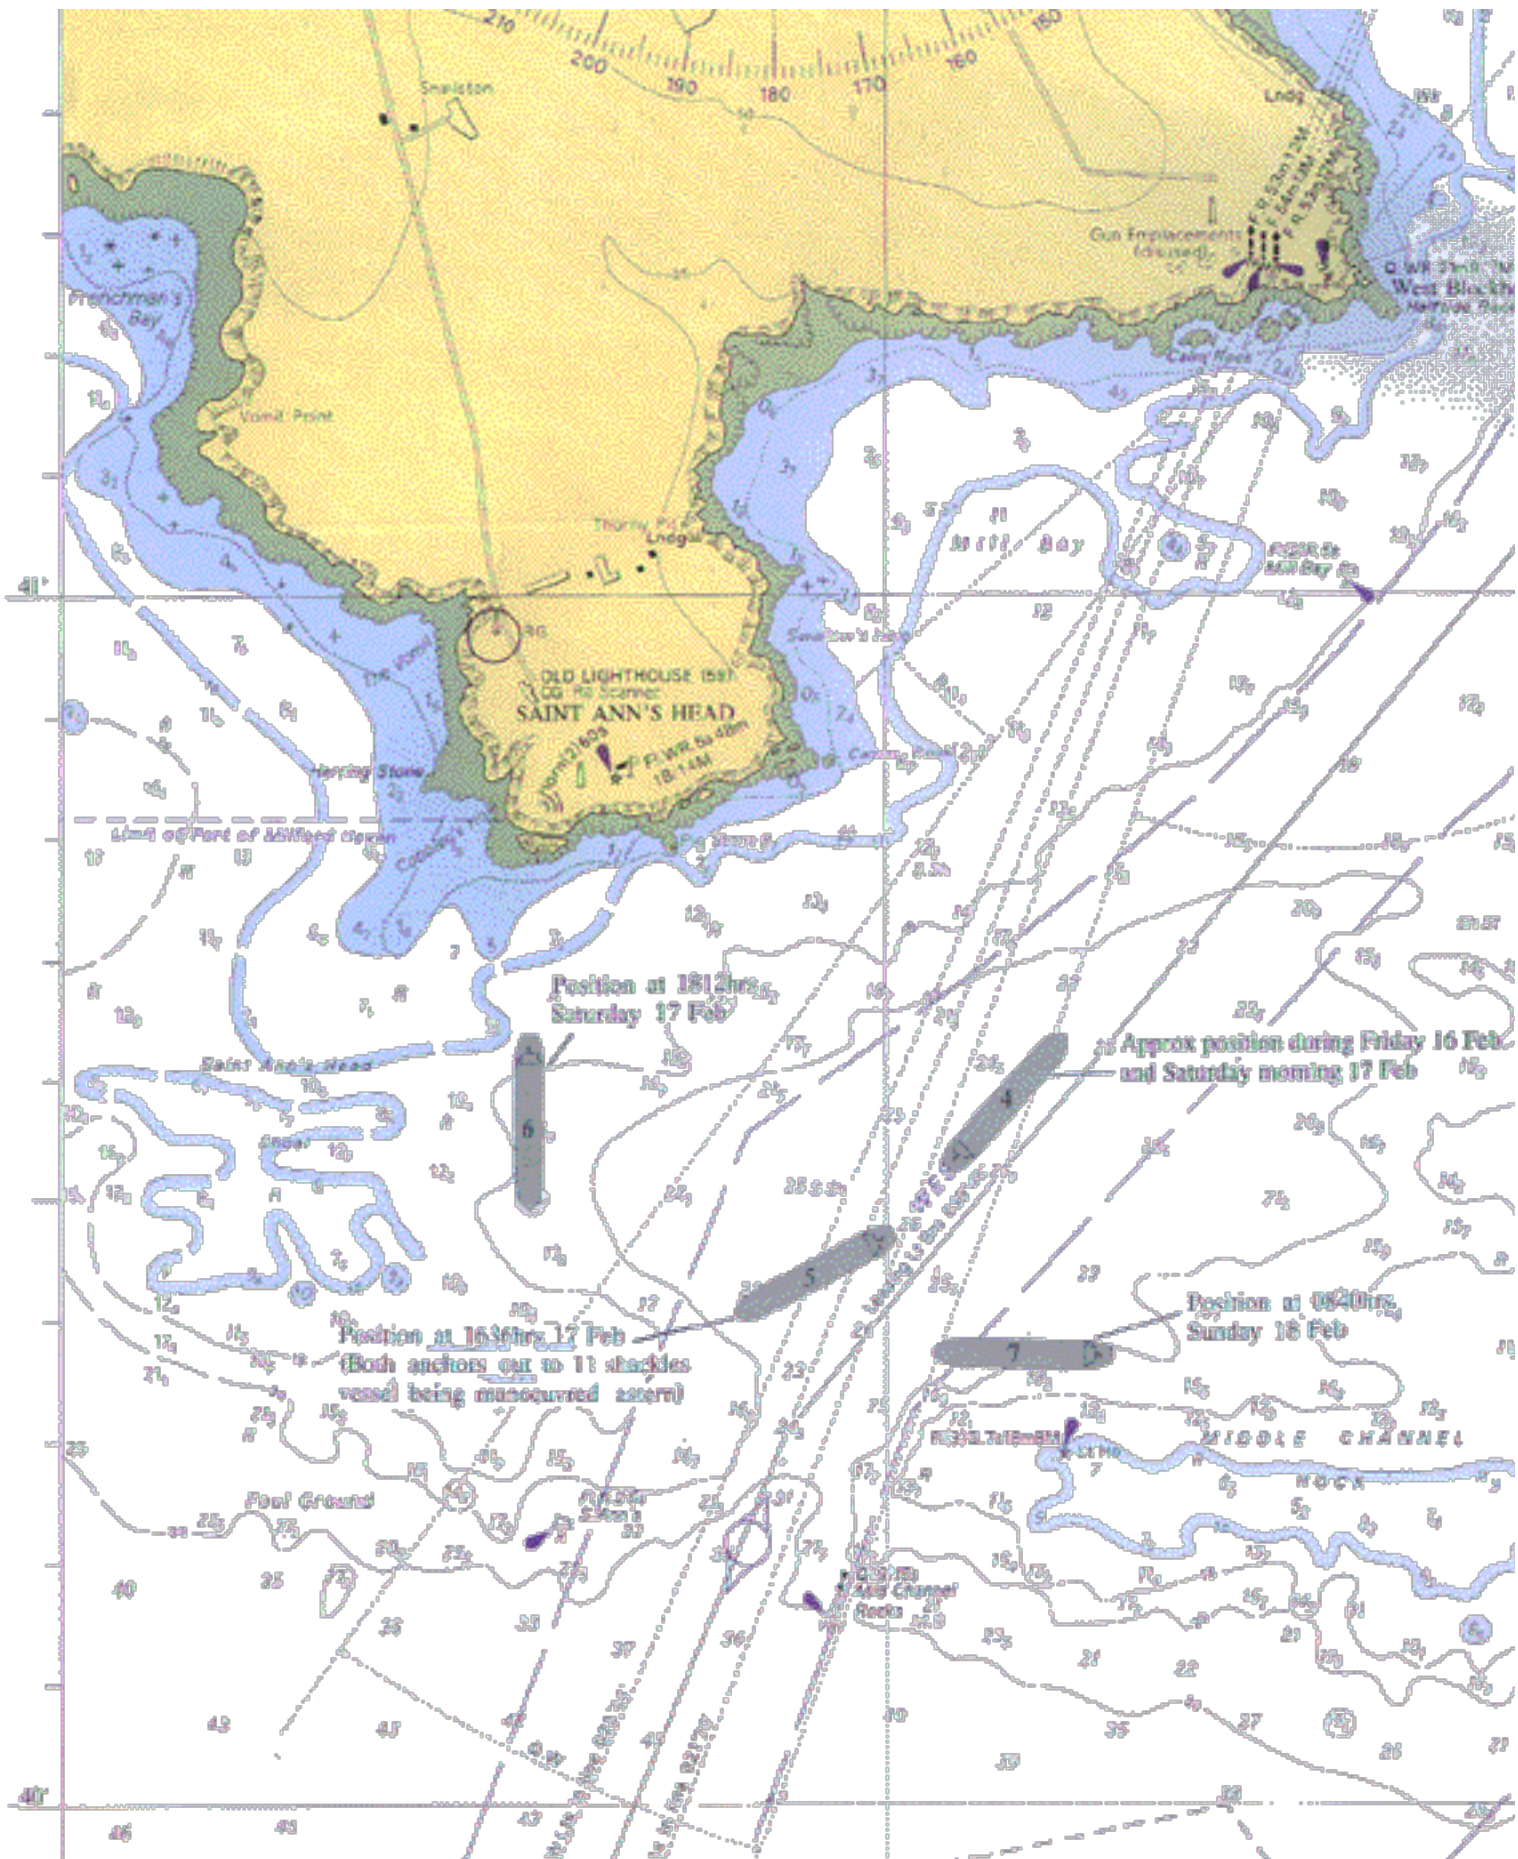
Figure 3.

Positions of the SEA EMPRESS on Saturday 17 Febuary to Sunday 18 February

being carried easterly across the 'pool' but the tugs were unable to hold her. In an attempt to control the movement ANGLIAN EARL (84 tpb) parted her tow line which had snagged on the bottom and ANGLIAN DUKE (100 tpb) alone tried to keep the stern of the casualty away from the Middle Channel Rocks Light. However at about 0840 hrs she grounded to the north of the Light and ANGLIAN DUKE (100 tpb) had to slip her tow because she herself was manoeuvring too close to the rocks and in danger of grounding (see Figure 3 Image 100k).

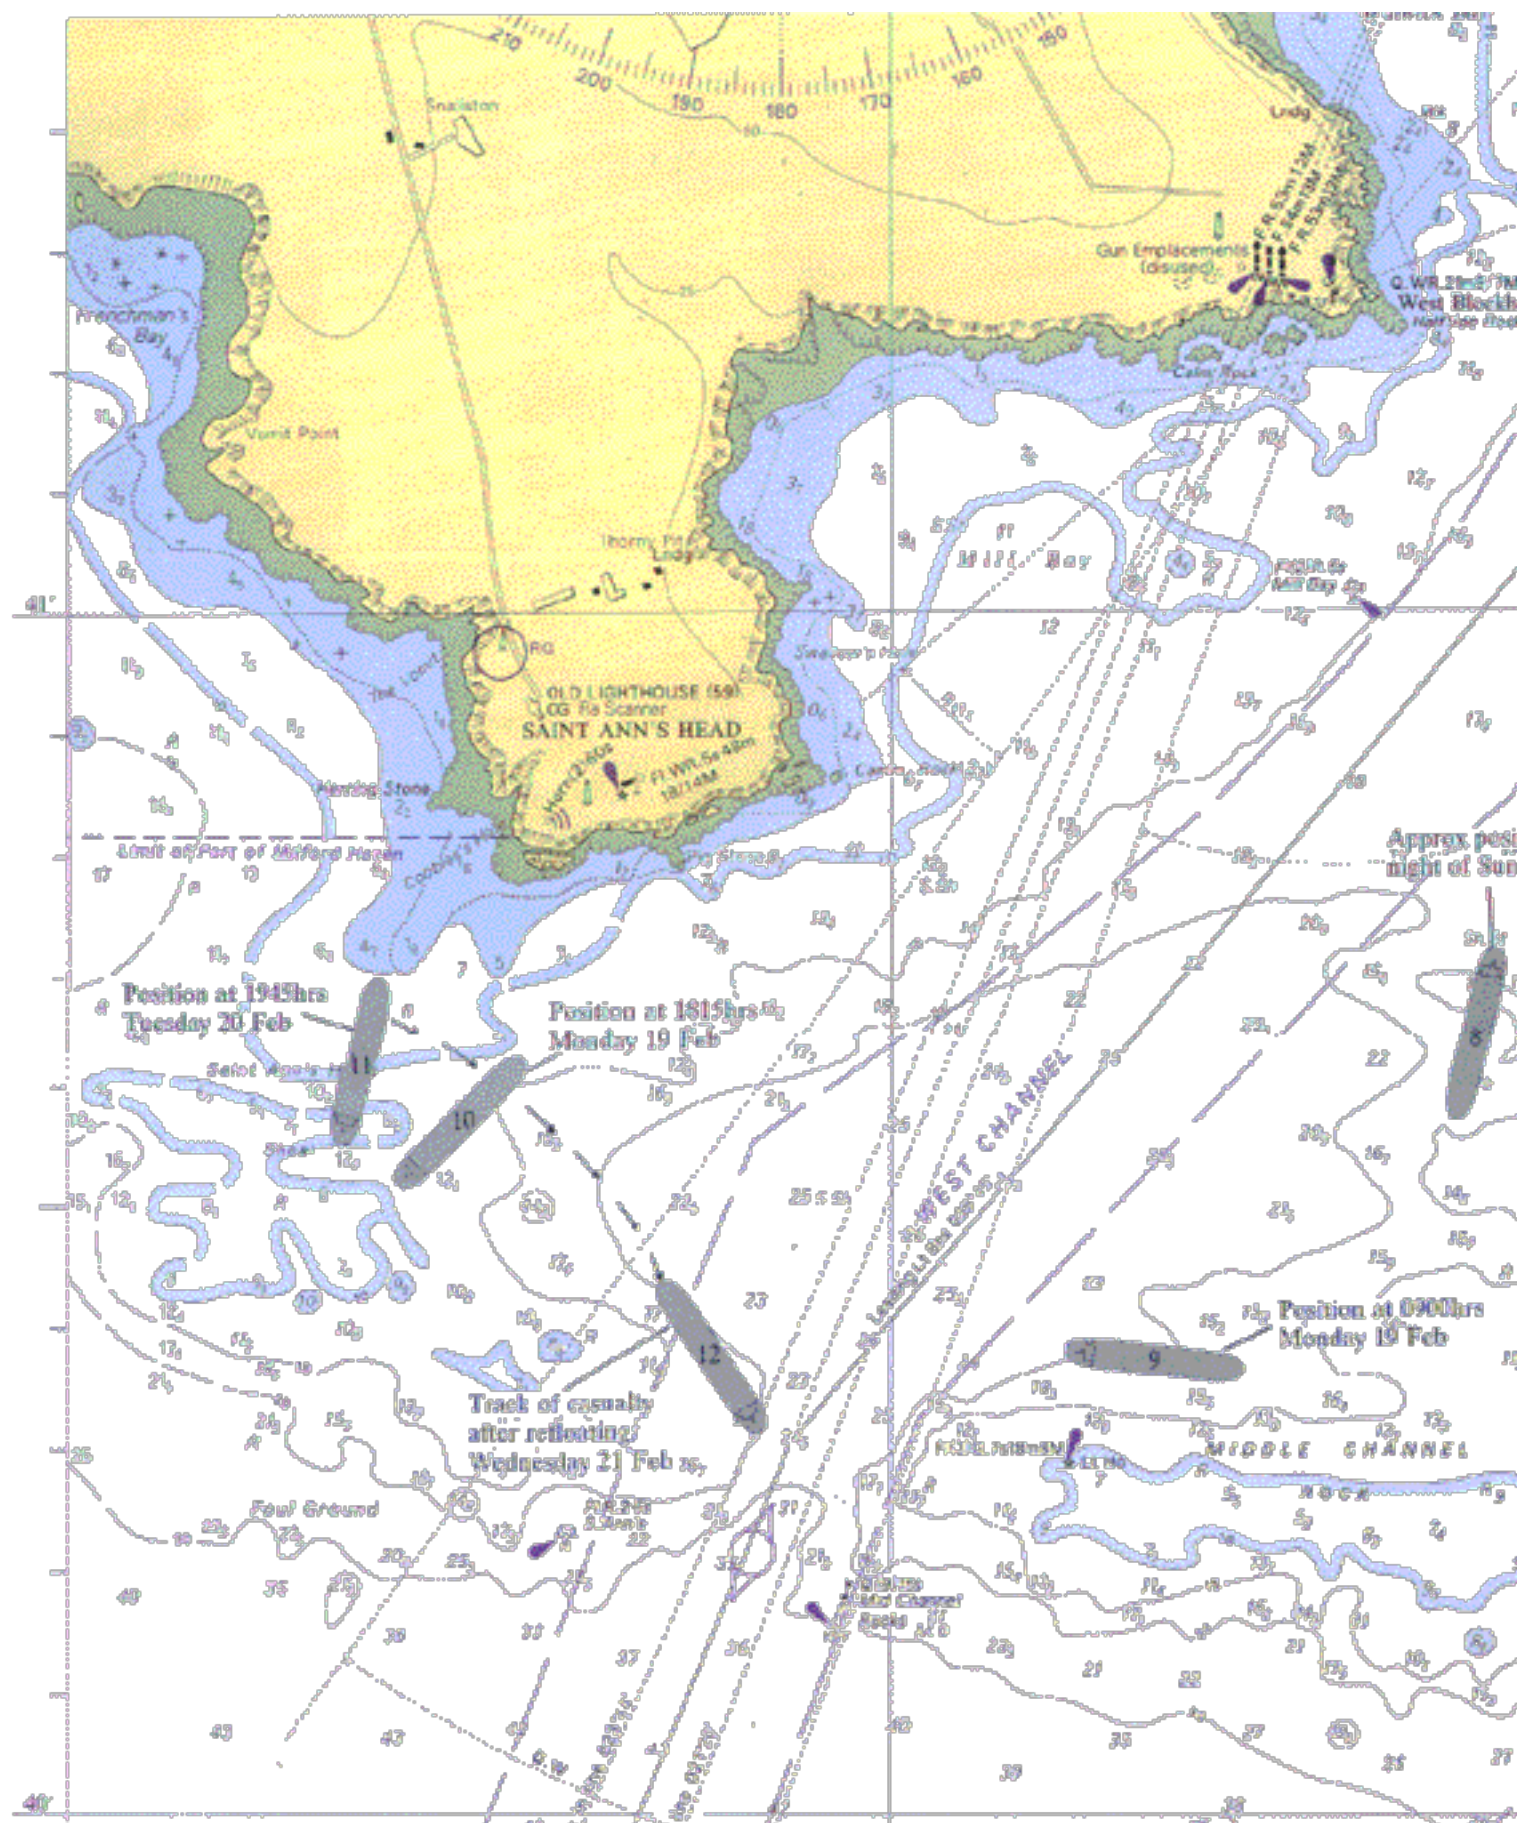
Figure 4.

Positions of the SEA EMPRESS on Sunday 18
February to Final Floating on Wednesday 21 February

D.4.13 Subsequently ANGLIAN DUKE (100 tpb) was instructed to assist DE YUE (200 tpb) and she made fast with one of her mooring ropes to the port bow of DE YUE (200 tpb) but at about 1700 hrs this mooring line parted. ANGLIAN DUKE (100 tpb) was then repositioned to push on the starboard bow of DE YUE (200 tpb), however in the swell conditions both tugs began to sustain damage and this operation was quickly aborted. At about this time ANGLIAN EARL (84 tpb) made fast on the port bow of the casualty after which the salvors had to leave the casualty as the helicopter (R169) had to return to its base at Chivenor. The casualty at this time was aground about 6 cables northeast of Middle Channel Rocks Light (see Figure 4 Image 97k).

D.4.22 ANGLIAN DUKE (100 tpb) and ANGLIAN EARL (84 tpb) remained connected to SEA EMPRESS with instructions from the Senior Salvage Master, to hold the casualty on the east side of the 'pool'. At about 0600 hrs, immediately prior to the time of the predicted high water, the Masters of ANGLIAN DUKE (100 tpb) and ANGLIAN EARL (84 tpb) observed that the casualty was again moving. The stern was beginning to swing to starboard towards the Middle Channel Rocks Light. Despite the efforts of the tugs to control the casualty, at about 0900 hrs SEA EMPRESS ran aground again on an easterly heading, to the north of the Middle Channel Rocks Light (see Figure 4 Image 97k). The two tugs remained connected to the casualty laying to their tow lines.

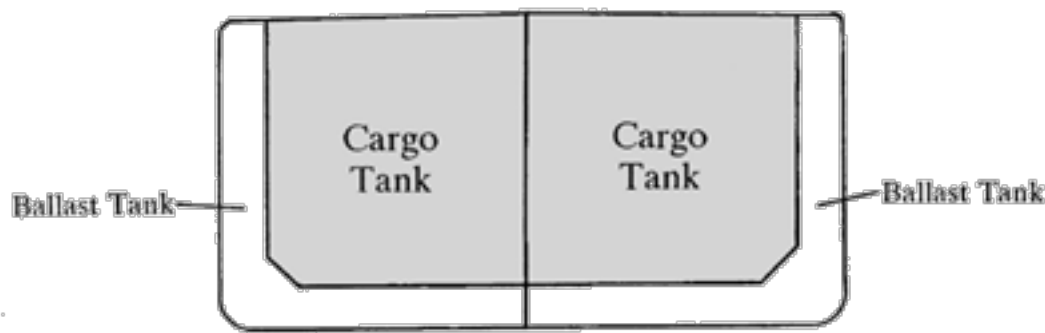
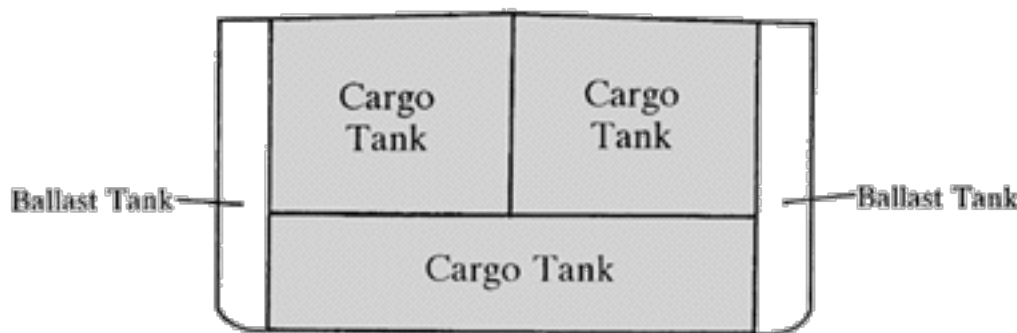
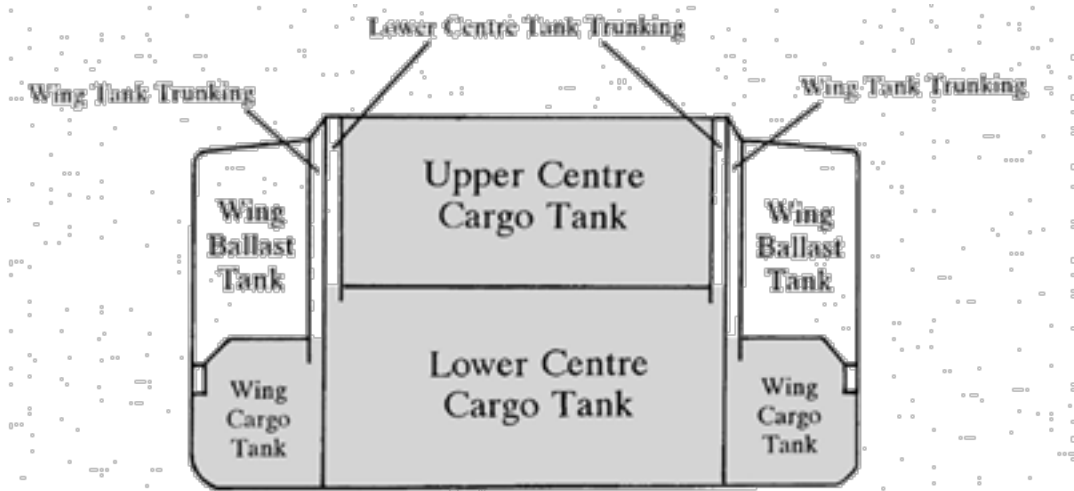
Figure 8.

20.15 There are many design concepts which have been proposed to reduce the risk of pollution in the event of an accident. International attention is increasingly focused on three main types: the Double Hull tanker, the Mid-deck tanker and the Coulombi Egg tanker. A typical cross-section for each of these types is shown in Figure 8 (Image 37k), but to date only the double hull tanker type has actually been constructed.

Typical Cross Sections of Various Tanker Types

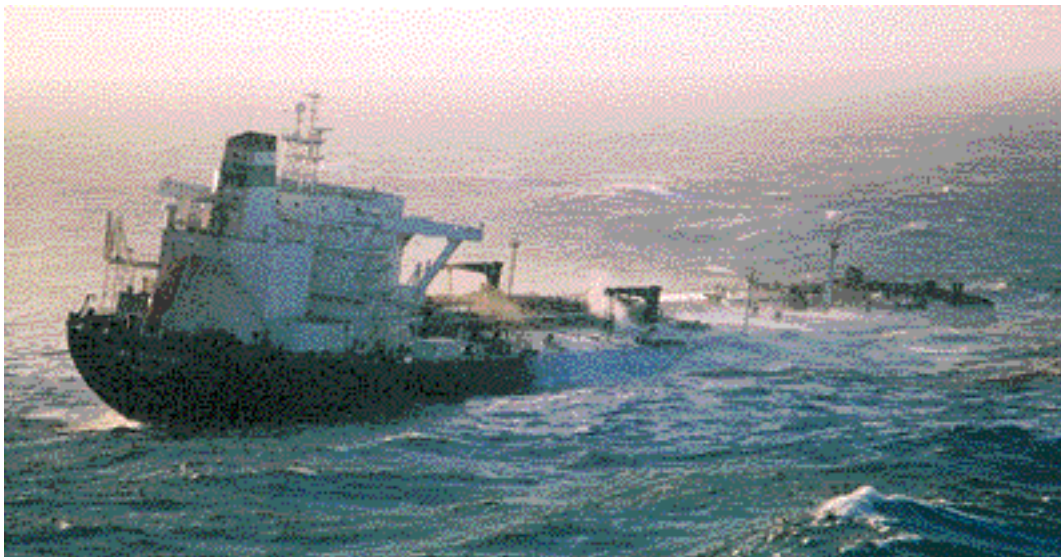
Photograph 1.

SEA EMPRESS on Sunday 18 February

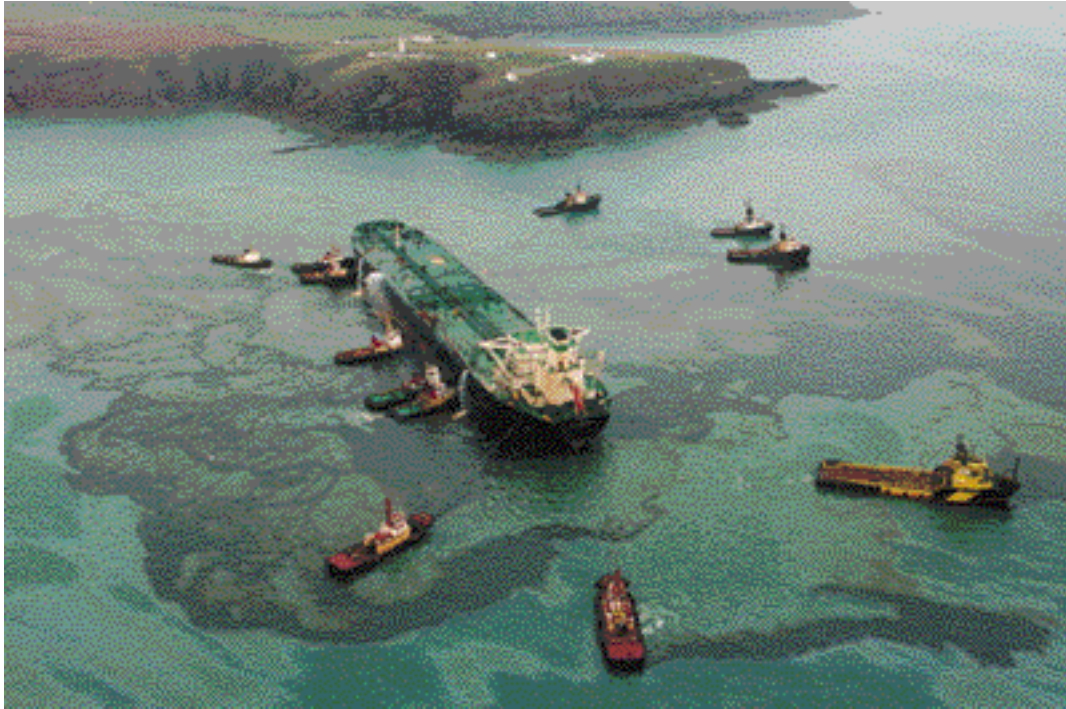
Photograph 2.

SEA EMPRESS and tugs on Wednesday 21 February
