SUMMARY
1234 Main Street McDonough GA
30252
Buyer Name
11/30/2023 9:00AM

Tanner Hall
ASHI
Avalon Home Inspections
678-782-3497
info@avalonhomeinspections.net

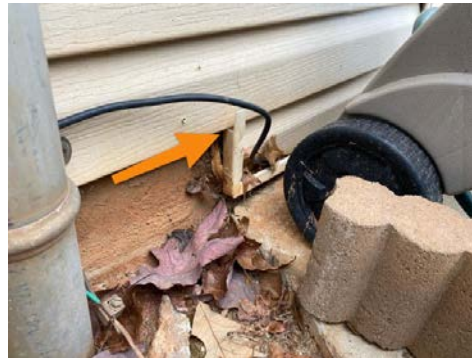
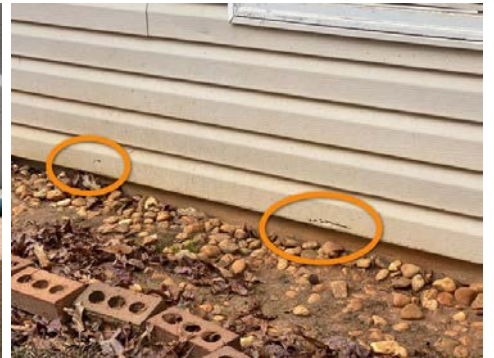
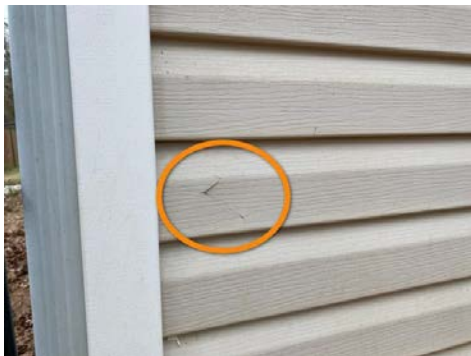
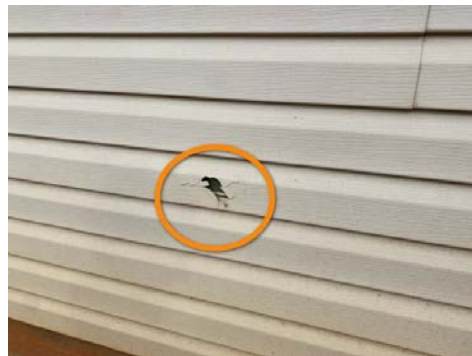
VINYL SIDING - DAMAGE

There was some degree of damage present to areas of the vinyl siding (holes, cracks, etc.). Repairs or replacement of damaged sections is recommended to be conducted as needed by an exterior contractor or other qualified person.

Recommendation
Contact a qualified siding specialist.

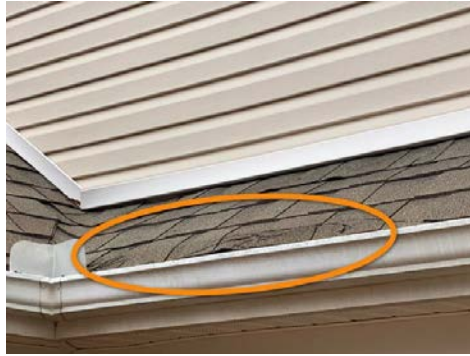
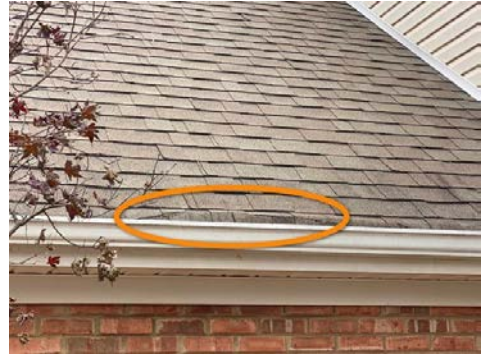
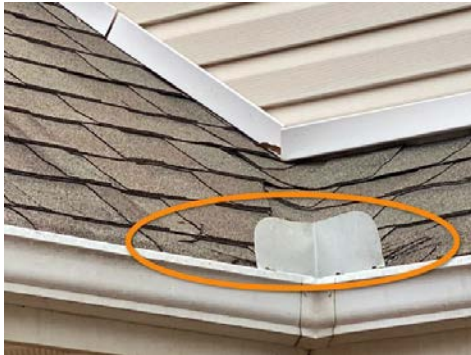
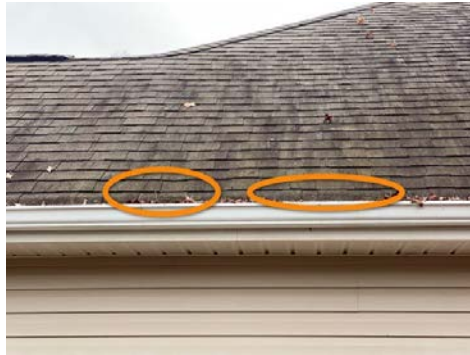
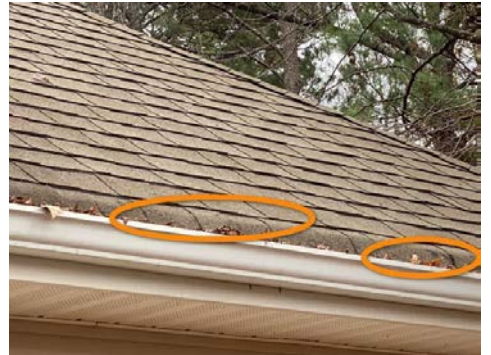
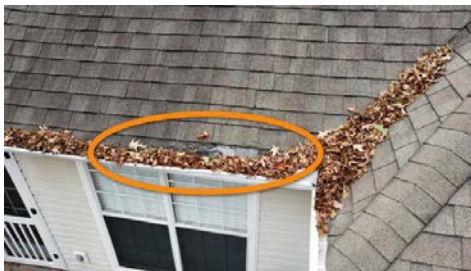
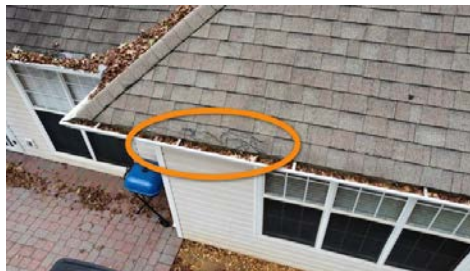
SHINGLES - DAMAGED

There were damaged shingle(s) present on the roof surface. Repairs to the affected shingle(s) is recommended to be conducted as needed by a roofing contractor.

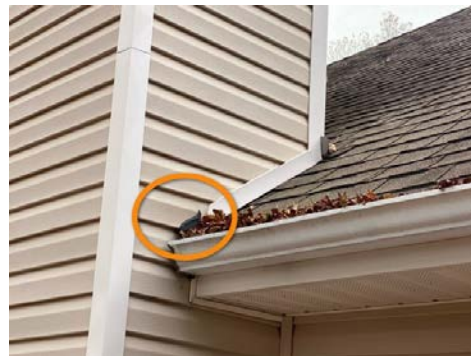
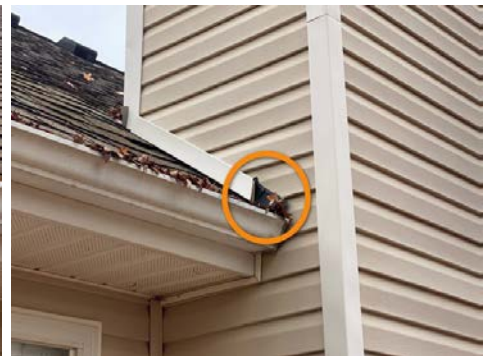
5.5.1 Roof Flashings KICKOUT - MISSING

Kickout flashing was not present in area(s) where guttering and/or fascia abutted a sidewall. The installation of kickout flashing is recommended to be performed by a roofing contractor at any areas where gutters or fascia meet a sidewall, preventing rain water from infiltrating between the end of the gutter/fascia and the wall. Hidden damage may exist in areas where kickout flashing is missing and this should be investigated during the installation of kickout flashing. This is a 2015 code and the seller is not obligated to update home to today's standards.

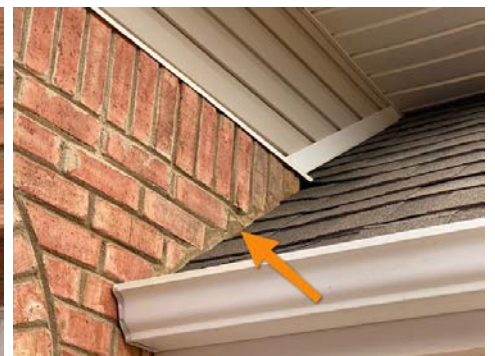
SIDEWALL - MISSING (MASONRY)

Proper sidewall flashing was not present where a lower roof abutted a sidewall. Some form of flashing is presumed to be present behind the brick, as no indications of leaks were present at visible/adjacent areas at the time of inspection. In a proper application, step and counter flashing would be visible here. The installation of proper step and counter flashing is recommended to be conducted by a qualified roofing contractor.

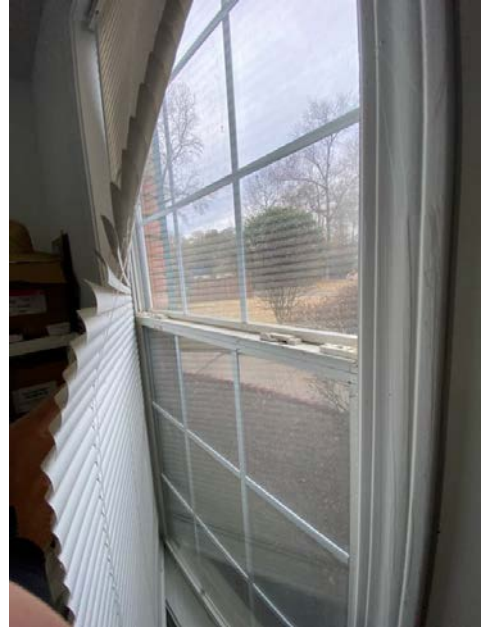
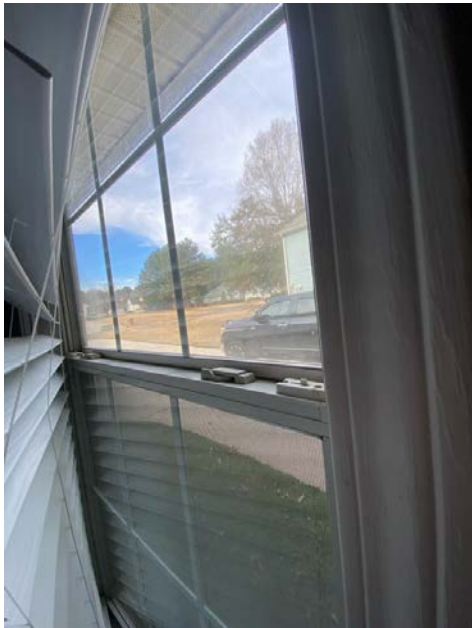
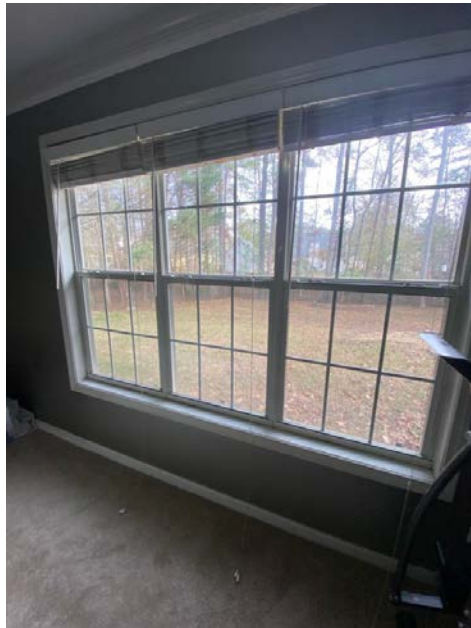
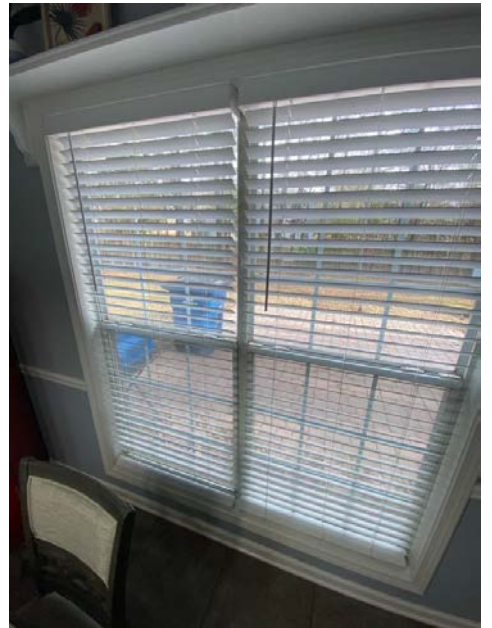
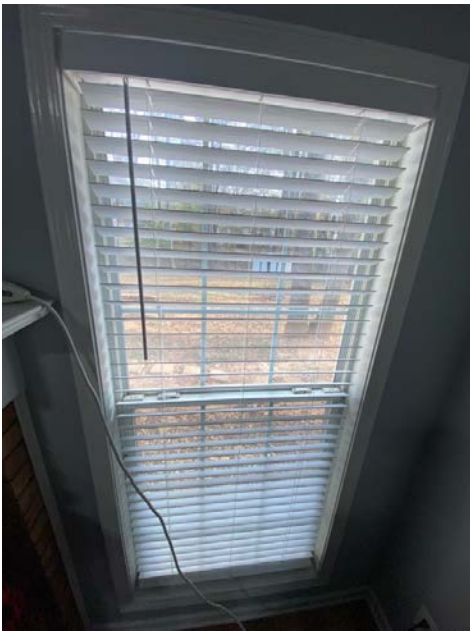
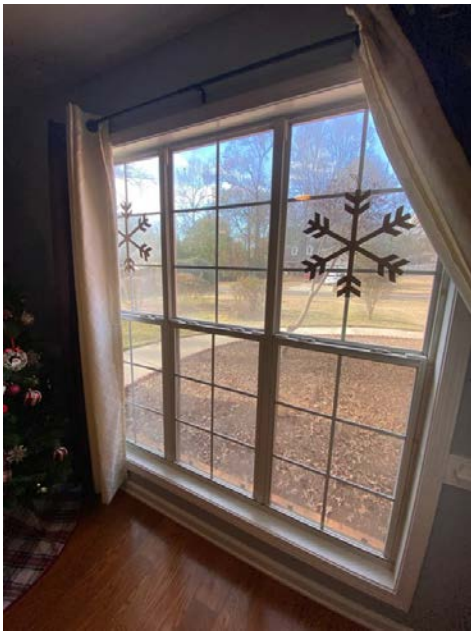
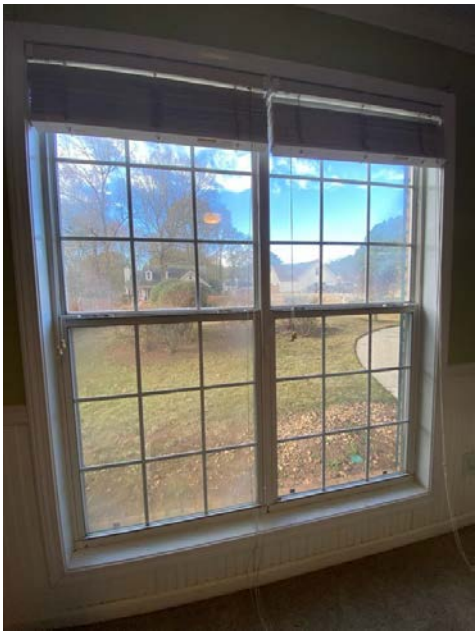
WINDOWS - CLOUDY (SEAL FAILURE)

Contact a qualified window repair/installation contractor.

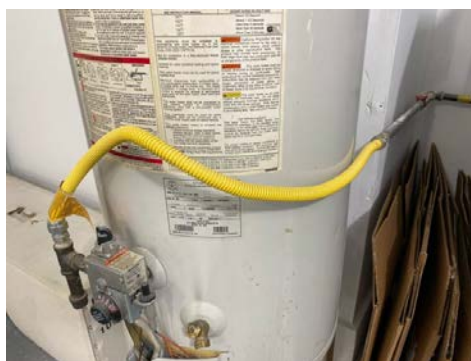
Garage

Manufacturers of black jacketed CSST products which have been tested and listed to ICC-ES E-1024, "CSST Utilizing a Protective Jacket," may not require or include in their instructions the additional direct-bonding step that is required with standard (yellow) CSST products. However local codes are controlling and may differ from manufacturer's requirements. Local codes are governing and must be adhered to.
