BURNED-AREA REPORT
(Reference FSH 2509.13)

- ☐ 1. Initial Request (Best estimate of funds needed to complete eligible stabilization measures)
- ☒ 2. Interim Report **# 1** **Interim report #1 Items are in Bold and in Red Font**
 - ☒ Updating the initial funding request based on more accurate site data or design analysis
 - ☐ Status of accomplishments to date
- ☐ 3. Final Report (Following completion of work)

- A. Fire Name: El Portal Fire B. Fire Number: CA-YNP-0083
- C. State: CA D. County: Mariposa County
- E. Region: 5 F. Forest: Stanislaus National Forest
- G. District: Groveland District H. Fire Incident Job Code: PPH9MF
- I. Date Fire Started: Saturday July 26th, 2014 J. Date Fire Contained: August 6, 2014
- K. Suppression Cost: Approximately \$10 million as of August 8, 2014
- L. Fire Suppression Damages Repaired with Suppression Funds
- Fireline waterbarred: 12.3 miles of Forest Service Dozerline
 - Fireline seeded (miles): None
 - Other (identify): None
- M. Watershed Number: HUC 6 Watersheds: 180400080306 Crane Creek-Merced River; 180400080305 Indian Creek-Merced River; 180400080307 Moss Creek-Merced River
- N. Total Acres Burned: Total 4,729 NFS Acres (3,575) Other Fed

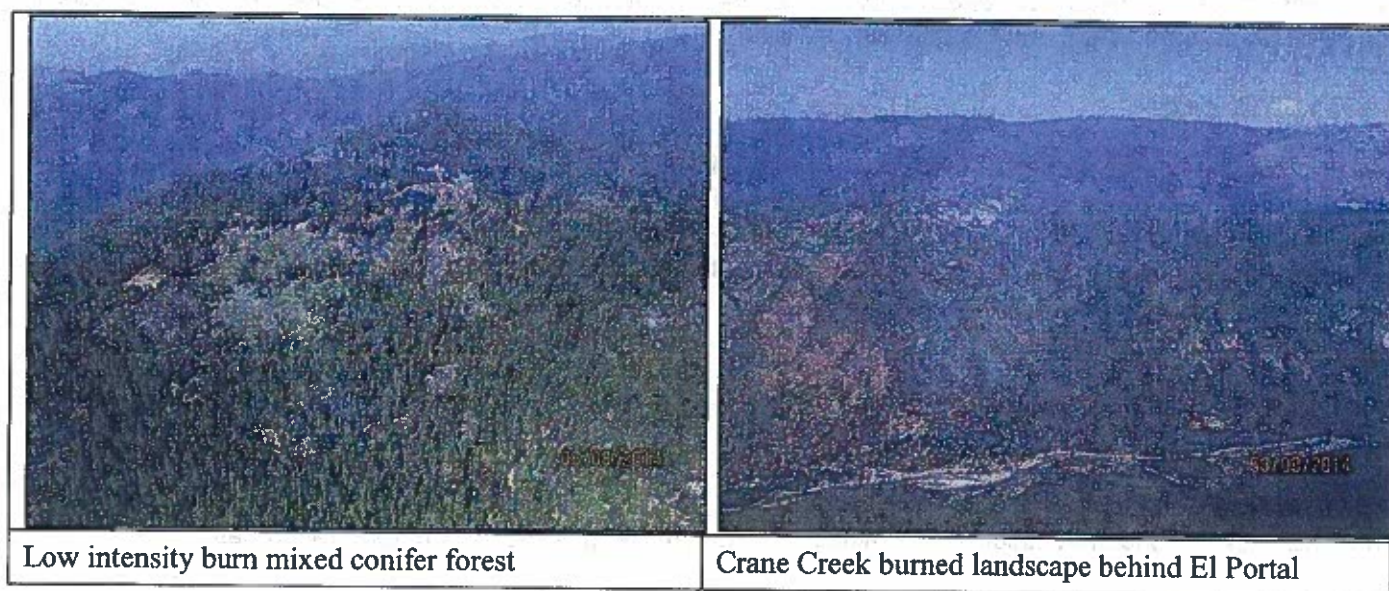
Forested areas in the upper watershed burned in the Arch Rock Fire in 1990 and re-burned with mixed severity in the EI Portal Fire. Areas that were lower elevations that were a mix of chaparral and Interior Live Oak burned hotter with complete mortality that burned hot leaving a bleak ashen landscape (see pics below). It is important to note that threats to life, property, and natural resources from flooding and debris flows exist.
