**BURNED-AREA REPORT**  
(Reference FSH 2509.13)**PART I - TYPE OF REQUEST**

**PART II - BURNED-AREA DESCRIPTION**A. Fire Name: GaviotaB. Fire Number: CASBC 004032C. State: CAD. County: Santa BarbaraE. Region: 5F. Forest: Los PadresG. District: Santa BarbaraH. Date Fire Started: 06-05-2004 I. Date Fire Controlled: Contained on 6/10, control expected 6/14J. Suppression Cost: approximately 5 million dollars

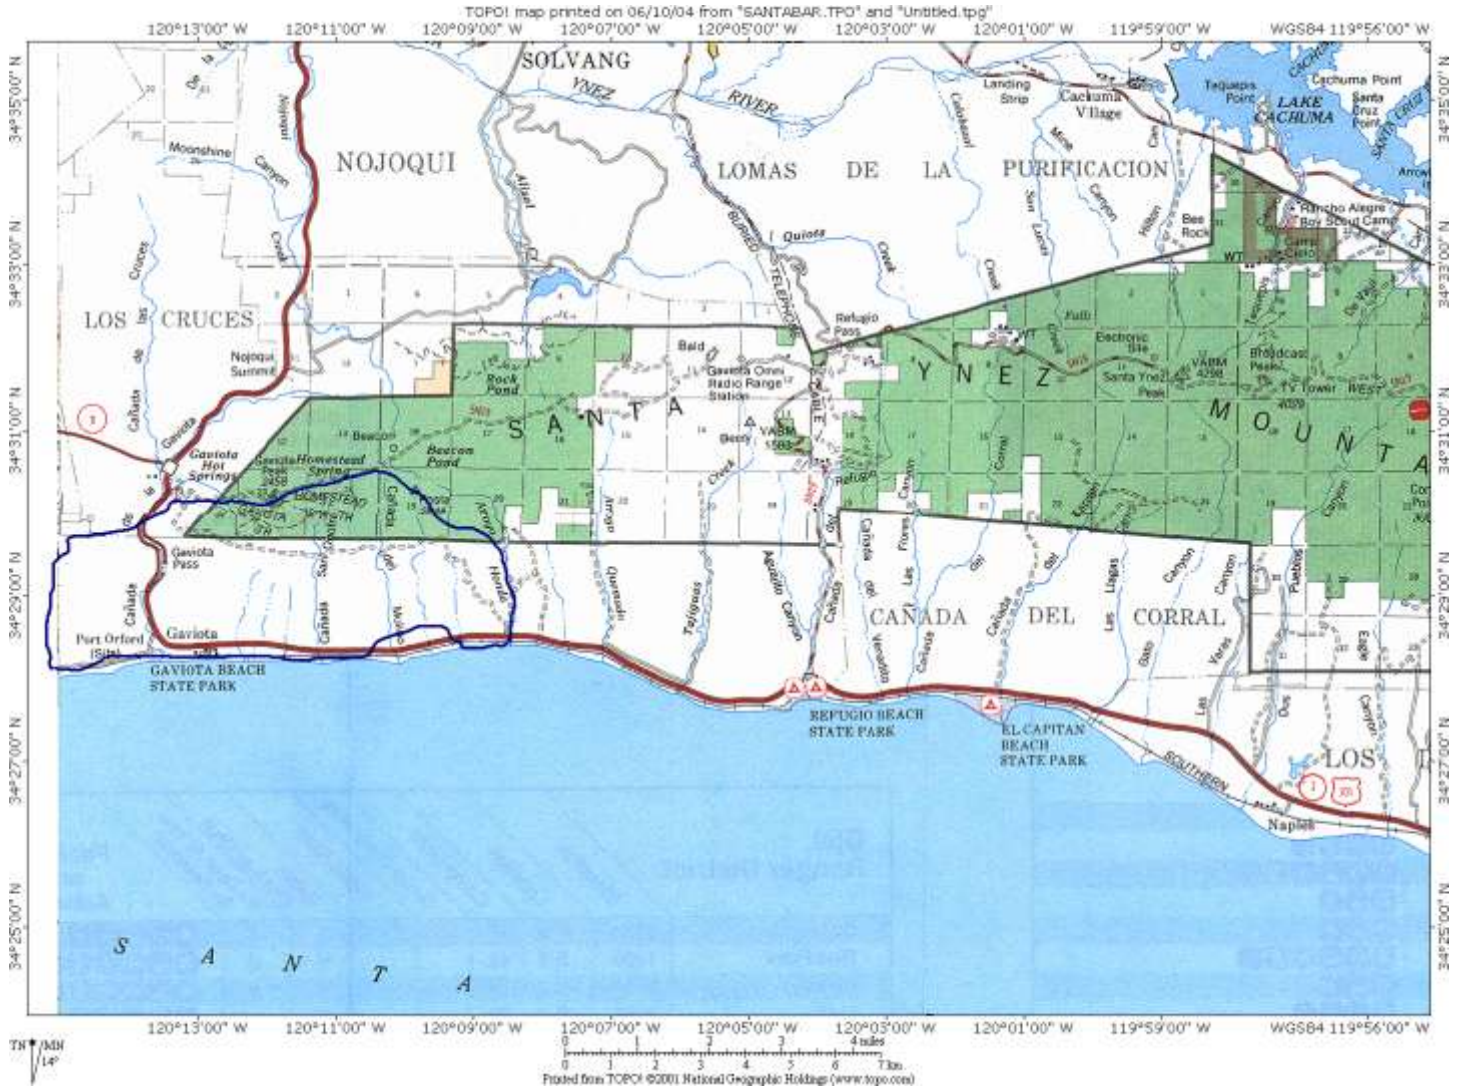
Map #1. Overview of Gaviota Burn Perimeter.

- A. Describe Watershed Emergency: Loss of water control at creek crossings under Hwy 101 and the Union Pacific railway along the Gaviota Coast (see Map 1 and 2).
