**KERLIN FIRE BURNED-AREA REPORT**  
(Reference FSH 2509.13)

Subject: Kerlin Fire Burned Area Report

A. Fire Name: Kerlin Fire B. Fire Number: CA-SHF-001438  
C. State: CA D. County: Trinity  
E. Region: 5 F. Forest: Shasta-Trinity  
G. District: SFMU H. Fire Incident Job Code: P5L4KN18  
I. Date Fire Started: 9/12/2017 J. Date Fire Contained: 9/20/2018  
K. Suppression Cost: \$7.6 million

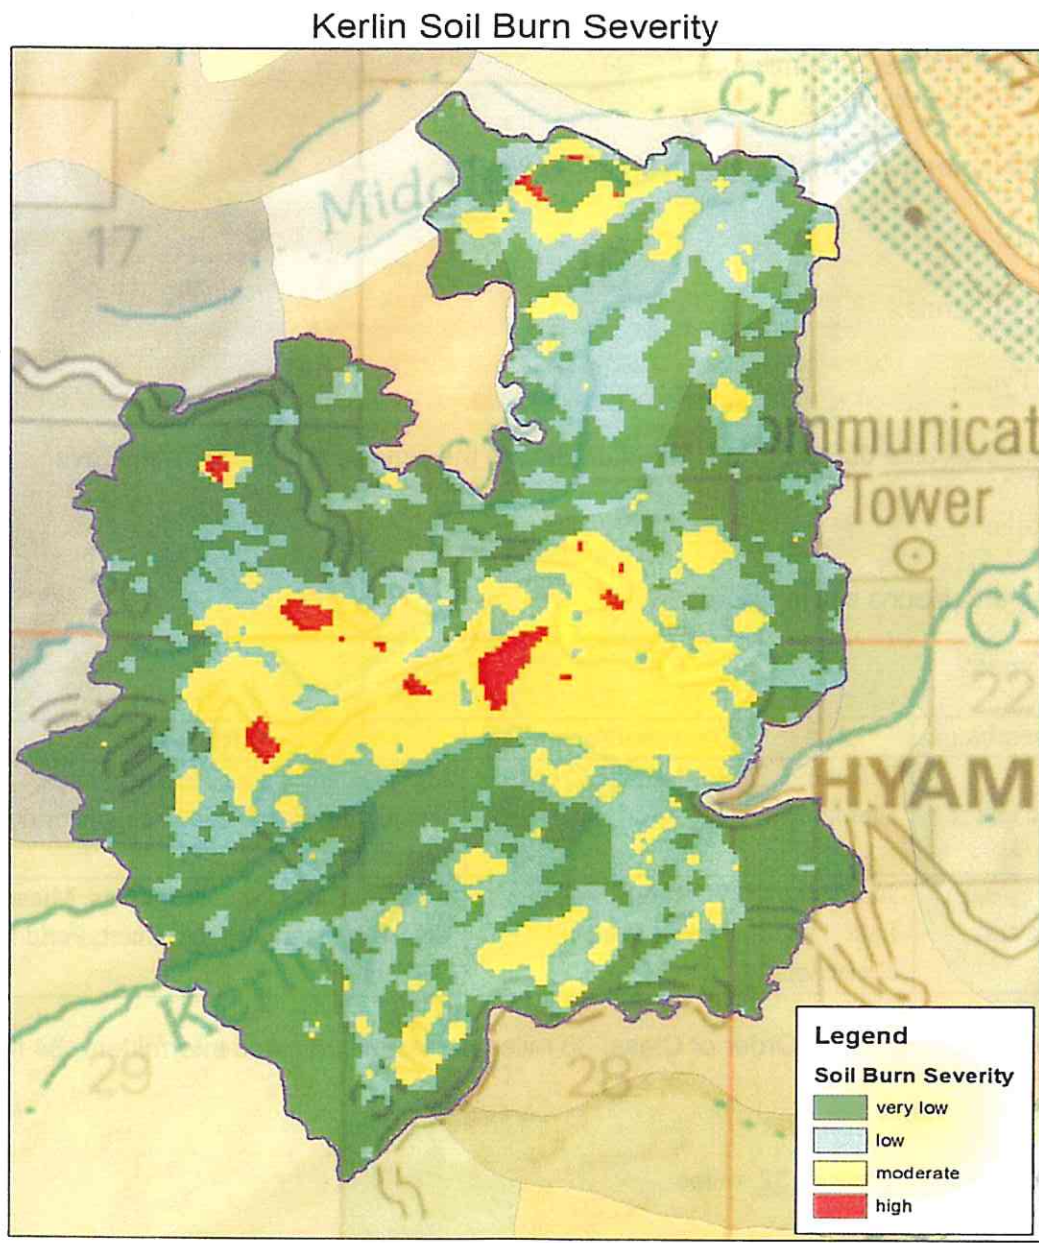
#### Kerlin Fire Final Soil Burn Severity Map:

Kerlin Fire Soil Burn Severity - Land Status Acres						
Land Status	Soil Burn Severity					
	unburned	very low	low	moderate	high	Grand Total
NON-FS	10.5	299.5	161.5	41.5	1.6	514.5
USDA FOREST SERVICE		550.6	358.9	307.4	19.9	1236.8
Grand Total	10.5	850.1	520.4	348.8	21.4	1751.2

General trends ridges burned moderate to high severity fed by aligned up-canyon South Fork River winds. Midslope areas burned moderate and lower areas along creeks and the Trinity River had low burn severity. In high soil burn severity areas on mixed brush/Douglas Fir/tanoak in Kerlin Creek had deep water repellency, deep, soil char, and repellency to 2 inches.
