USDA-FOREST SERVICE

BUCK FIRE BURNED-AREA REPORT
(Reference FSH 2509.13)

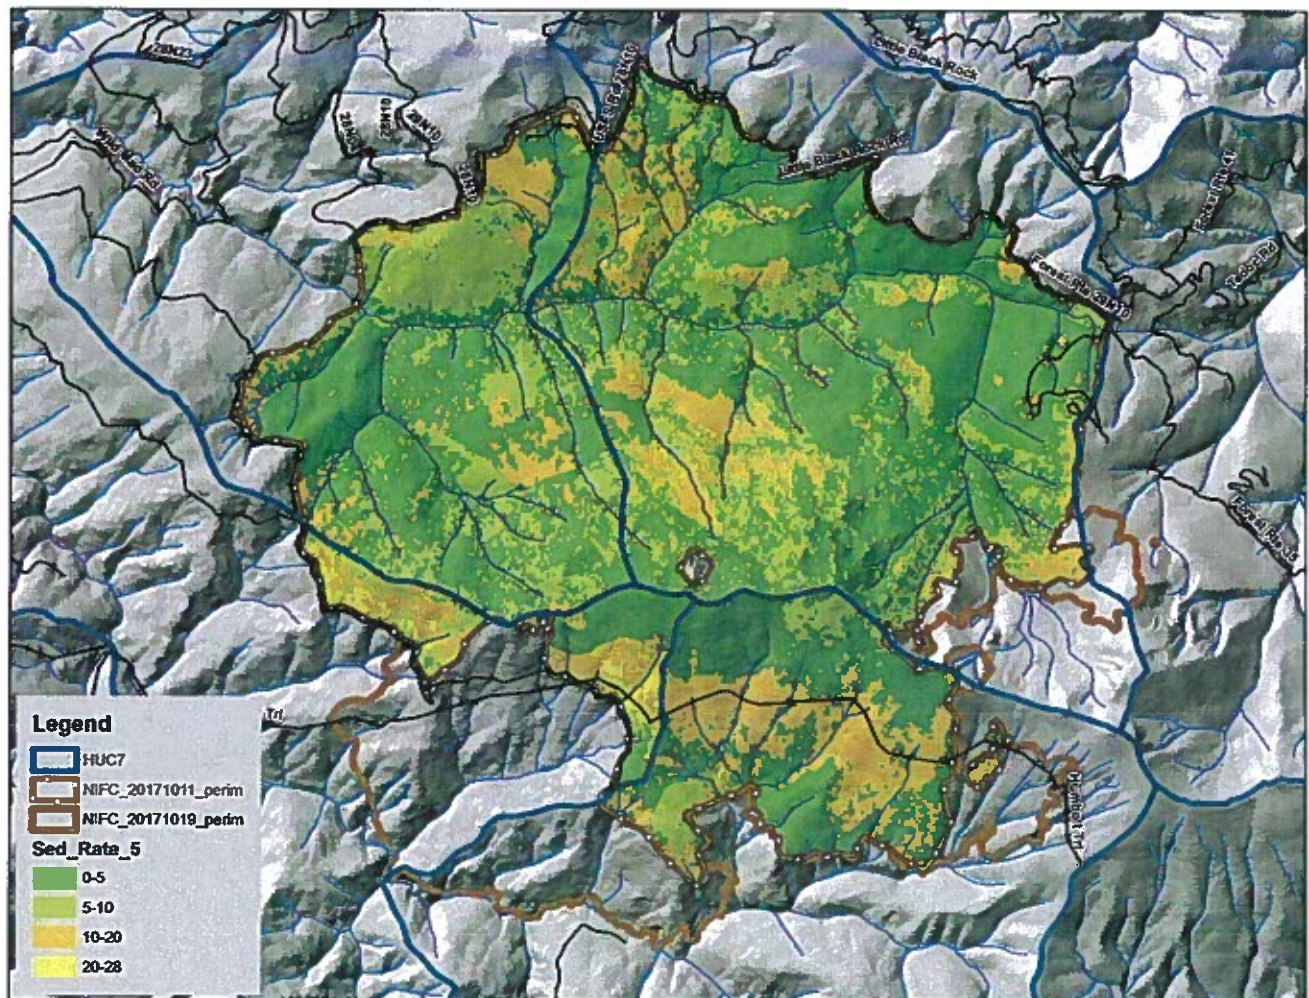
Map 4 – ERMiT Erosion Rate Map (tons/acre) for 5-year “runoff” event.

Map 4 (see below) display geographically the areas of greatest soil erosion risk. Areas identified with relatively high predicted erosion rates would represent priority areas for potential land treatments where erosion and sediment production pose a threat to values at risk. Treatments are often considered when predicted erosion rates exceed 20 tons/acre or more (personal threshold of concern). These areas would further be examined for treatment feasibility and suitability considering factors such as accessibility, slope gradient, stream density, and other down-slope values at risk. Most hillslopes within this fire are expected to produce under 20 tons/acre post-fire with a 5-year or 10-year event. Therefore increased post-fire flows will be relatively clean of soil, not substantially bulked flows, given events of reasonable magnitude (10-50% probability of occurring). Summer thunderstorms would present a much greater erosion

response, but these are notably very low probability events for any given specific location (again, actual risk is lower).

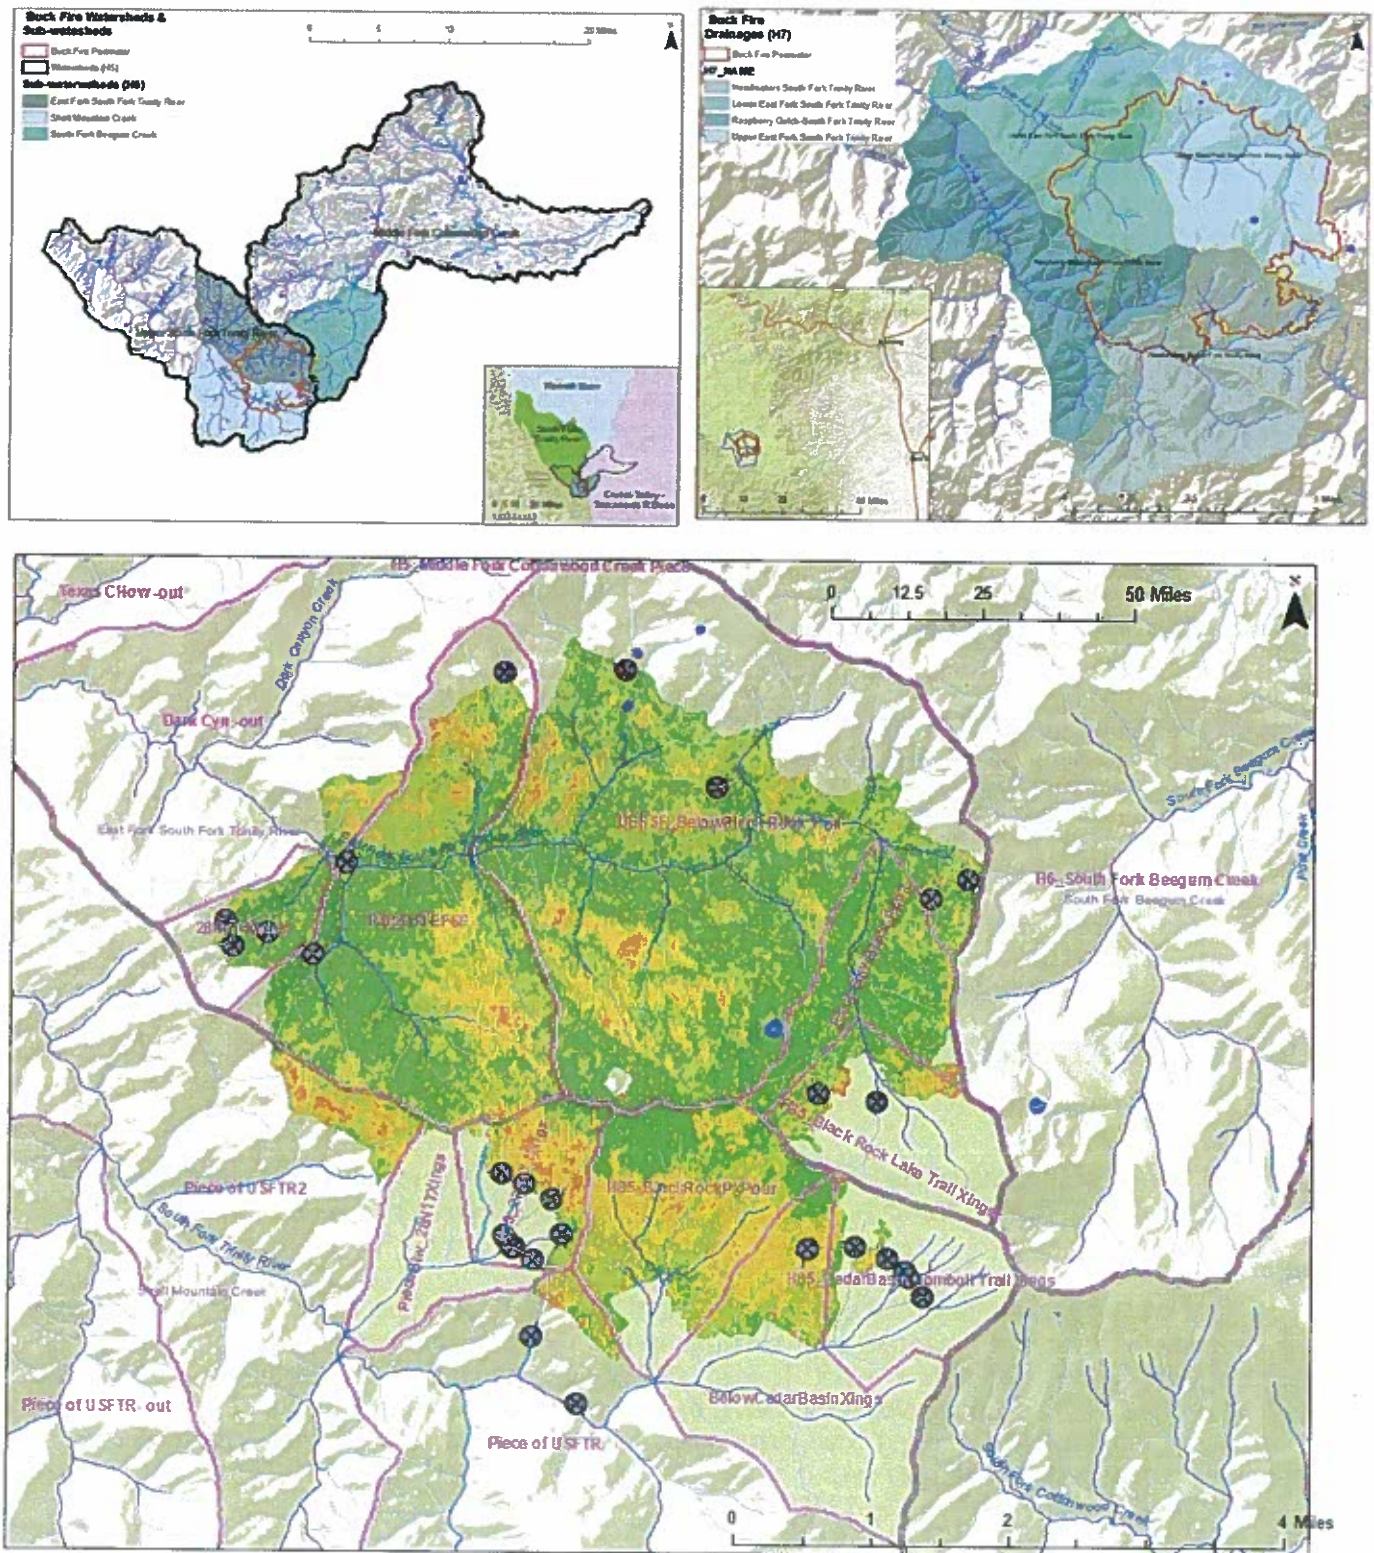
Figure 4: Watersheds of Concern
Pre and Post Fire Peak Flow Model Results:

Increases in peak flows result in rapid transport of loose materials such as floatable debris and increased fine sediment from accelerated hillslope erosion delivered to streams. This causes elevated nutrients, suspended sediment, turbidity, and accumulation of fines in pool and spawning habitat. In addition, accelerated surface and fill erosion on forest roads may result in delivery of fine sediment to stream channel. In some cases this can lead to failure at undersized pipes.
