Date of Report: September 23, 2013

BURNED-AREA REPORT
(Reference FSH 2509.13)**PART I - TYPE OF REQUEST**

A. Fire Name: Hardluck

B. Fire Number: WY-SNF- 251C. State: WyomingD. County: ParkE. Region: 2F. Forest: ShoshoneG. District: WapitiH. Fire Incident Job Code: P2HR4QI. Date Fire Started: 07/17/2013J. Date Fire Contained: 09/16/2013K. Suppression Cost ~ \$723,981 on 9/12/2013

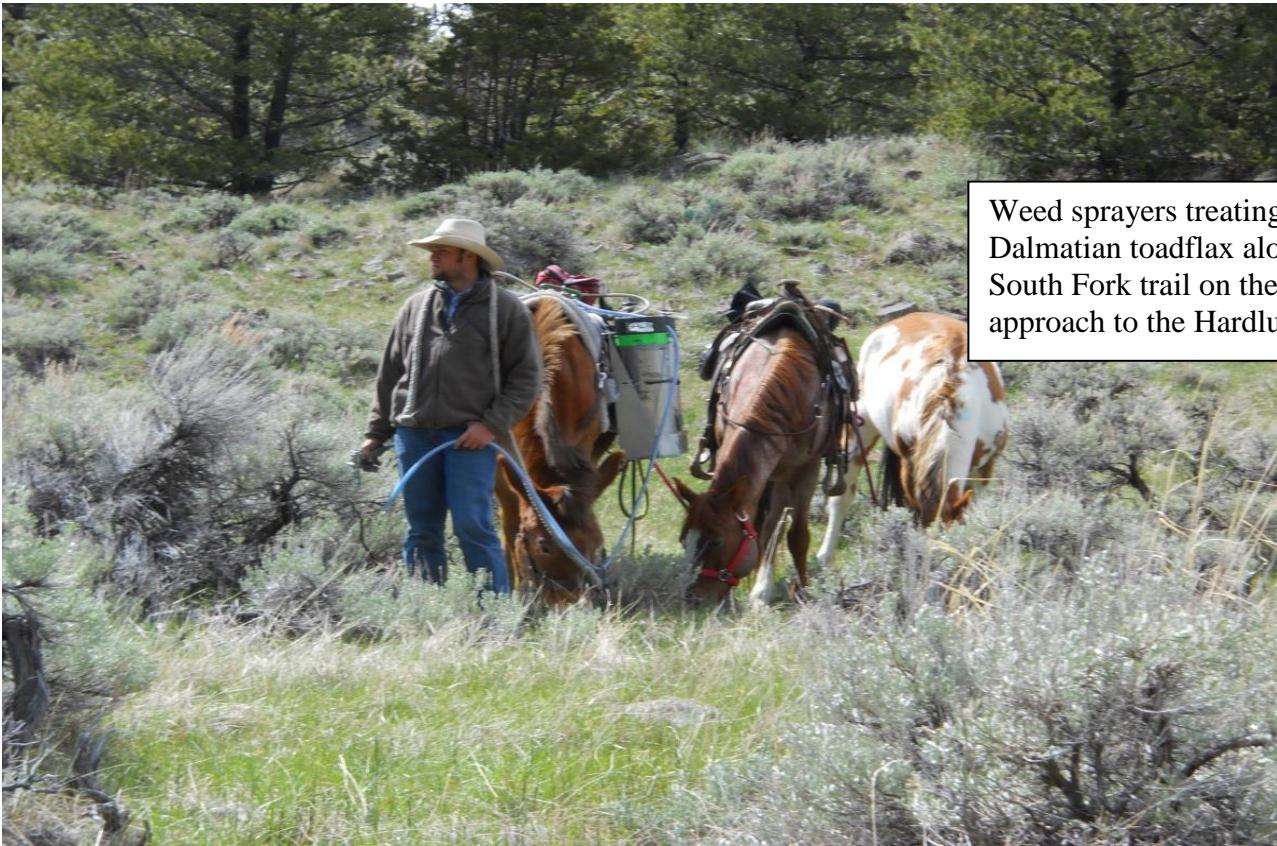
Approximately 1000 gross acres of a known Dalmatian toadflax infestation occur adjacent to the fire area. New infestations can easily start in nearby burn areas.

Weed sprayers treating Dalmatian toadflax along the South Fork trail on the approach to the Hardluck Fire.

If emergency mitigation activities are not implemented this problem will expand exponentially and will require future extensive resources to manage. If left unmanaged the results could permanently alter plant communities and habitat. Results of uncontrolled weed spread are well documented. Without treatment, weeds will increase.

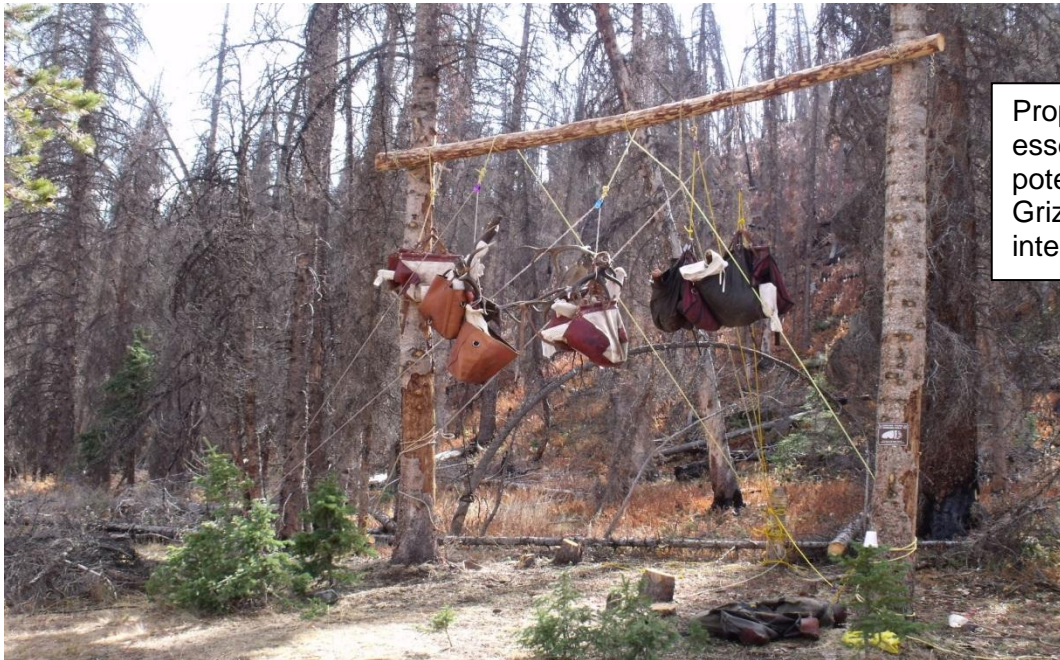
The Grizzly bear is listed as a threatened species. One of the main methods of reducing human contact and conflict in the backcountry is through proper food storage. Within the burn area 6 of the 24 “Bear poles” that are used to keep food unavailable to grizzly bears in outfitter and dispersed sites were burned. Replacement of these poles is essential to maintain safe working conditions for trail crews and the general public.

Proper food storage is essential to reduce the potential of life threatening Grizzly bear - human interaction.
