READING FIRE BURNED-AREA REPORT
(Reference FSH 2509.13)

A. Fire Name: Reading Fire
 B. Fire Number: CA-LNP-G3H7
 C. State: CA
 D. County: Shasta
 E. Region: 5
 F. Forest: Lassen & LNP
 G. District: Hat Creek
 H. Fire Incident Job Code: P5G4HN
 I. Date Fire Started: July 23, 2012
 J. Date Fire Contained: August 22, 2012
 K. Suppression Cost: \$16 million

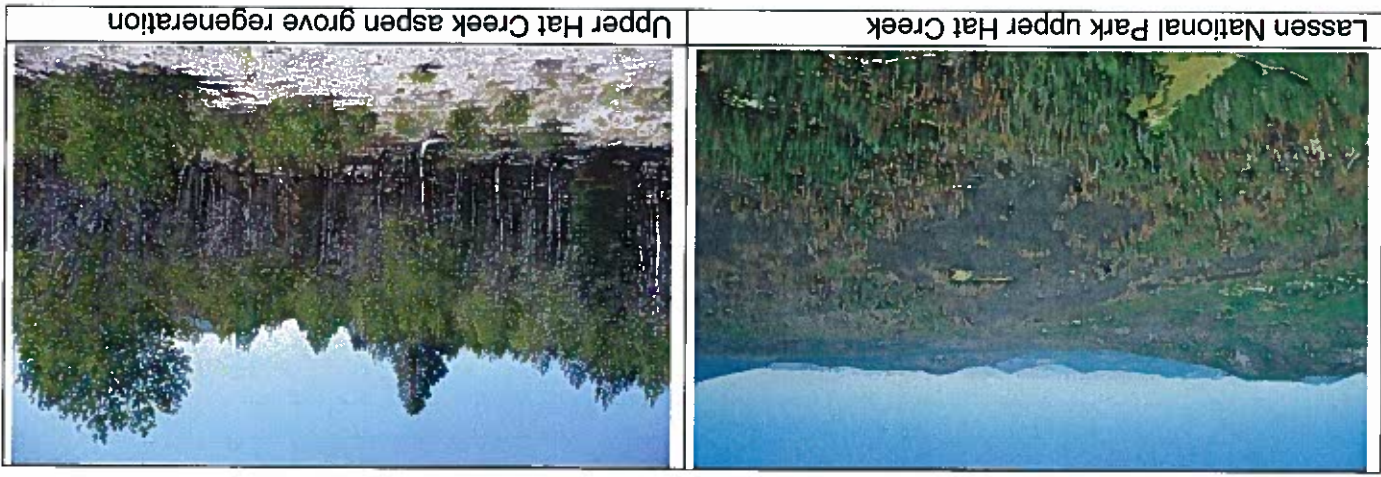
Upper Hat Creek Aspen Restoration Project: These areas are lodgepole thickets that are completely consumed that have residual Quaking aspen groves that were choked out by lodgepole. After the fire these areas will come back rapidly with lodgepole choking out aspen groves. These areas need to be restored to aspen groves through hand thinning of lodgepole and fencing to reduce competition for aspen regeneration and meadow development. Soils are sandy loams that have high water tables making them ideal for aspen. See Botany report.
