DRAFT SOBERANES 2 BURNED AREA REPORT
(Reference FSH 2509.13)

A. Fire Name: Soberanes 2 Fire

B. Fire Number: CA-BEU-003422

F. Forest: Los Padres

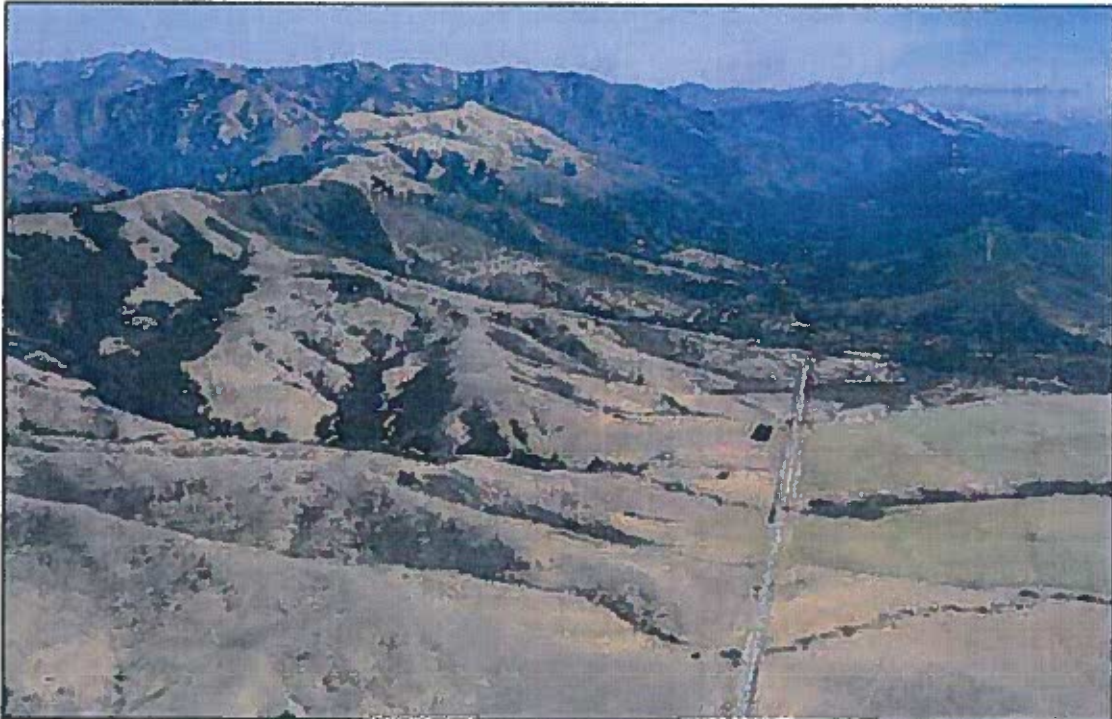
The Soberanes 2 Fire of 2016 looking at Big Sur River drainage.

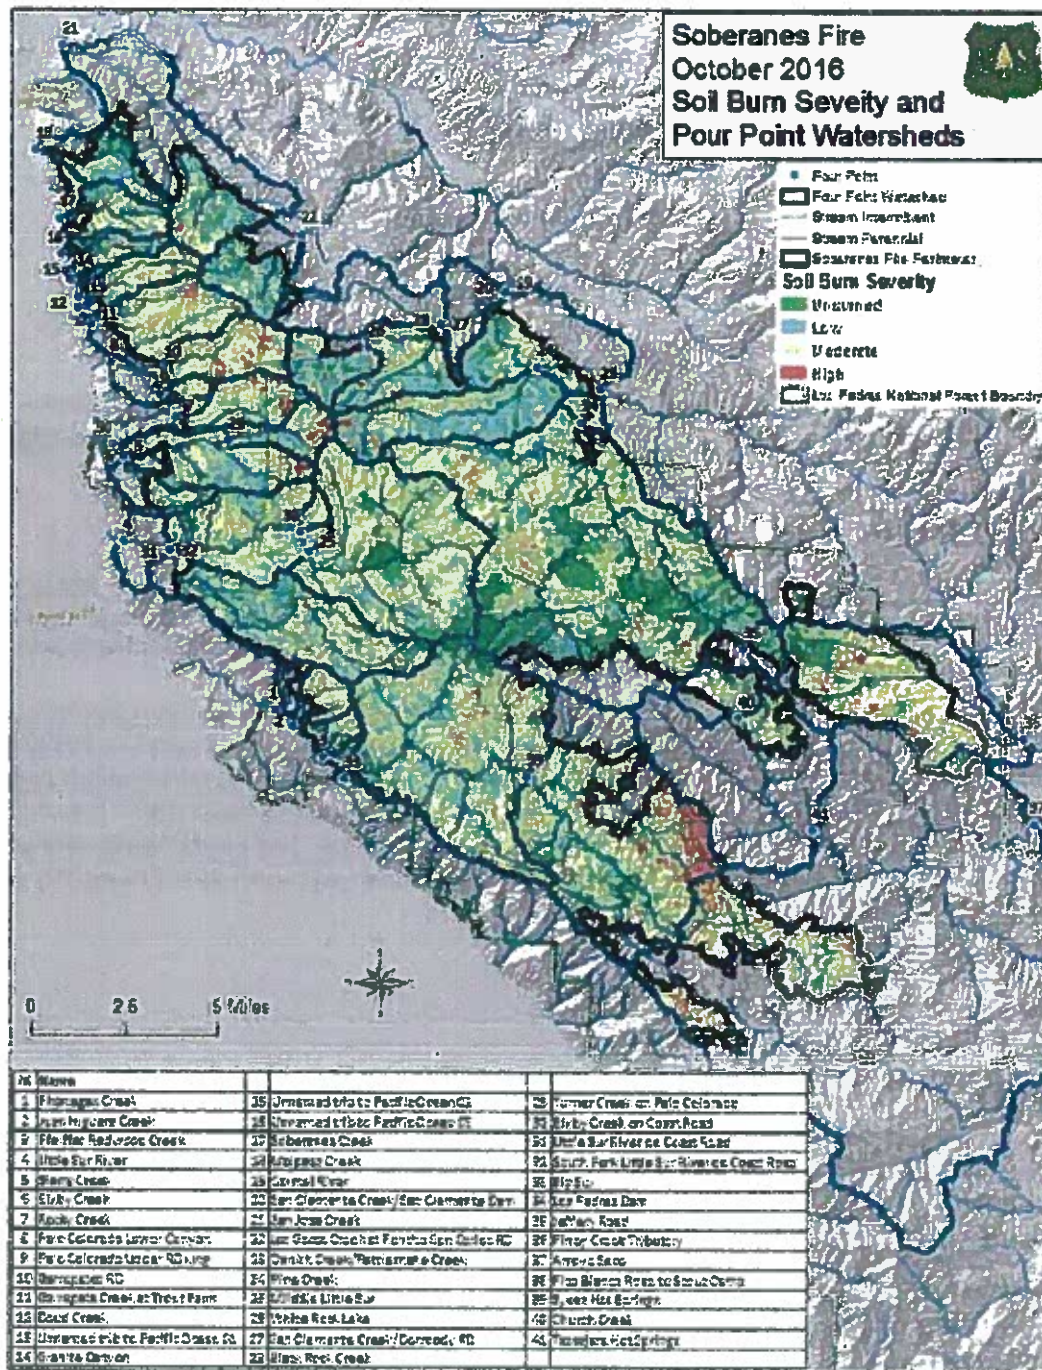
Figure 1 – Soil Burn Severity Map for the Soberanes 2 Fire

The following soil burn severity map (Figure 1) illustrates the general soil burn severity pattern on the landscape. The soil burn severity is overwhelmingly moderate (59%) and low (32%). In most of the moderate burn severity, and some of the low severity (particularly on south-facing slopes), there is very little vegetation or ground cover remaining except surface rock. There is only 2% high soil burn severity because of the low pre-fire ground cover, and partly because the fire was heavily wind-driven and had short residence times. Very low soil burn severity was 6% of the fire area.

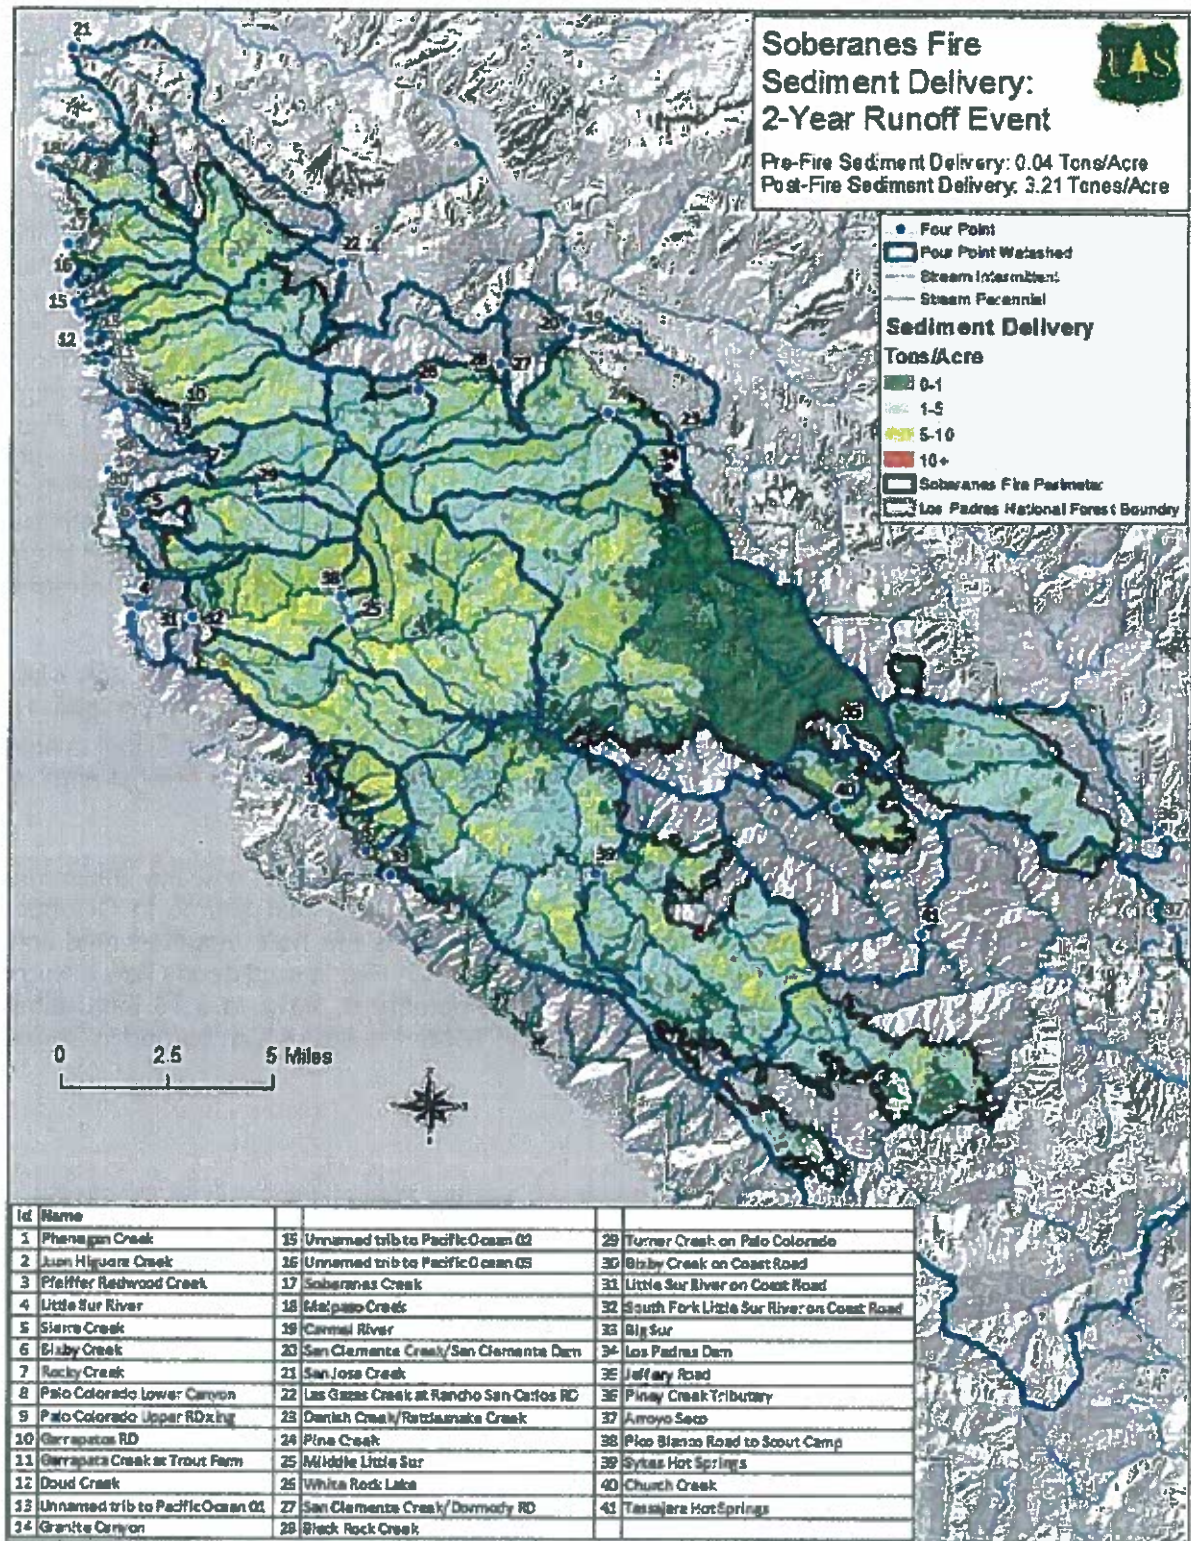
Figure 4 – Sediment Delivery for 2-Year Runoff Event

Sedimentation Rate (Tons/Acre)					
		2 Year		10 Year	
Pourshed	Acres	Burned	Unburned	Burned	Unburned
Arroyo Seco	76,589	0.4	0.1	2.9	1.3
Big Sur	30,022	6.6	0.3	35.2	12.6
Church Creek	1,793	1.3	0.1	2.9	1.3
Jeffery Road	788	0.0	0.0	2.1	2.0
Los Padres Dam	28,771	1.9	0.0	6.2	2.1
Pico Blanco Scout Camp	377	4.0	0.0	11.0	2.4
Piney Canyon Road	10,210	1.5	0.2	11.2	3.8
Sykes Hot Springs	15,623	1.9	0.1	13.3	5.0
Tassarajara Hot Springs	12,797	0.5	0.1	3.9	1.6
Average	19,663	2.0	0.1	9.8	3.6

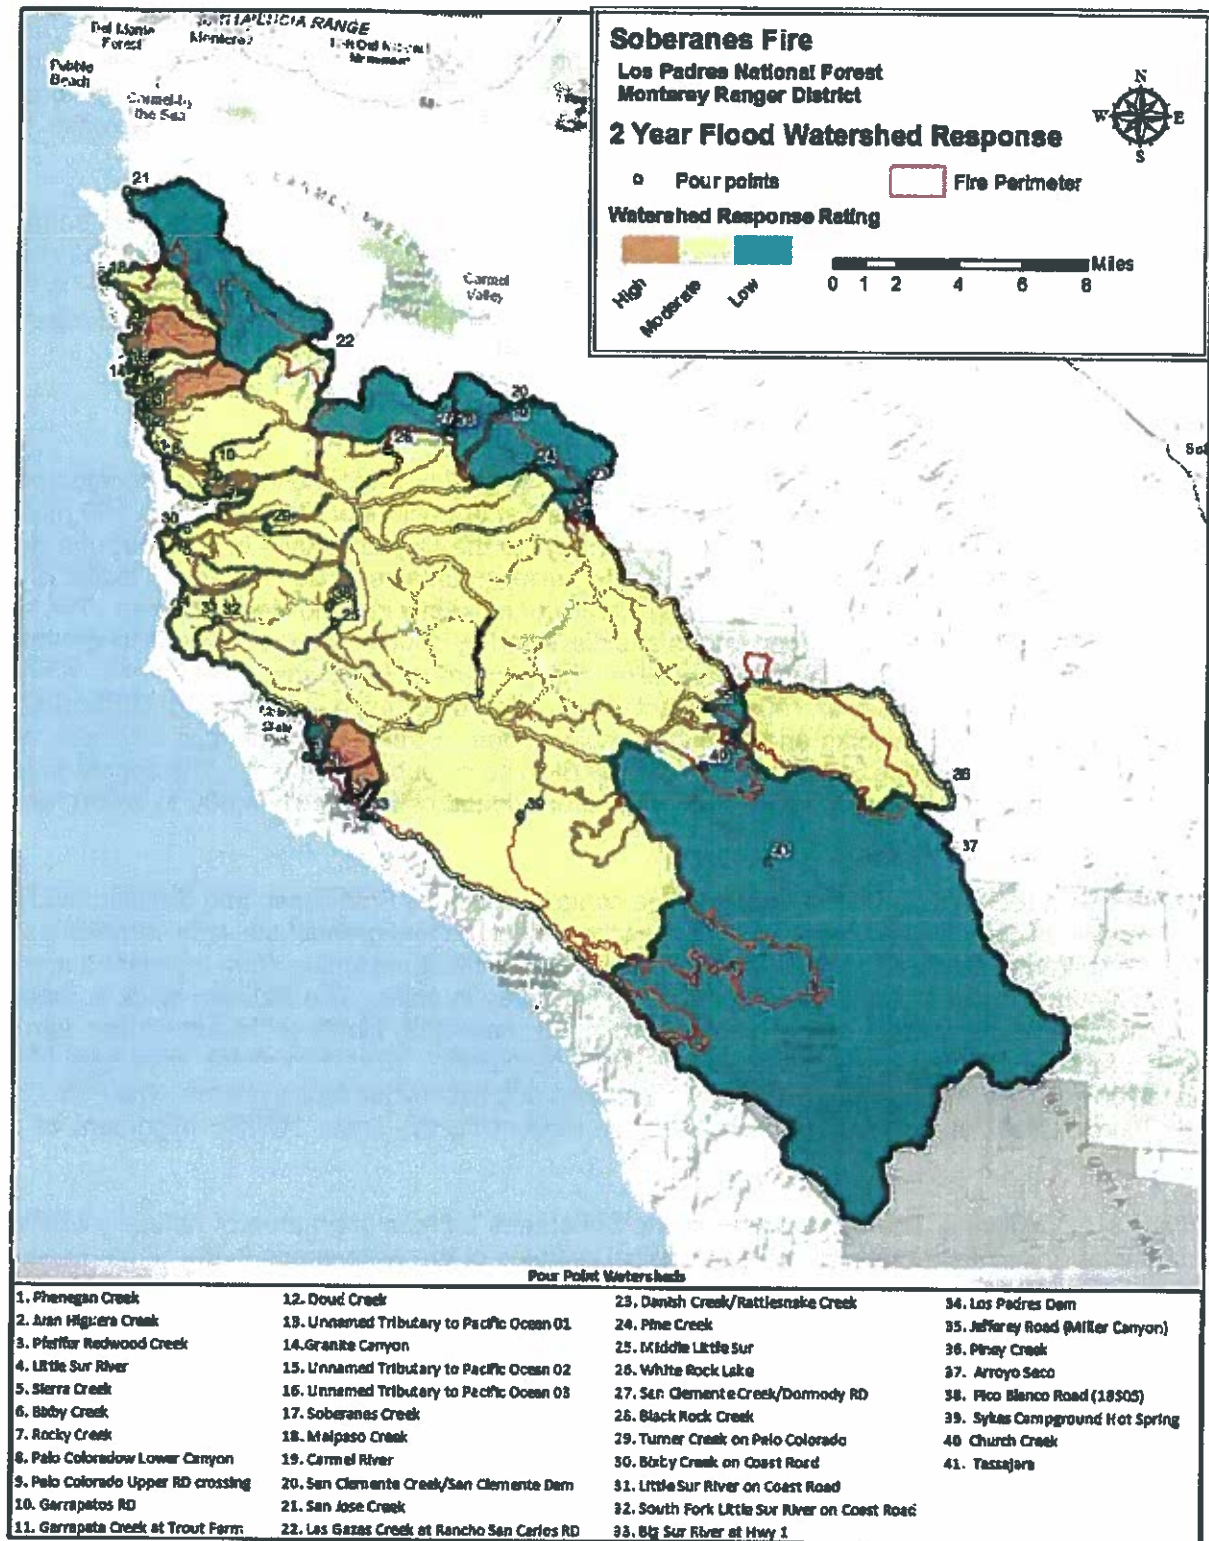
Figure 5 – 2-Year Storm Watershed Response

Watersheds along the coast are expected to have the highest post fire watershed response. State and private property and state, county and private roads within and downstream of these areas are identified as values at Risk.

The increase in peak flows is most applicable during the first year of recovery, as hydrologic response will decrease in subsequent years. Predicted post-fire peak flows show an increase of about one to three times pre-fire values. The peak flow values highlight the post-fire effects on the Fire, with the most increase reflected in watersheds where burn severity is moderate and high and where the greatest susceptible soils are affected. The early precipitation events fill in available slope detention storage and create the rill and gully networks that are necessary to fully induce the expected increase in flood response from rainstorms.

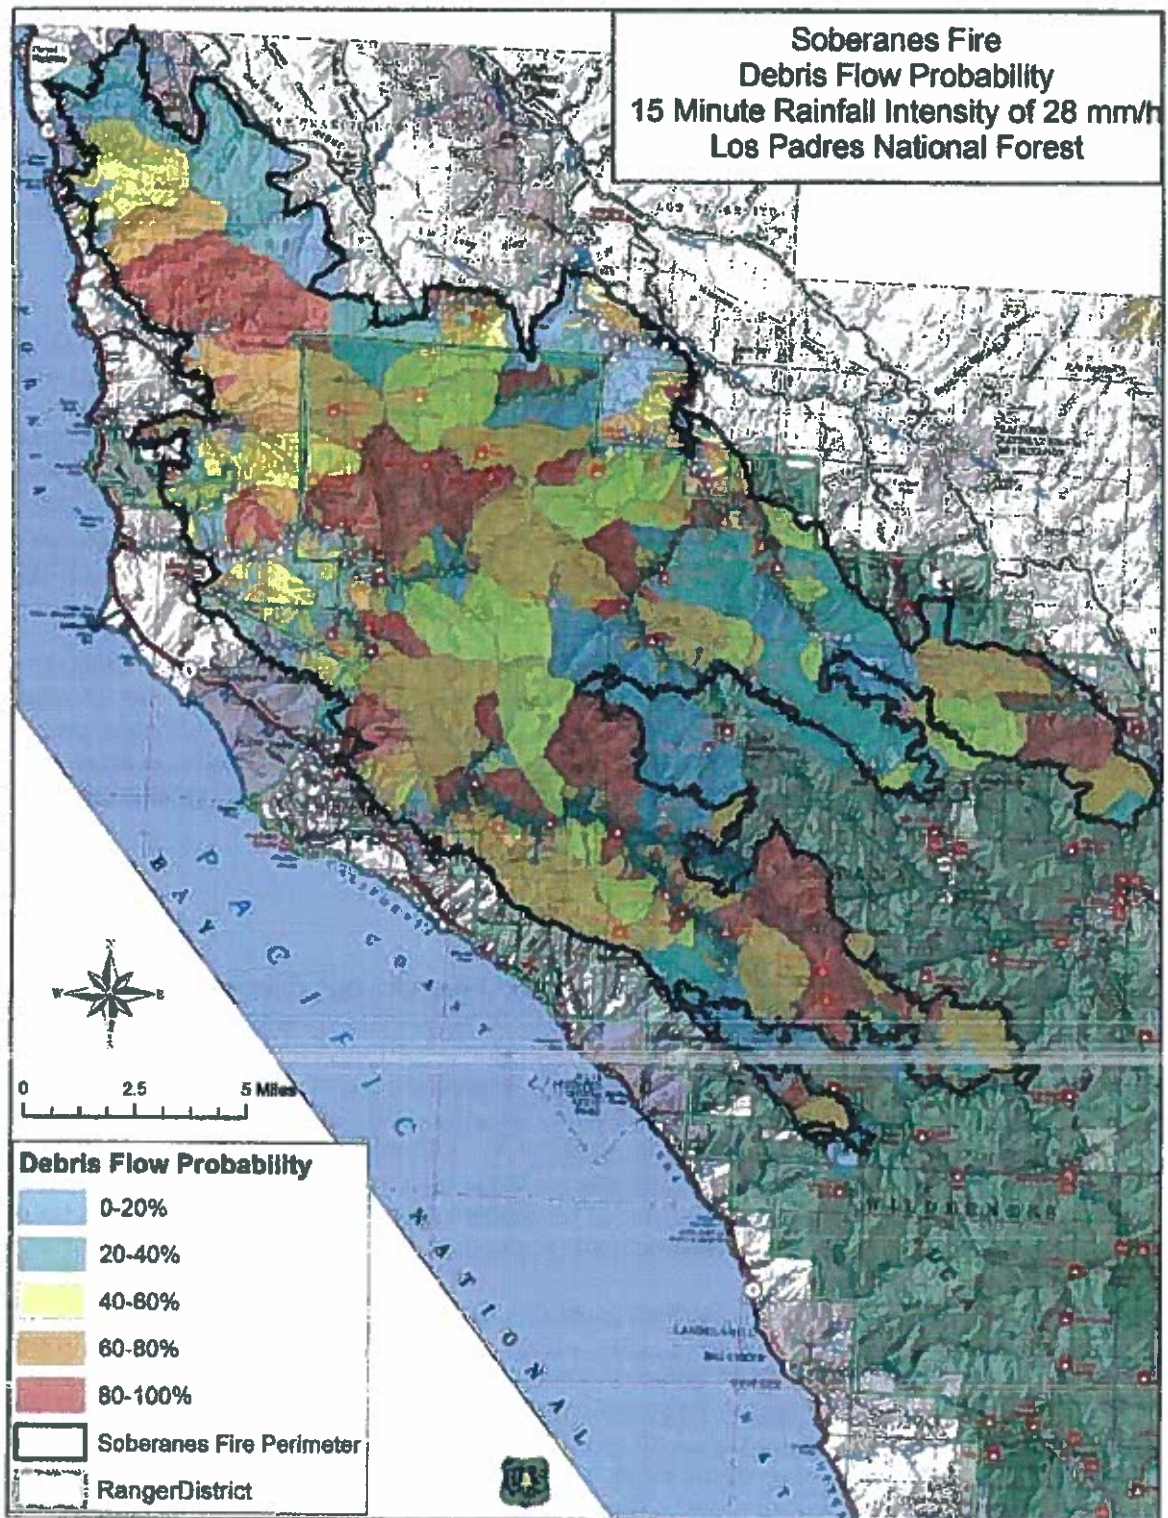
Figure 6 – Predicted Debris Flow Probabilities for the Soberanes 2 Fire

Based on USGS debris flow modeling, basins / creeks in the Soberanes 2 fire burned area have a wide range of probability (0-100%) of producing debris flows. Similarly, predicted volumes of debris flows through-out the burned area range from under 1k cubic meters to 100k cubic meters. Even though some creeks are predicted to produce debris flows with high probability and /or high volumes, based on field observations and the parent rock material not all of these creeks / slopes contain the surface rocks to produce those large and destructive debris flows. From analyzing the combined hazard maps, it is clear that even though high hazard debris flows drainages exists through-out the burned areas, the concern areas are focused on the creeks and drainages located directly above existing communities, private residences and State Park facilities

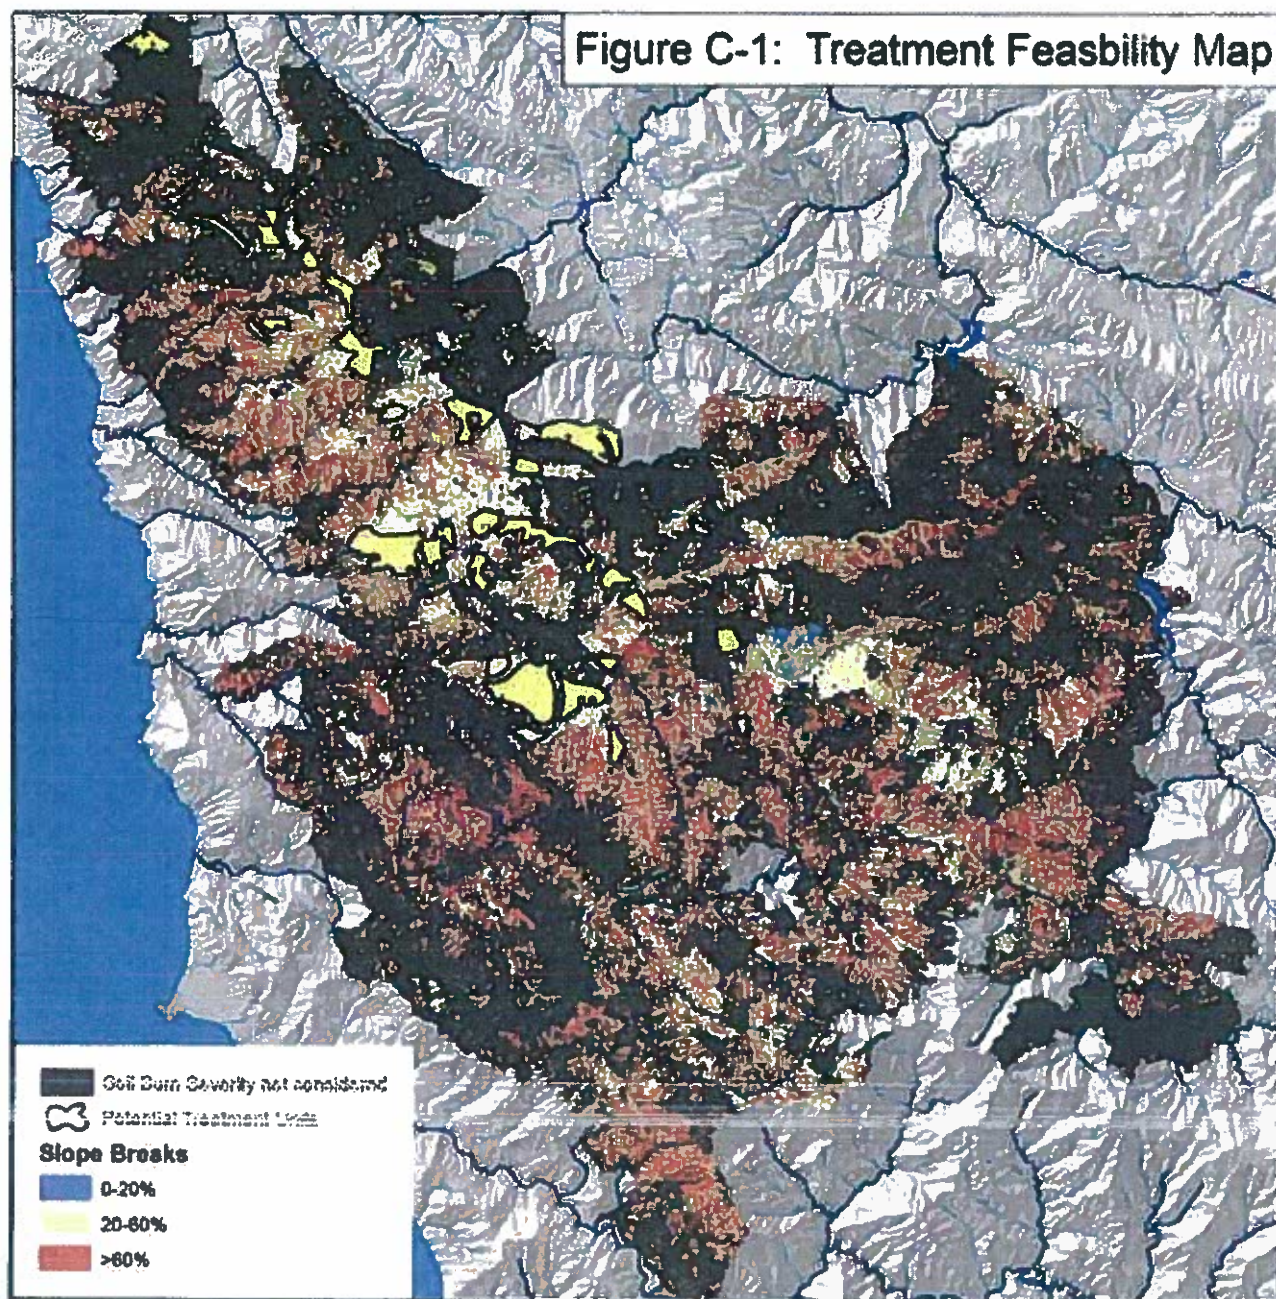
Figure C-2: North versus south aspect vegetation differences as shown in Turner Creek.

either were browned or remained intact. It is expected that natural needle fall will provide enough soil cover to lessen the hydrologic response of the first damaging storm. In addition, mulch applied to a forested stand with high canopy retention results in mulch interception in needles and branches greatly decreasing the efficacy of mulch applications. Figure C-2 depicts the burn characteristics differences between north and south aspects with *moderate* soil burn severity.
