Date of Report: September 12th, 2013

**DUGAN FIRE
BURNED-AREA REPORT**
(Reference FSH 2509.13)

PART II - BURNED-AREA DESCRIPTIONA. Fire Name: DuganB. Fire Number: MT- MCD - 171C. State: MontanaD. County: CarterE. Region: Northern (1)F. Forest: CusterG. District: SiouxH. Fire Incident Job Code: PDG8DCI. Date Fire Started: 09/14/2012J. Date Fire Contained: 9/19/2012K. Suppression Cost: TOTAL: \$684,300**L. Fire Suppression Damages Repaired with Suppression Funds**

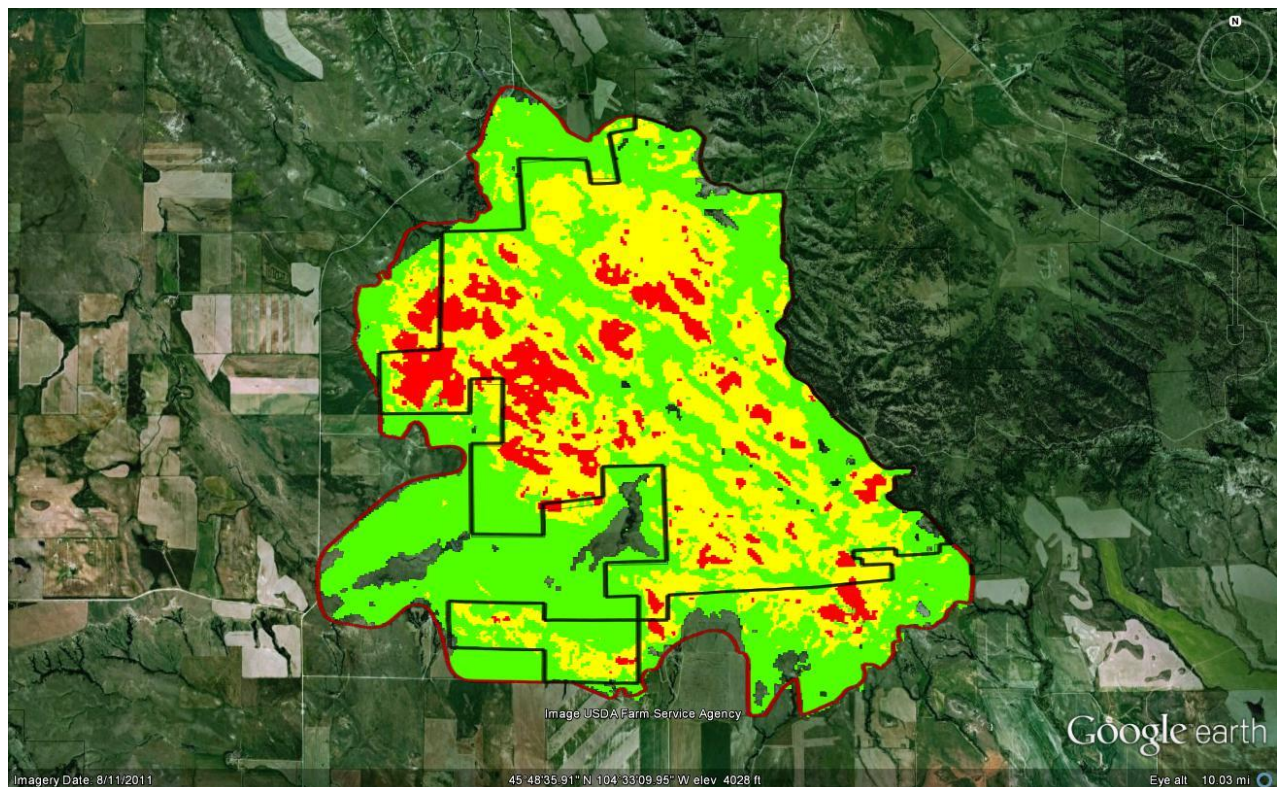
Figure 1. Dugan Fire Burn Severity Map (Red=High; Yellow=Moderate; Green=Low)

The Dugan Fire had substantial areas of high severity burn on the National Forest portion of the fire within the Sioux District boundary. Ponderosa pine stands, with their higher fuel loadings, generally burned much hotter than adjacent grasslands, particularly on north facing slopes. These areas have the majority of the post fire values at risk that can be addressed by the Burned Area Emergency Response (BAER) authorities. Downslope and downstream areas of concern on private land were judged by the NRCS staff as minimal.

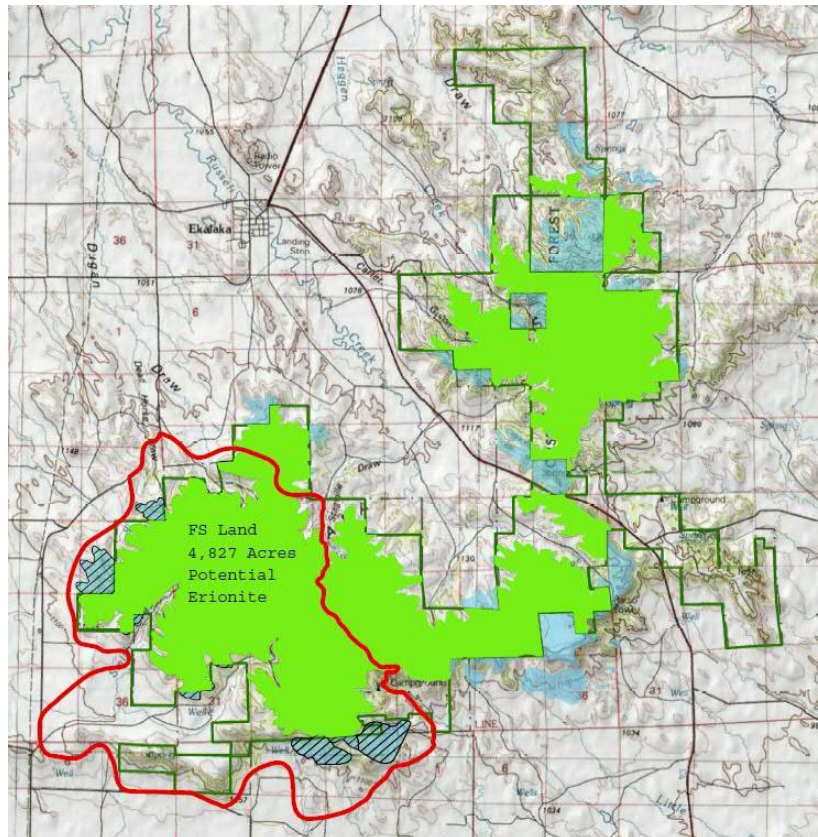
- Erionite:** The majority of the Dugan Fire is underlain by the Arikaree formation. Sampling conducted by the CNF within this geologic formation has identified the presence of erionite, a naturally occurring asbestos form mineral in concentrations ranging from trace to 20%. Recent investigations have identified potential human health and safety concerns associated with inhalation of erionite fibers, similar to concerns associated with asbestos. While presence has been established, extent to which individuals are inhaling erionite fibers when working in this area is unknown. Further, it is unknown how wildfire may affect erionite exposure risk to FS personnel working within the fire perimeter as well as potential for increased off-site travel. *Of note is that all project work proposed within this request will be contingent upon the results of sampling within the fire perimeter to ensure FS employee and contractor safety during implementation.*

- Eolian Transport of Erionite:** High winds common to the area coupled with loss of vegetative cover on areas burned under high and moderate severity fire will be highly conducive to off-site ash and mineral soil transport until understory vegetation recovers. Off-site ash and soil transport may exacerbate erionite exposure for residents adjacent to the Ekalaka Hills. Aerial seeding was explored as an option to mitigate this potential hazard. This treatment was projected to cost between \$800,000 and \$900,000 and has had only marginal success in past applications on the CNF. Because the cost-effectiveness of this treatment is questionable, no request for seeding is being made at this time.

Figure 3. Map of the Dugan Fire perimeter relative to surficial bedrock geology containing erionite.
