Date of Report: 9/17/12

**BURNED-AREA REPORT**  
(Reference FSH 2509.13)**PART I - TYPE OF REQUEST**

**PART II - BURNED-AREA DESCRIPTION**A. Fire Name: MillieB. Fire Number: MT-GNF-000164C. State: MTD. County: GallatinE. Region: 01F. Forest: GallatinG. District: 06H. Fire Incident Job Code: P1G67RI. Date Fire Started: 08/28/2012J. Date Fire Contained: estimated 11/1/12K. Suppression Cost: \$7,800,000 as of 09/14/2012

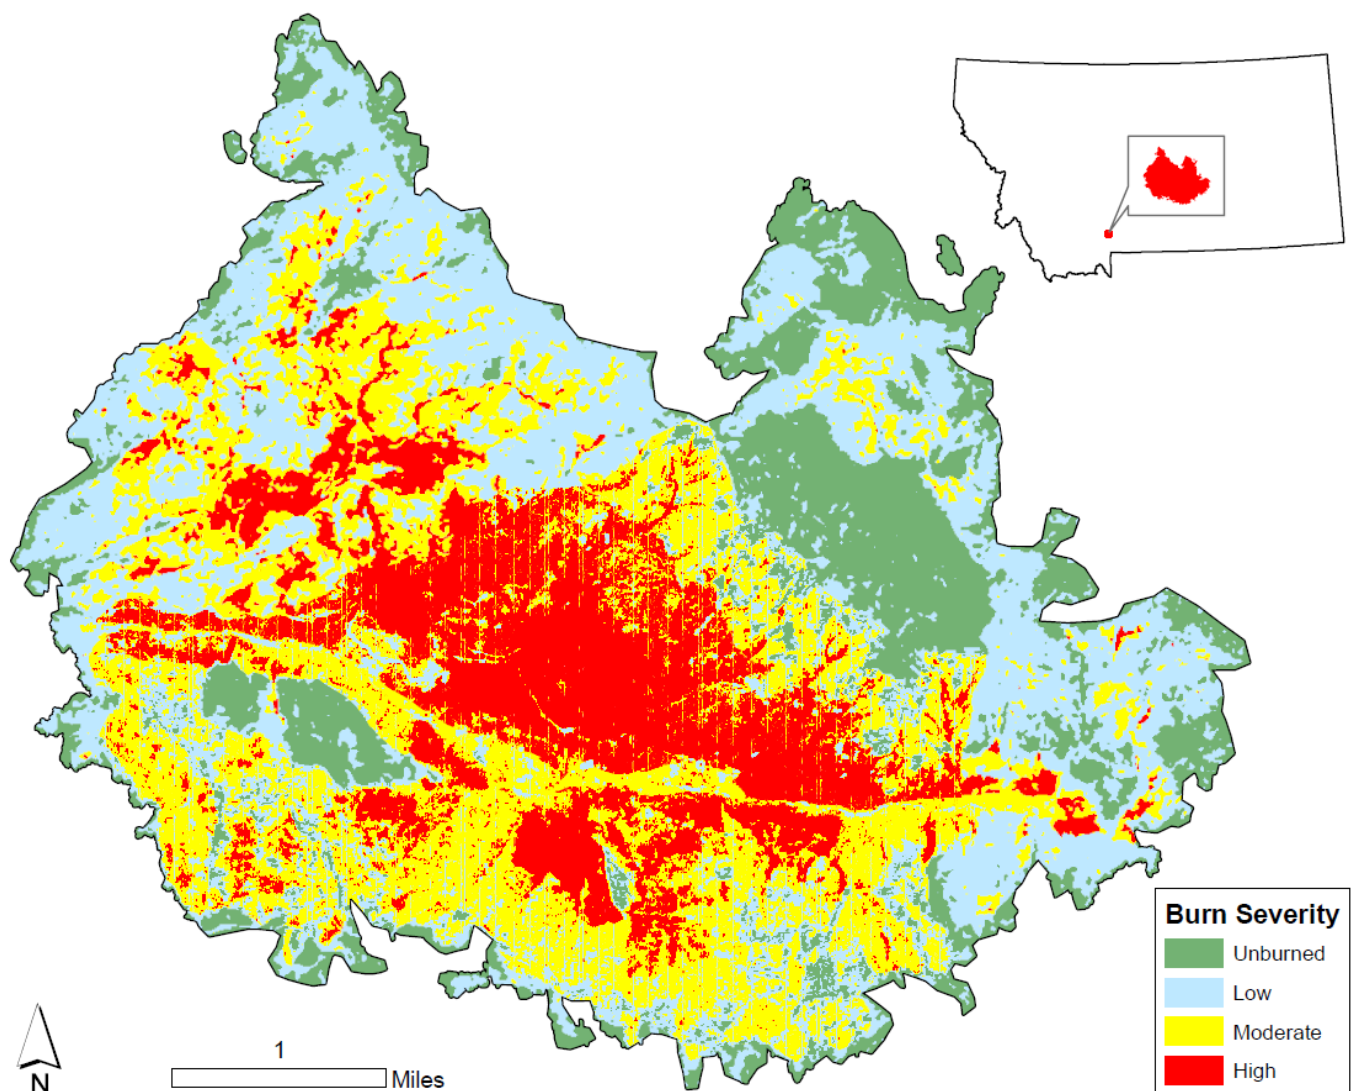
North Central part of the Millie Creek Fire above the Storm Castle Creek Road 132, this watershed has a high runoff, erosion, and debris flow potential.
