BURNED-AREA REPORT
(Reference FSH 2509.13)**PART I - TYPE OF REQUEST**

PART II - BURNED-AREA DESCRIPTIONA. Fire Name: TroughB. Fire Number: P53744C. State: CAD. County: Colusa, GlennE. Region: 05F. Forest: 08G. District: 53H. Date Fire Started: 8/8/2001I. Date Fire Controlled: 9/11/01J. Suppression Cost: \$14 million

Photographs of Trough Fire BAER Treatments

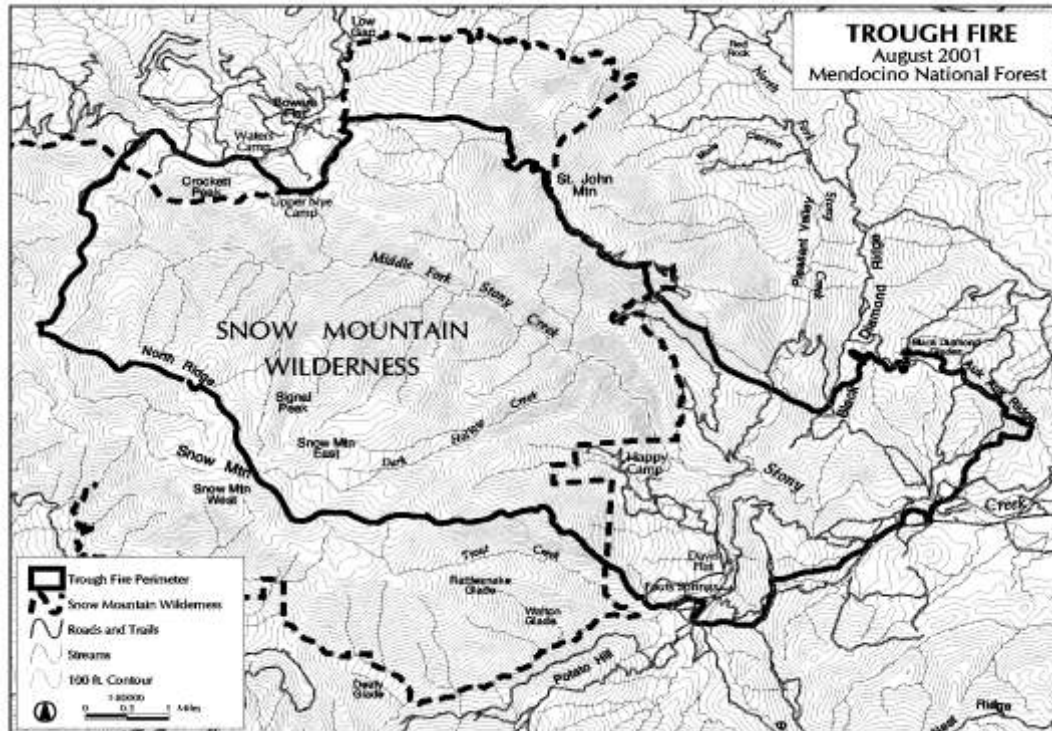
Photograph 1. Outline of the Trough fire. Dark solid black line is the fire perimeter. Noxious weeds were surveyed for on 12 miles of dozer line and 23 miles of handline. Most of the handline was in the wilderness. It was critical to determine no invasive were introduced in fire suppression activities.

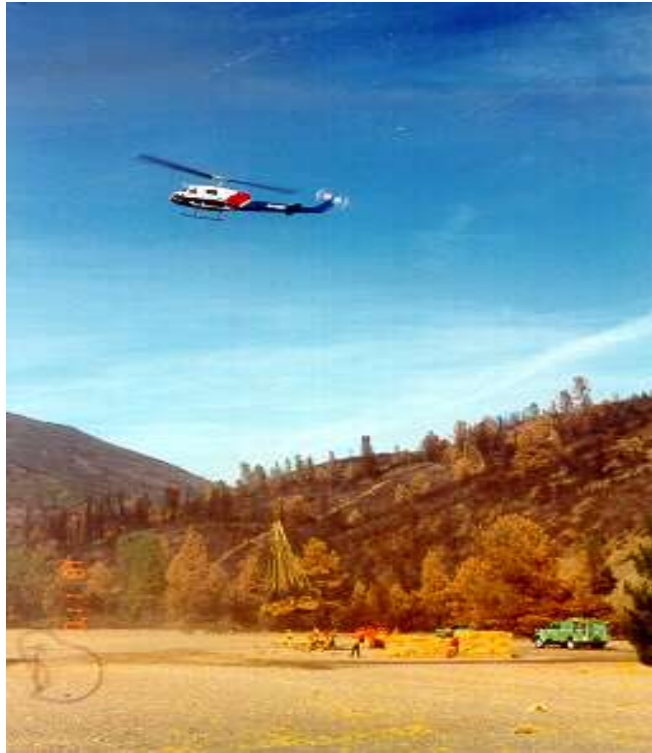
Photograph 7. A type 2 helicopter with a four hook carousel and four nets was used to spread straw. An inmate crew loaded the nets.

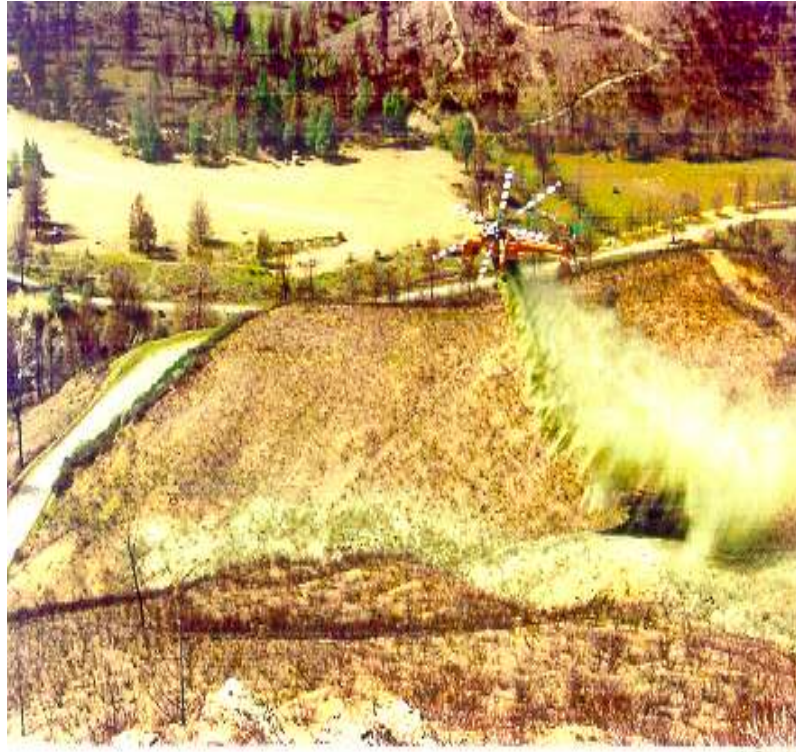
Photograph 13. An Erickson Air-Crane helicopter making a tight turn air drop of hydromulch. Besides aerial straw mulching, aerial hydromulching was another technique evaluated by San Dimas Technological Development Center.
