Date of Report: 09/04/2013

BURNED-AREA REPORT
(Reference FSH 2509.13)**PART I - TYPE OF REQUEST****A. Type of Report**

- A. Fire Name:** Salmon River Complex **B. Fire Number:** CA-KNF-005561
C. State: CA **D. County:** Siskiyou County
E. Region: R5 **F. Forest:** Klamath
G. District: Salmon River Ranger District **H. Fire Incident Job Code:** P5HS98
I. Date Fire Started: July 31, 2013 **J. Date Fire Contained:** 8/30/2013
K. Suppression Cost: \$23 million
L. Fire Suppression Damages Repaired with Suppression Funds

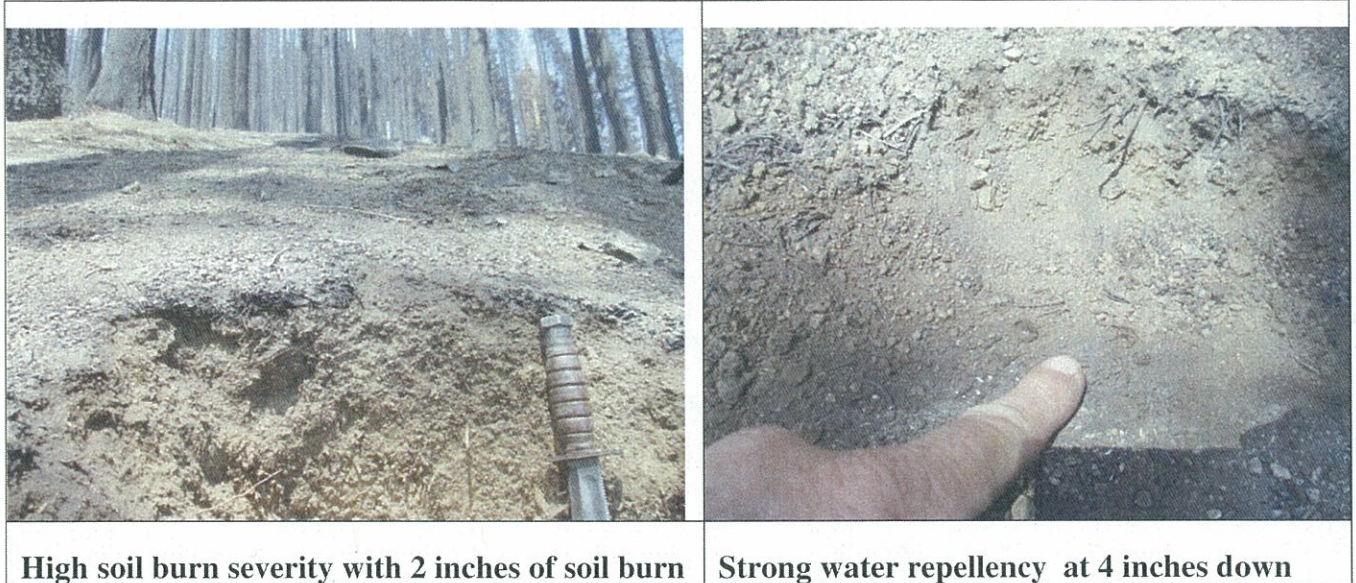
Figure 1 – Pictures of soil burn severity in upper Boulder Creek

Soil burn severity is assessed by looking at above ground cover and surface cover, soil char (depth of soil burning), soil structure, destruction of soil organic matter, destruction of fine roots, and water repellency strength and depth. Water repellency is running from 2 to 6 inches deep depending on soil texture and vegetation that was burned. Landscapes on north or east-facing were steep gravelly loam mixed conifer areas that burned moderately hot leaving strong water repellency down to 2 inches. Char and soil organic matter destruction was also present. Landscapes that were steep gravelly sandy loam P-pine/brush areas that were either south or west-facing burned hot leaving strong water repellency down to 4 inches. Deep char and soil organic matter destruction was also present. Soils within the fire perimeter generally have a weak granular structure consisting of soil microorganisms, soil organic matter, and fine roots. This is present in the upper 1 to 3 inches of most soils and is an important soil property protecting the soil from wind and water erosion. In the moderate and high soil burn severity areas, soil structure was destroyed down to 2 to 4 inches leaving loose unconsolidated single grained material lacking organic matter and soil cover.
